# **STANDEN HALL, WORSTON ROAD, CLITHEROE, LANCASHIRE**

## **Historic Building Survey Report**

**Oxford Archaeology North**

August 2017

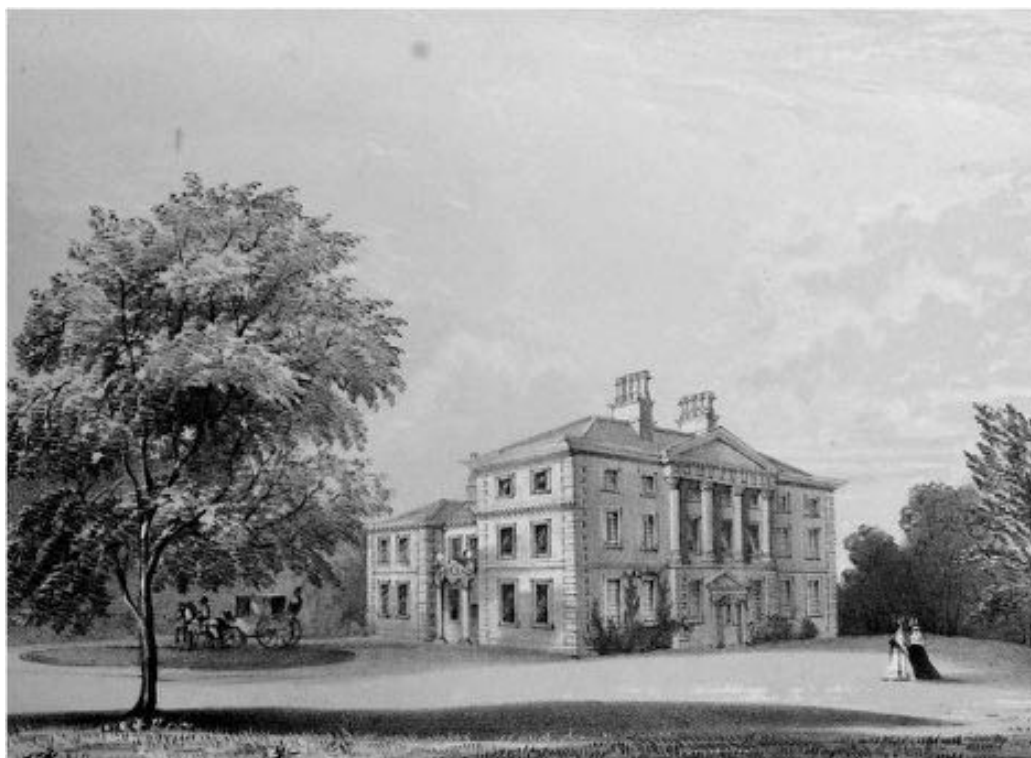
*Plate 1: Standen Hall as depicted in a lithograph of 1847 and prior to the 1856 rebuilding of the west wing*

- 3.2.3 In the eighteenth century, the western wing was rebuilt, possibly on a similar plan to the original, and the southern portion of the central range was also substantially rebuilt, replacing the south elevation completely. The eastern range was also significantly altered with the rebuilding of the southern end and replacement of the eastern elevation with a seven bay Palladian-style façade with a shallow projecting central pediment (Plate 1). Unusually for a hall of this date, the kitchen occupied the northern three bays of this grand wing, probably reflecting the original function of the east wing.

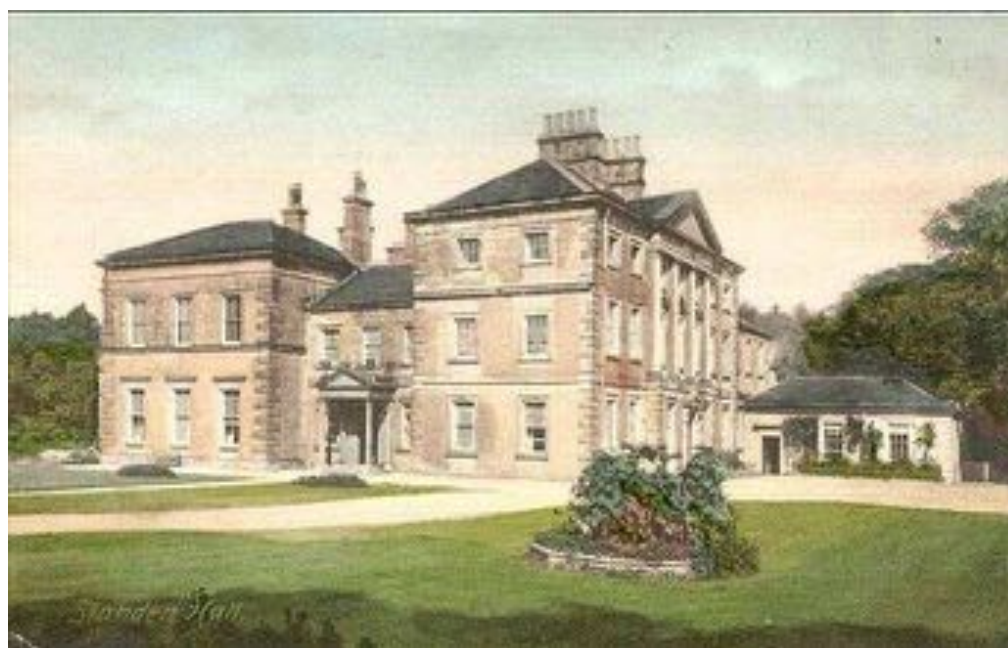
*Plate 2: Early twentieth century photograph, before the extension of the Billiard Room*

eastern wing, a single-storey extension was then erected on an east/west alignment to accommodate a three bay Billiard Room (Plate 2).

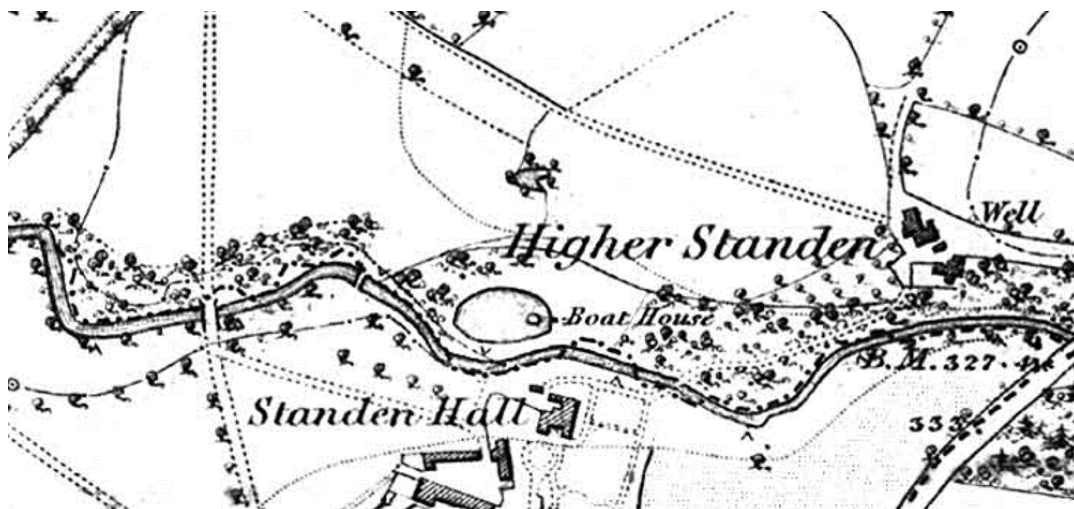
Plate 4: OS 6" map of 1847, showing the Hall with the boating lake to the north and stable buildings to the south-west

- 3.3.2 **OS 1:10560 Map, 1847 (Plate 4):** the 1847 OS map shows the H-plan hall with its northern service range and associated yard. There is a small rectangular detached structure to the north-west of the house and a series of linear rectangular buildings to the south-west, set around a triangular yard, which may be the stables. Despite the elaborate eastern façade, the formal approach still lies to the south, with gardens to the south and east. A large ovoid boating lake appears to the north of the brook, set within a wooded landscape.

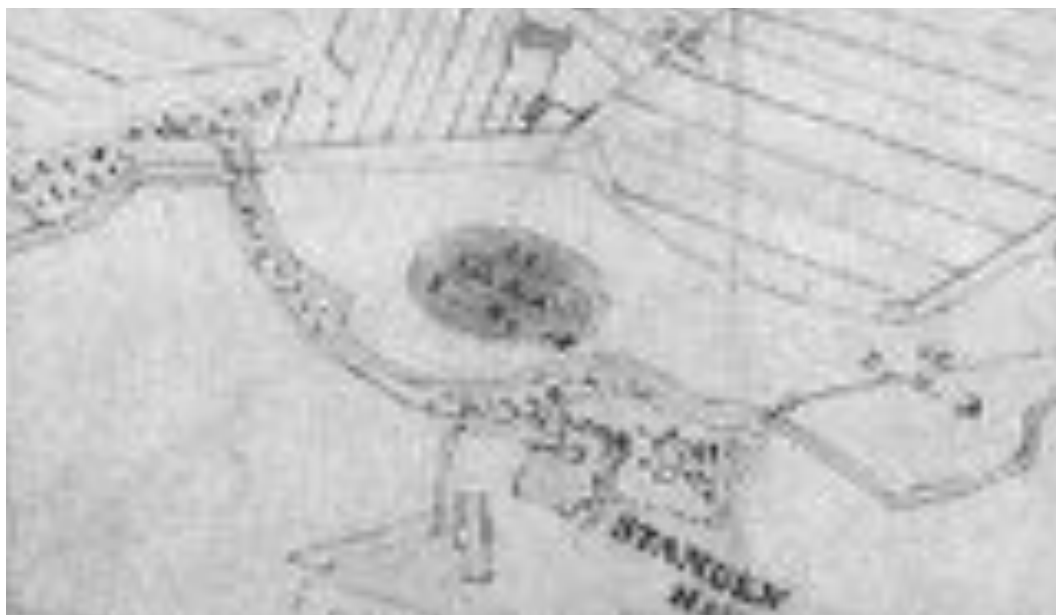
Plate 5: Estate plan of 1870 (reproduced from Bridan 2015)

- 3.3.3 **1870 Estate Plan (Plate 5):** the estate plan of 1870 shows the house after the rebuilding of the southern end of the west wing. The detail is sufficient to identify the as yet unenclosed service yard, although the small rectangular detached building to the north-west of the house is no longer depicted. The triangular stable yard can still be identified to the south-west of the house

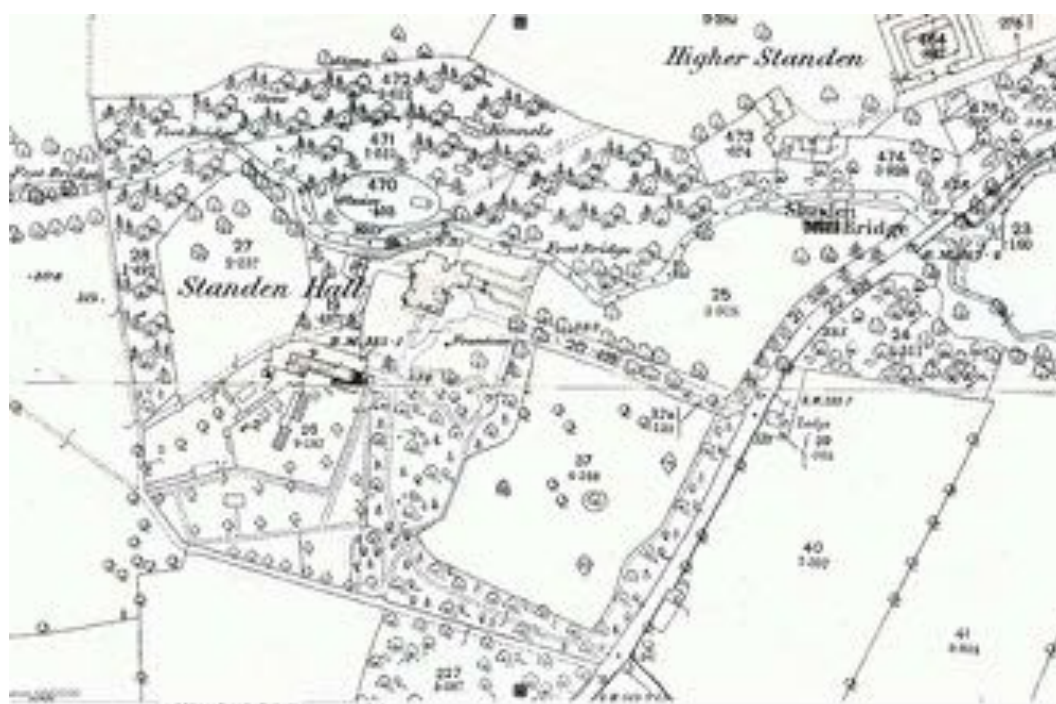
Plate 6: OS 25" map of 1886-93, following the completion of the service wing extension

- 3.3.4 **OS 1:2500 Map, 1886-93 (Plate 6):** the late nineteenth century map shows Standen Hall after the completion of the north-western service wing and Billiard Room. The approach has now been switched to the east, where a tree-lined avenue has been established from the main road. The two northernmost stable buildings closest to the house have been removed.

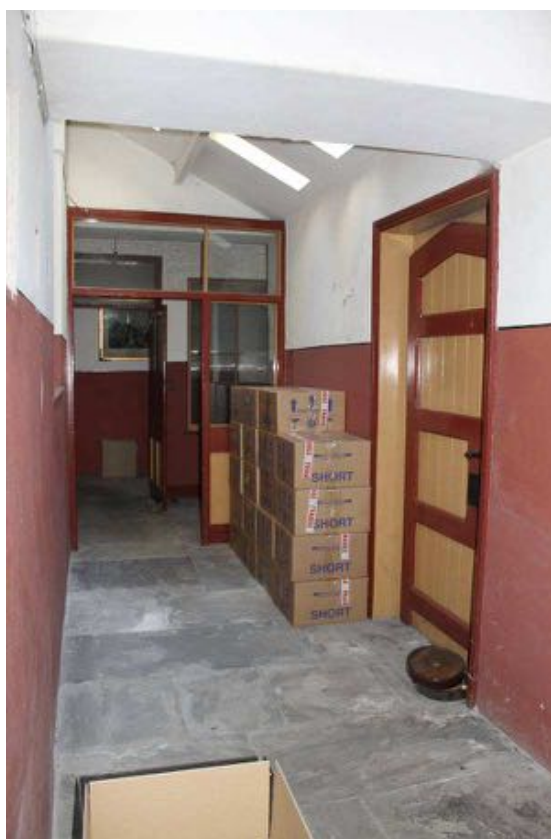
*Plate 7: Room G9a, facing east*

- 4.2.1 **Room G9a (Fig 2):** **Room G9a** formed a short east/west-aligned corridor within in the service wing of the house, with a rectangular circulation area at the western end (Plate 7). To the east it was divided from **G9g** by a glazed partition, while to the south, door **GD47** led into an external yard. At the western end, doorway **GD18** connected **Room G9a** to the south-western wing via a small vestibule **G7b**, with another door **GD19** immediately to the west through which, access was gained to the cellar. At the centre of the western wall, door **GD20** led into the room **G11** to the west, while to the north door **GD25** linked the space to **Room G9b**.

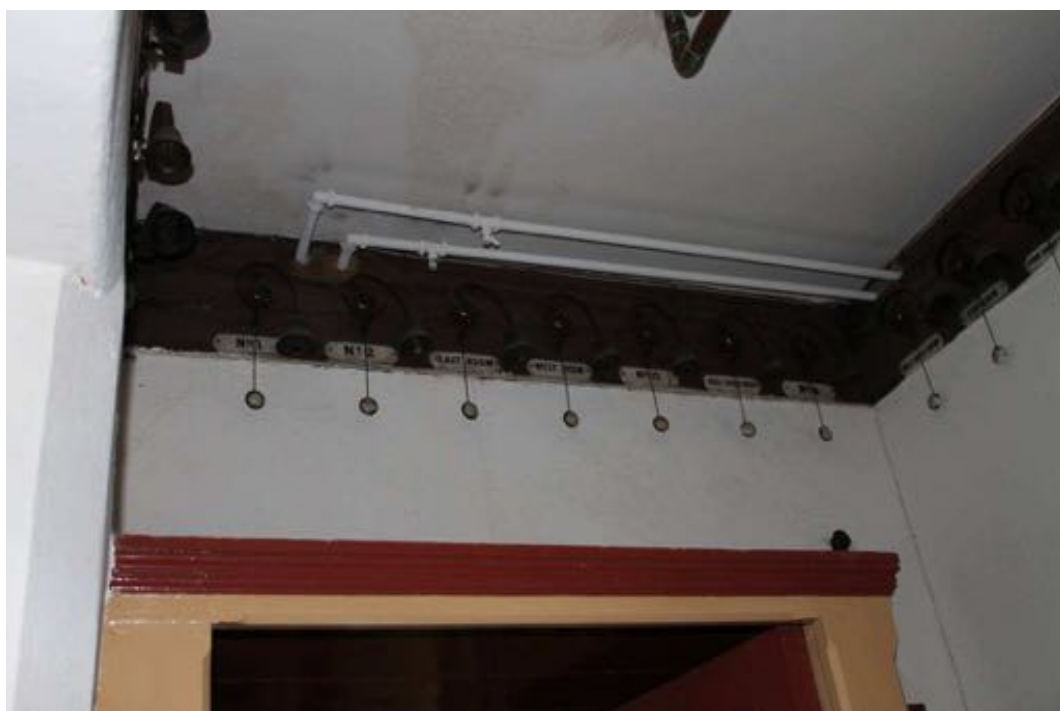
*Plate 8: Servants bells at western end facing south*

- 4.2.4 Lining the head of the southern, eastern and western walls, below a moulded picture rail were a series of white name plates, recording the names of 27 of the rooms in the house in black lettering (Plate 8). Each name was accompanied by a spring-mounted bell, with an attached pendulum to indicate which room that required service, except the front door where the original bell had been replaced with a modern electric bell.

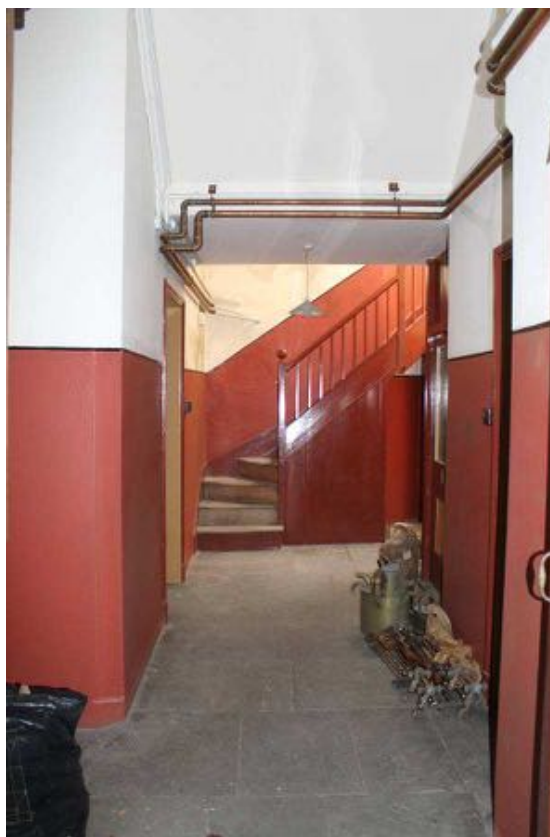
Plate 10: **Room G9b** facing north

- 4.2.6 **Room G9b (Fig 2):** this room was a north/south-aligned corridor that connected several service rooms within the north-western corner of the building (Plate 10). To the west, it was connected to the east/west-aligned corridor **G10**, and north of this to the scullery **G12** via door **GD29**. At the northern end it led onto corridor **G13**, while to the east it provided access to the cellar via doorway **GD30** and to room **G9c** through doorway **GD26**. At the southern end, a glass and timber door **GD25** led into the circulation space at the western end of **Room G9a**.
- 4.2.7 The corridor was plastered and decorated in the same white-over-red scheme as **Room G9a**, with red and mustard coloured doors, and the flagstone floor continued unbroken. A number of heating pipes were exposed, running across the ceiling.

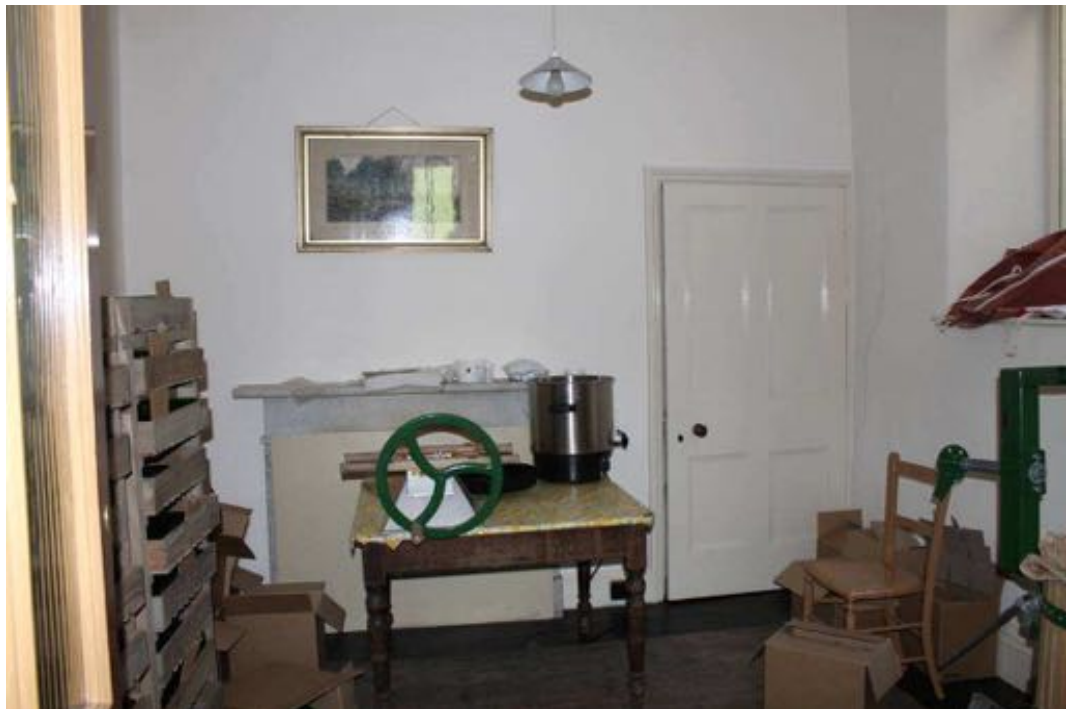
- 4.2.8 **Room G9c (Fig 2):** this was a small square room, located at the heart of the service wing and accessible from **Room G9b** via doorway **GD26**. The walls were plastered and painted white and there was a moulded skirting board (Plate 11). The ceiling was undecorated and the floor laid down to floorboards, with the margins of the floor painted black to suggest that a large rug or other floor covering had once been fitted. At the centre of the east wall lay a boarded over fireplace with marble surrounds and beside this, a cupboard had been built into the space to the south of the chimney breast, fitted with a four-panel door **GD27**.
- 4.2.9 Although the room had no external walls, natural light was borrowed from **Room G9a** via a two-light window **GW45** occupying the eastern half of the

*Plate 11: Room G9c, facing east*

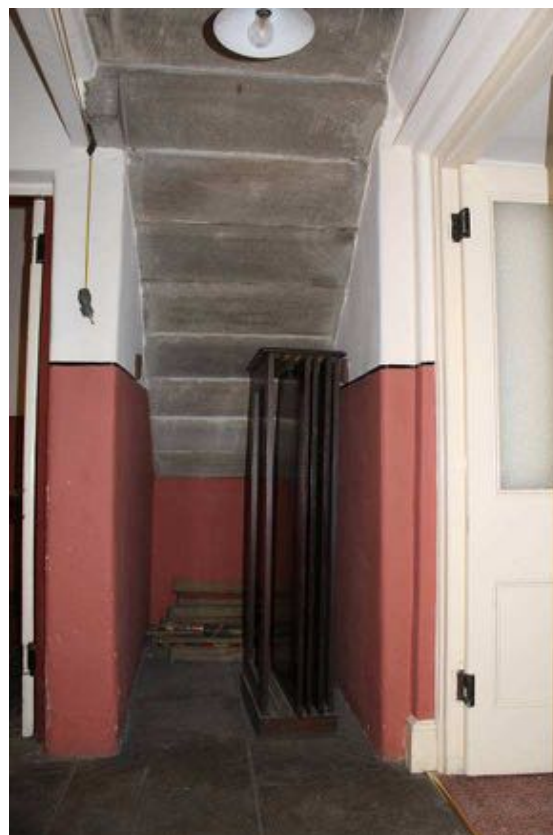
*Plate 12: Room G9d, facing south*

- 4.2.10 **Room G9d (Fig 2):** was a small corridor immediately to the south of the kitchen **Room G15** that also served as a landing at the foot of staircase **Room F14c** from which, it was divided at the western end by doorway **GD37** (Plate 12). At the eastern end, a small service cupboard **Room G9e** had been partitioned off and doorway **GD39** led through into the circulation area at the northern end of corridor **Room G9f**. To the west of this lay a narrow space sitting beneath staircase **Room F14g** and on the opposing wall doorway **GD36** that led into the Kitchen. The room repeated the red and white decorative paint scheme previously described, had a moulded white skirting board and a floor laid in flagstones.

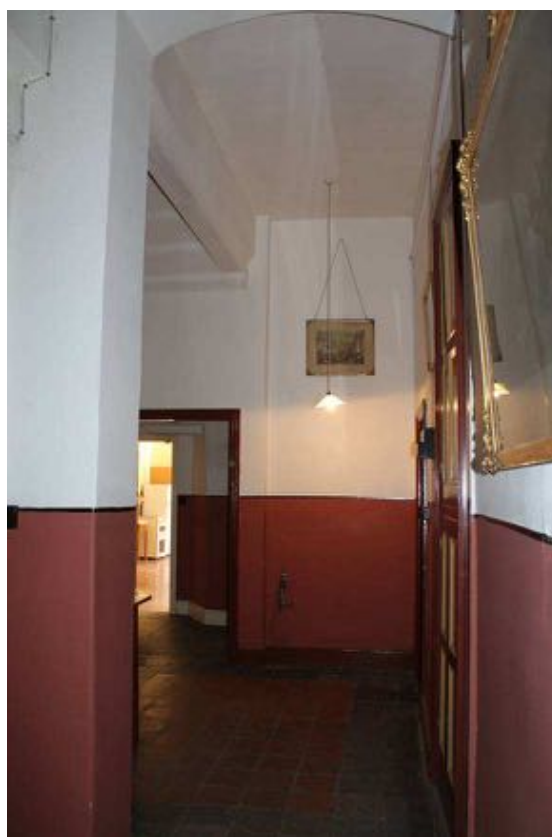
Plate 13: **Room G9f**, facing north

- 4.2.12 **Room G9f (Fig 2):** was a two-cell corridor aligned upon a north/south axis, with a circulation area at the northern end (Plate 13). To the south, a doorway **GD42** connected the space to corridor **G26** while to the west it led into corridor **Room G9g** through doorway **GD44**. A doorway at the northern end **GD39** linked the circulation space to **Room G9d** and another doorway to the east **GD40** led into corridor **G17**.

- 4.2.13 The northern and southern parts of the room were separated by an opening with a shallow segmental arch. Again, the walls of the room had been decorated in the same red and white scheme previously described. To the south, the floor had been laid down to flagstones, the northern portion was covered in red and black ceramic tiles. This difference was accentuated using skirting to the north but not in the southern part. The ceiling in both cells was plain but to the south it incorporated a pair of skylights, reinforced with iron bars and borrowing light from the floor above.

- 4.2.14 On the eastern wall of the northern part of this room, a two-part cupboard had been built into the wall, one above the other **GD41**. Both had been fitted with a pair of two-panel doors, with moulded margins. In addition to the skylight, the southern part was lit by a four-light fixed-frame timber window in the western wall that borrowed light from the adjacent corridor. The slender mullions and transoms held panes of fluted glass to reduce visibility between the two rooms.

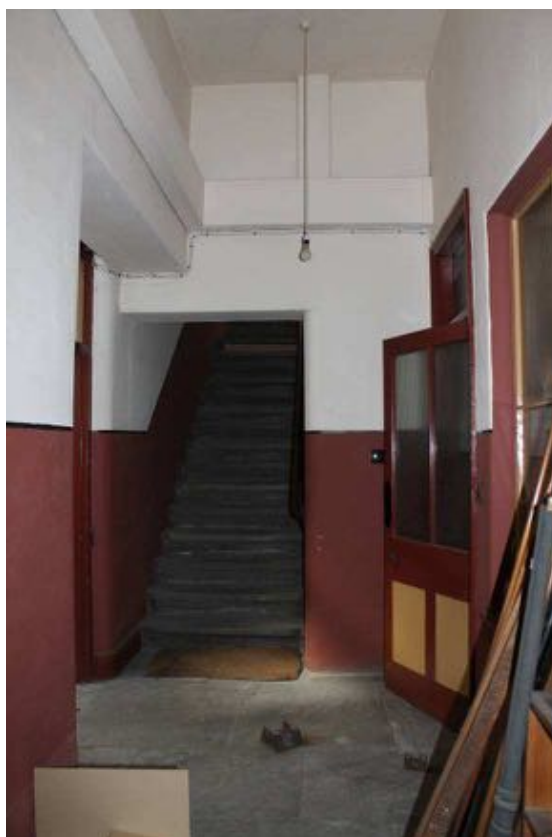
Plate 14: **Room G9g**, facing north

- 4.2.15 **Room G9g (Fig 2)**: was a north/south-aligned corridor located to the east of corridor **Room G9a**, from which, it was divided by a timber doorway, with a horizontal over-light above but no door. This room lay to the west of corridor **Room G9f** from which, it was divided by doorway **GD44**. To the south this room provided access to a store room **Room G27a** via doorway **GD45**, while to the north, it served as the landing for staircase **F14g** (Plate 14).

- 4.2.16 The decorative scheme already described continued in this room, although the use of skirting was restricted to the area at the base of the staircase. Once again, a flagstone

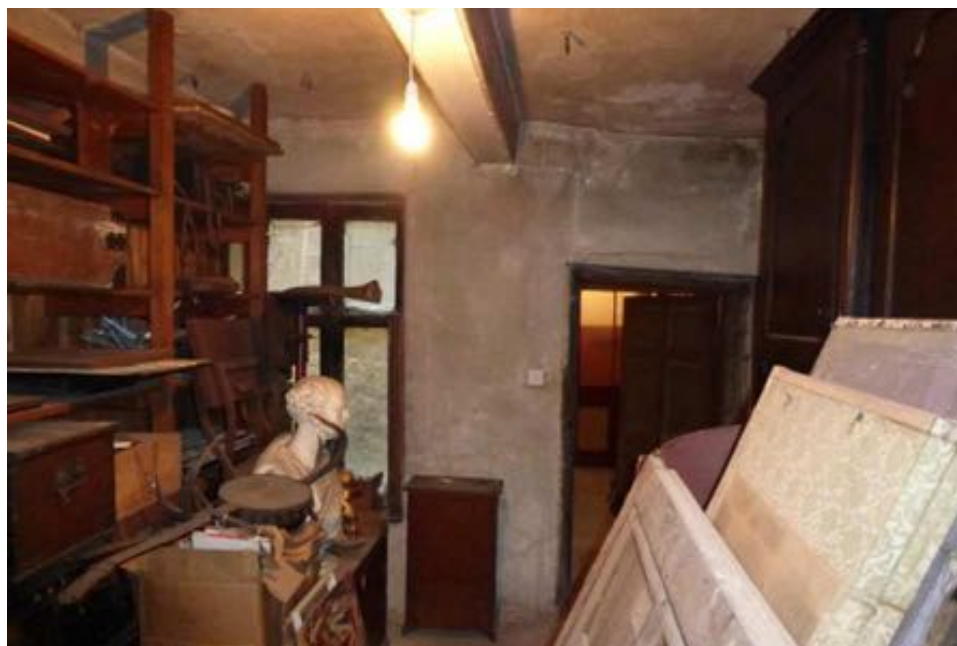
Plate 15: **Room G27a** facing north

4.2.18 **Rooms G27a and G27b (Fig 2)**: these rooms had clearly once formed a single broadly square room to the north of the South Hall **Room G3**. The erection of a thin timber matchboard partition had divided this space into two unequal parts (Plate 15). The eastern part was accessible only from doorway **GD45** located in the north-east corner, while the western part was entered from doorway **GD16**, at the centre of the west wall.

4.2.19 The two halves were both plastered but not painted and shared a flagstone floor, which notably had not been laid to the same alignment as the rest of the house. This odd alignment may be explained by the presence of a canted chimney breast that was set into the south-western corner of the room, against which, the slabs appeared to have been aligned. A series of iron hooks hung from the ceiling of both halves and the partition bisected a four-light mullion window **GW44** in the middle of the north wall.

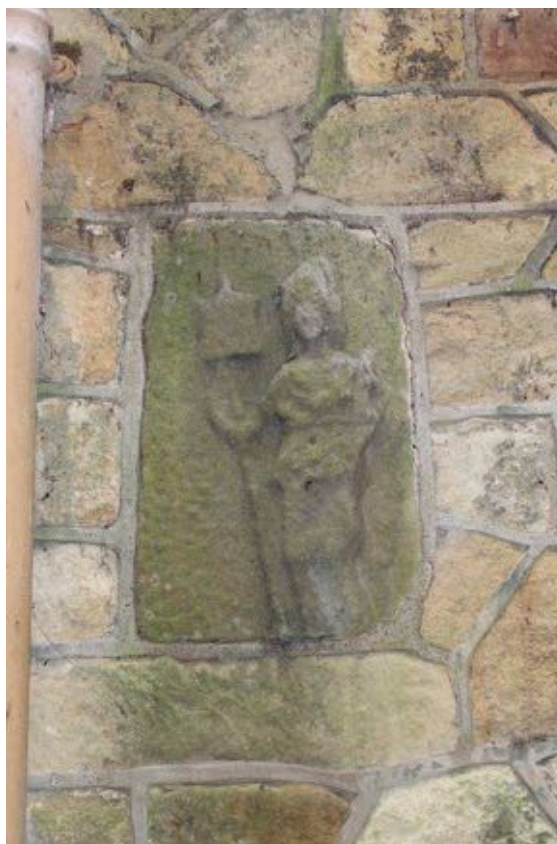
4.2.20 **The Yard (Fig 2)**: the yard was a small rectangular space at the centre of the house, enclosed upon all four sides, with its only access from doorway **GD47** in the north-west corner. The north wall extended to just a single storey in height and formed part of a lean-to structure enclosing corridor **Room G9a**. It was constructed of a cream-coloured rubblestone, that had been ribbon pointed with a cement mortar. A piece of rectangular stone had been incorporated into the wall towards the centre at about head height, upon which had been carved in relief a figure holding a staff or banner (Plate 16). The piece of sculpture was heavily weathered and possibly of Roman date.

*Plate 16: Roman sculpture on north wall of yard*

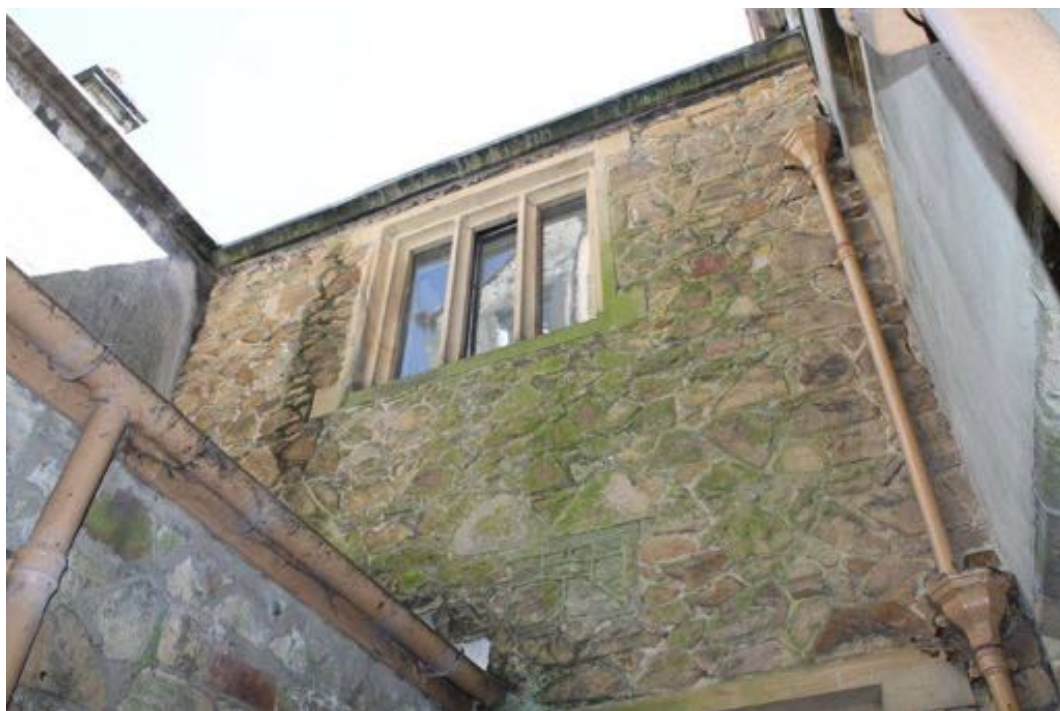
- 4.2.22 The eastern wall was of two-storeys and similar construction, although without the ribbon pointing (Plate 17). It preserved a four-light cross window **GW43** at ground floor level and a three-light mullioned window **FW39** at first floor height. There was some evidence to suggest the remnants of an additional aperture at the base of the first floor, where a pair of narrow stones met, one vertical the other horizontal to form a right angle. Notably, this was the only area of the wall where ribbon pointing had been employed across a small area.

*Plate 17: Central yard, facing east*

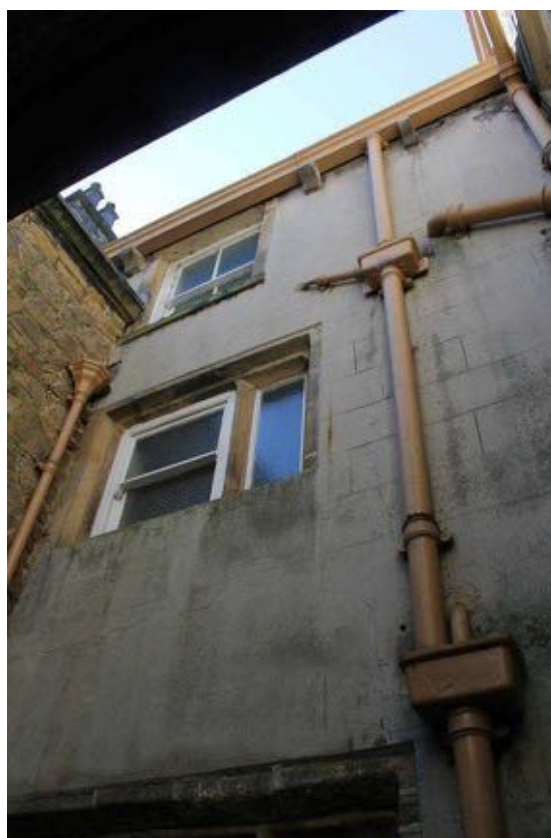
- 4.2.23 The southern wall extended to three storeys but had been cement-rendered and scored to produce an ashlar effect (Plate 18). It carried a cast iron downpipe to the west with another waste pipe at the western corner, and there were a series of three stone corbels at the head of the wall supporting what appeared to be an original timber gutter. The elevation included a four-light window **GW44** at ground-floor level, a modified two-light window **FW40**, a four-light windows at first-floor level and a two-over-two sash **SW21** at second-floor height.

*Plate 18: South wall of central yard*

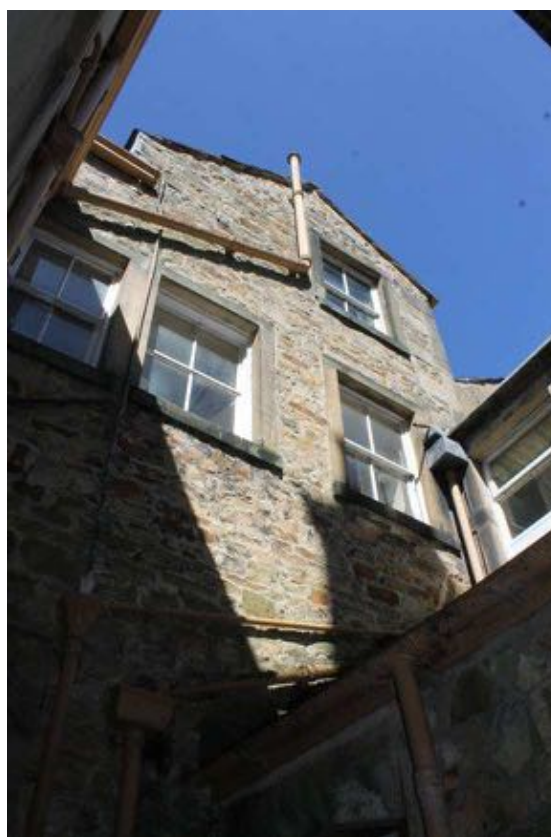
- 4.2.24 The western wall reached three storeys, with the upper storey forming a gable, and was constructed of coursed rectangular rubble blocks set in a lime mortar, with alternating quoins on the top floor (Plate 19). The ground floor had a narrow two-over-two sash window **GW42** at its southern end, with three further two-over-two sashes at first floor height **FW35-37** and another on the second floor **SW13**.

- 4.2.25 A cast iron soil stack extended above the gable at the centre of the elevation, with a down pipe to the north carrying water over the lean-to roof to another pipe at the centre of the wall.

*Plate 19: Central yard, facing west*

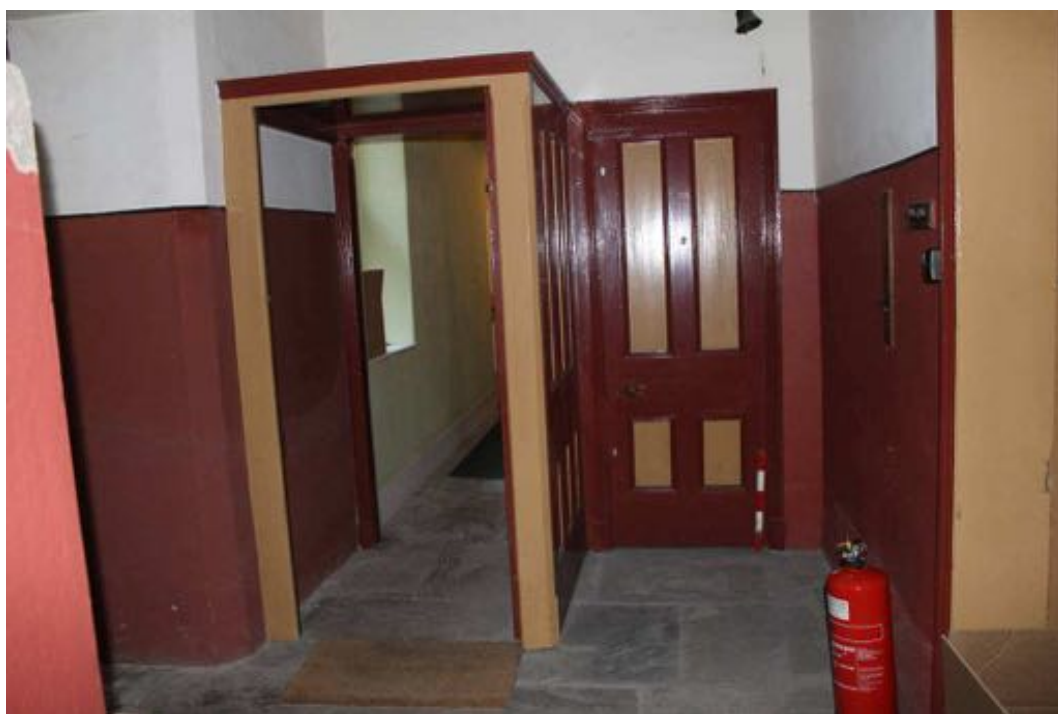
- 4.2.26 **Room G7b (Fig 2):** this was a small vestibule area in one corner of **Room G9a** (Plate 20). It had been subdivided from **Room G9a** by the erection of a short timber panel partition that formed the western side, the installation of a door to the north and the fitting of a flat timber ceiling above. It was decorated in the familiar red and mustard paint scheme and included a moulded cornice across the head of the outer face of its northern and western walls. The flagstone floor identified in **Room G9a** continued through the vestibule and into corridor **Room G7a** beyond. The room had presumably been built to reduce drafts between the family rooms and service rooms and a part glazed door **GD17** defined its northern extent.

*Plate 20: **Room G7b**, facing south*

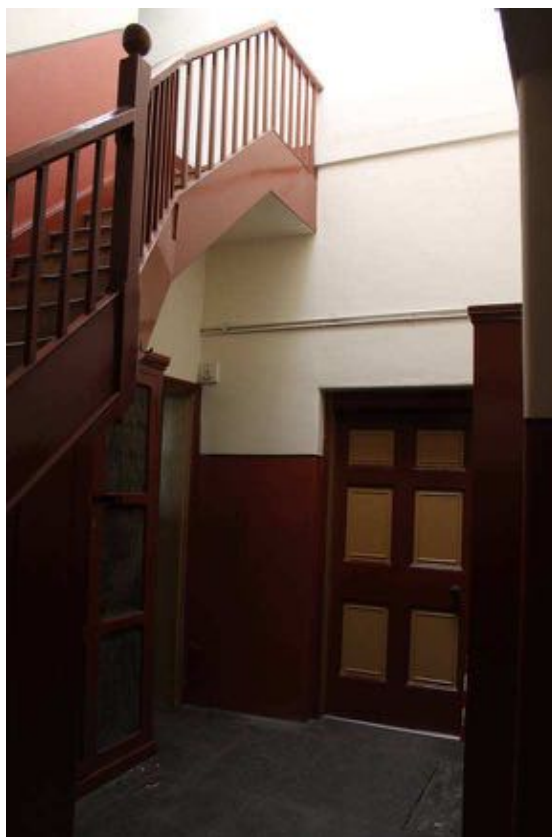
- 4.2.27 **Room G13 (Fig 2):** this room lay to the south of the pantry **Room G14** and east of the scullery **Room G12** in the north-western corner of the service wing. It formed a short east/west-aligned corridor with a timber staircase occupying the north-western corner, that led up to the servant's quarters on the first floor (Plate 21). The room had two doors, one at the north-east corner **GD31**, and a second on the east wall **GD32**, that gave access to the pantry and kitchen respectively. Both doors had six-panels, with moulded margins and insets.

- 4.2.28 The red and white paint scheme continued, as did the flagstone floor. The room was lit from above by a glazed lean-to roof and at the base of its southern wall, a low window provided a degree of light to the cellar steps beyond.

- 4.2.29 The stairs appeared to be of softwood and of relatively utilitarian design, with square section balusters. The edges of the treads showed significant wear indicative of a long period of use.

*Plate 21: **Room G13**, facing east*

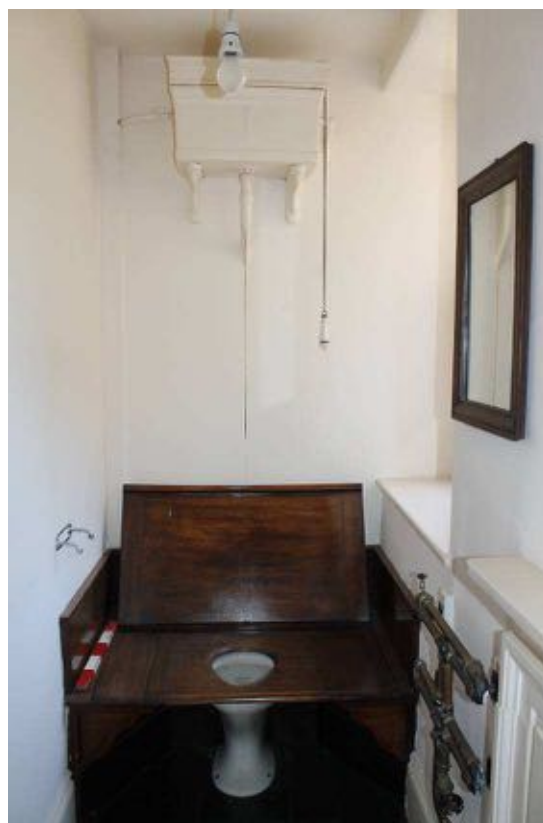
Plate 22: **Room F13a**, facing north, 0.5m scale

- 4.3.1 **Room F13a (Fig 3):** this was a narrow toilet located to the west of corridor **Room F13** that served the bedrooms in the western half of the house (Plate 22). It was accessed via a door **FD15** at the southern end of the room and lit by a single window **FW35** in the north-east corner. The toilet was mounted upon the north wall, set within a timber surround beneath a hinged lid and the cistern was attached the wall above. The makers name was visible;

- 4.3.2 To the south of window **FW35**, copper pipes formed a radiator and to the south of this, lay a fire place with timber surrounds. The room was painted white and had a moulded skirting board in the same but was otherwise fairly plain. The floor was of timber and carpeted along the centre.

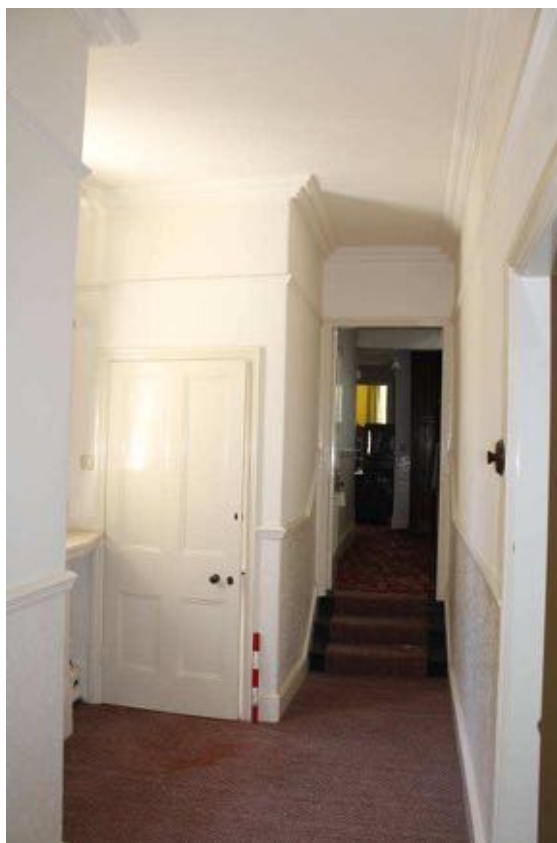
Plate 23: **Room F14a**, facing south, 0.5m scale

- 4.3.3 **Room F14a (Fig 3):** this room formed a north/south-aligned corridor that provided access to the bedrooms in the north-western corner of the building (Plate 23). At its southern end, it led up a short flight of steps into corridor **Room F13** via door **FD16**, while doors **FD18** and **FD20** on the western wall led into bedroom **Room**

**F15** and the connecting corridor **Room F18** respectively. At the northern end, it served as the upper landing for staircase **Room F14c**, from which, it was divided by door **FD25**. At its north-eastern corner, the corridor led on to a small vestibule-like area, **Room F14d**, that connected the corridor to the kitchen **Room F14e** beyond. A small storage cupboard **Room F14b** accessed via door **FD17** occupied the south-eastern corner of the corridor and to the north of this, a two-over-two sash window **FW35** on the east wall overlooked the central yard below.

- 4.3.4 The corridor was painted off-white and had a moulded skirting board, dado and picture rails and a moulded cornice. The wallpaper above the picture rail and below the dado rail was embossed and the floor was carpeted. Beneath the window on the eastern wall there was a radiator comprising large bore pipes under a wooden shelf, while on the western wall, was a wooden intercom system mounted to the south of door **FD18** (Plate 24).
- 4.3.5 **Room F14b (Fig 3):** was a small store cupboard fitted with a four-panel door **FD17** in the south-eastern corner of corridor **Room F14a**. It was lit to the east by a modified four-light sash **FW36** beneath which, lay a sink set into a work surface. The floorboards were covered by rubber matting and the plain white decoration was accompanied by a skirting board.

- 5.2.17 On the first-floor, in addition to the staff accommodation above the new kitchen, there were new day nurseries to the west above the butler's pantry and servants hall with an access corridor to the east (**Room F14a**). The room above the former Laundry (**Room F14e**) may have been retained as a staff bedroom, although one drawing shows an east/west partition dividing the room, the scar of which was noted on the ceiling during the survey (Plate 38). The identification of a summoning bell in this room also indicates that at some point it was of a higher status. The room above the former wash house was now divided into a bathroom (**Room F14h**) to the east, with staircase **Room F14g** to the west and a landing/corridor to the south. At first-floor level, the western wall of the two-storey extension that had been erected across the eastern end of the yard had blocked the eastern end of window **FW40**. This building accommodated a corridor (**Room F14f**) along its western side and storage rooms (**Rooms F14i** and **F14j**) to the east.

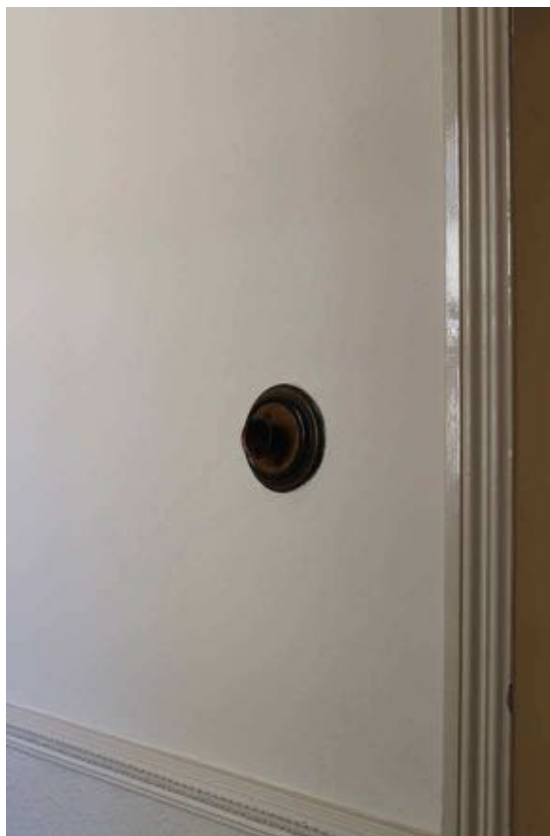
*Plate 24: Intercom system, on west wall of corridor **Room F14a***

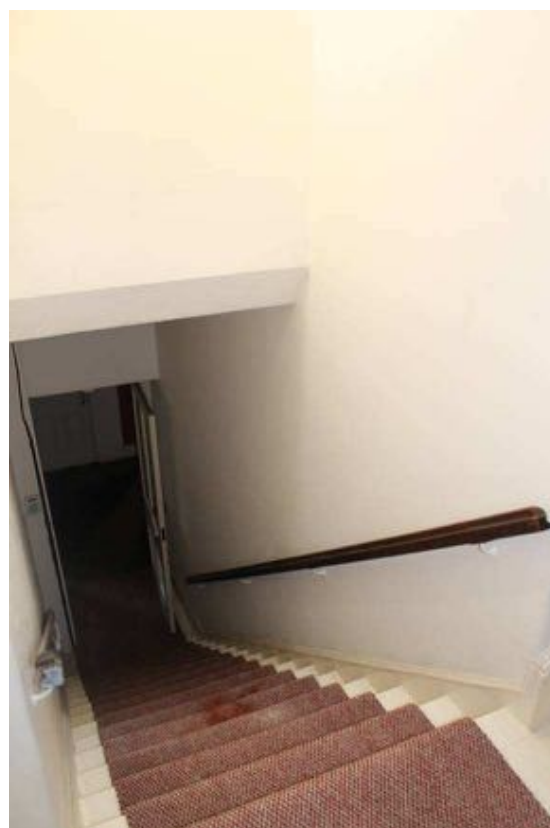
*Plate 25: Staircase **Room F14c**, facing east*

- 4.3.6 **Room F14c (Fig 3):** this room comprised a quarter-turn staircase with a quarter-pace mid-floor landing that connected the service area at ground level to the bedrooms at first floor level (Plate 25). At ground floor level, the stairs were enclosed by a part-glazed four-panel door **GD37**, while at the top of the staircase was further four-panel door **FD25**.

- 4.3.7 The staircase was lit from above by a single skylight and had a moulded skirting board at the base of each wall. All the walls, ceilings, risers and treads were painted white. A moulded timber handrail was attached to both walls of the lower flight and a carpet runner had been fitted to the steps, each with a brass stair rod at the base of the riser.

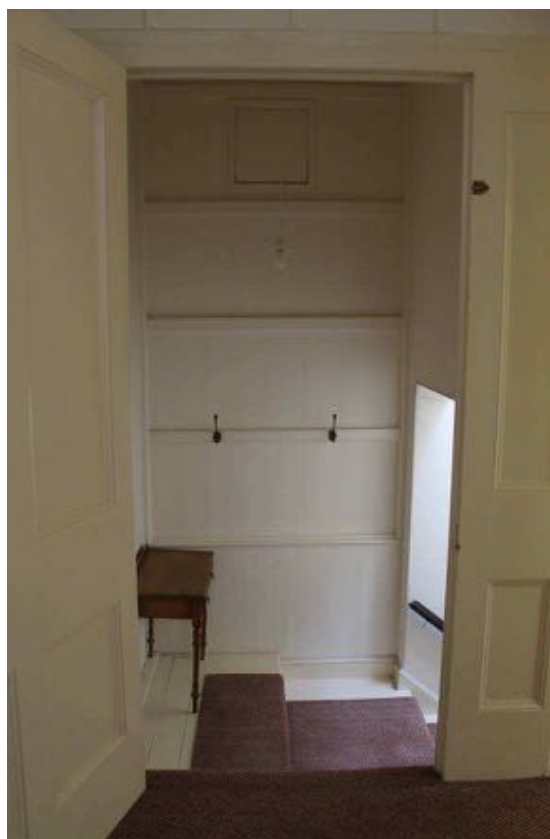
Plate 26: First floor landing at top of staircase **Room F14c**, facing north

- 4.3.8 The northern wall of the mid-floor landing appeared to be of relatively lightweight timber construction and had a pair of coat hooks fastened to one of its horizontal battens (Plate 26). At the head of this partition lay a blocked square aperture, that may possibly once have been a window or vent of some kind.

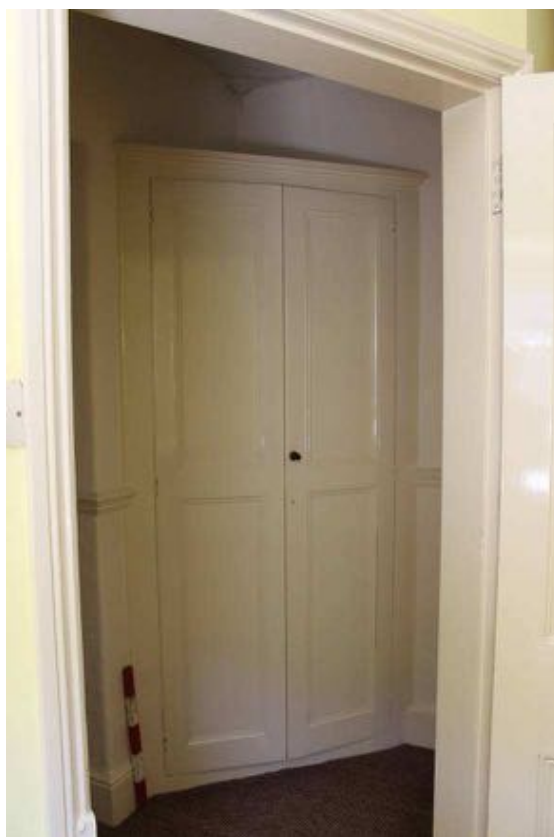
- 4.3.9 Room **F14d** formed a small linking corridor, connecting corridor **F14a** to the west with the first-floor Kitchen **F14e** at the centre of the building. It was a small rectangular space with a doorway at its south-eastern corner **FD26**, but evidently there had been another in the eastern wall, only the architrave of which remained. The space had a moulded skirting and chair rail, with the walls and ceiling above the rail painted white and below covered in embossed wallpaper. The floor was carpeted as a continuation of corridor **F14a** and a built-in corner cupboard fitted

with a pair of two-panel timber doors and topped by a moulded cornice occupied the north-western corner of the space (Plate 27).

Plate 27: Corridor **Room F14d**, facing north, 0.5m scale

Plate 27: Corridor **Room F14d**, facing north, 0.5m scale

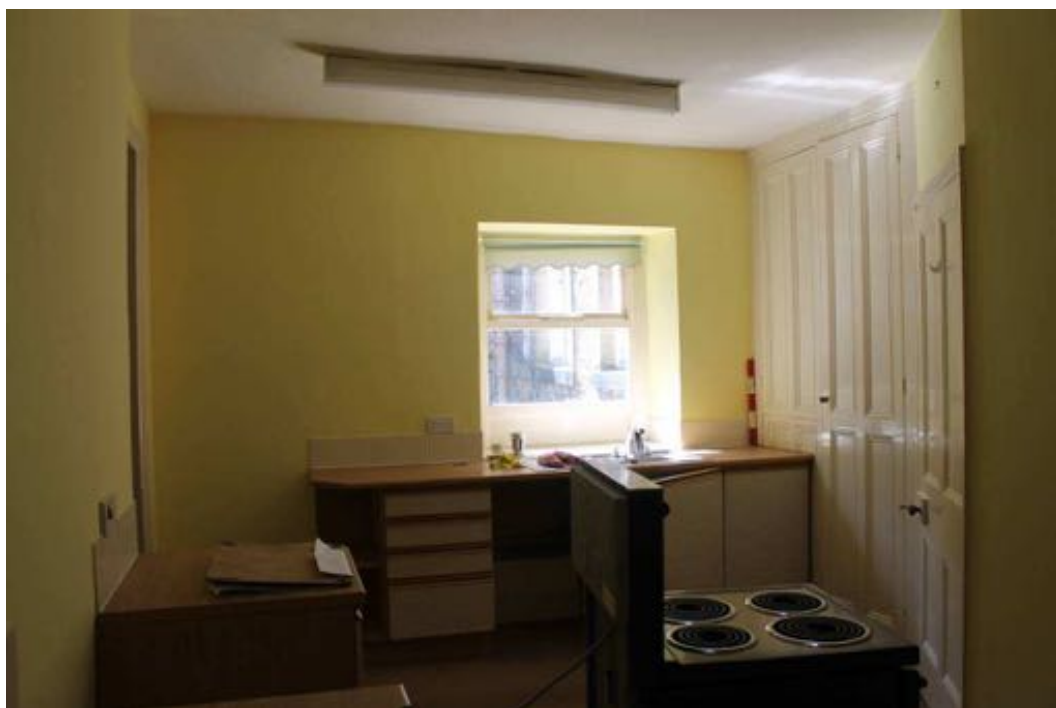
- 4.3.10 **Room F14e (Fig 2)**: this room occupied the centre of the building and was an L-shaped space, fitted out as a basic modern kitchen (Plate 28). To the west, it was joined to linking corridor **Room F14d** via doorway **FD26** while to the east, a short flight of steps led through doorway **FD27** into corridor **Room F14f**.

- 4.3.11 The room was decorated in a plain modern style, with a white ceiling, yellow walls, skirting board and carpet. It was lit from above by a rectangular skylight and to the south by a modern window installed within an earlier stone surround **FW38**. A chimney breast projected from the centre of the eastern wall, although any fireplace there may have been, had been blocked. Above this was a circular ceiling mounted metal vent. To the south of this vent an east/west scar on the ceiling appeared to denote the former position of a partition wall that may once have divided the room.

- 4.3.12 The only features of historic significance to survive were a circular bell pull, which was mounted on the rooms western wall towards its northern end and a set of built in cupboards in the south-western corner. The cupboard doors each had four panels with moulded margins and a cornice ran across the head. The northern door of the pair was still in operation, but the southern door had been sealed with the installation of the modern kitchen sink and cupboard units to the east.

Plate 28: **Room F14e**, facing south, 0.5m scale

Plate 28: **Room F14e**, facing south, 0.5m scale

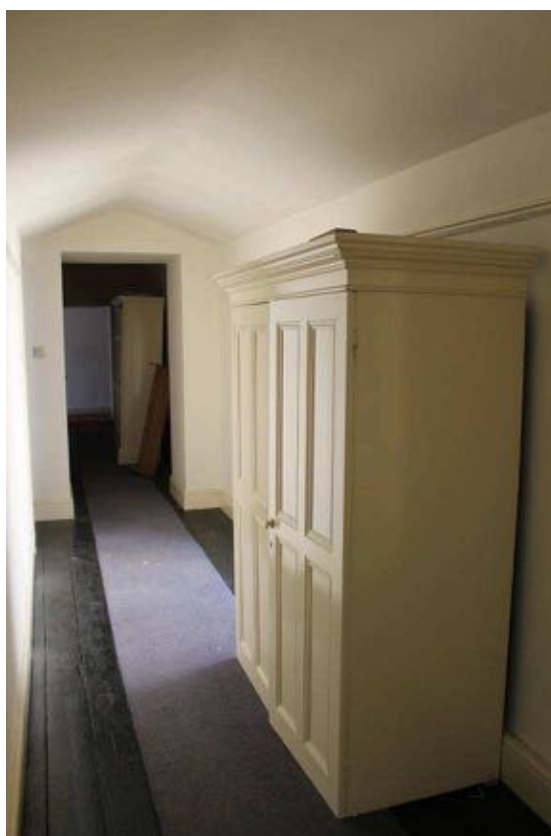
- 4.3.13 **Room F14f (Fig 3)**: this room was an L-shaped corridor located towards the centre of the building (Plate 29). To the south, it continued into corridor **Room F28** while a doorway **FD28** to the north, led down to staircase **Room F14g**. At its northern end, the corridor turned to the east, where it provided access via a short flight of steps and doorway **FD30**, to the bedrooms in the north-eastern part of the house. An adjacent doorway **FD29** set into the north wall, led into bathroom **Room F14h**, while another doorway **FD27** at the northern end of the west wall, opened on to the kitchen **Room F14e**. To the east of the corridor lay a pair of service rooms **Room F14j** and **Room F14i**, both of which were entered from doorway **FD35** at the southern of the corridor.

- 4.3.14 The walls and ceiling of the corridor were painted white, with skirting boards and a picture rail employed throughout, but the ceiling at the southern end was lower than that to the north and formed a distinctive shallow pointed arch along its length. The floor boards were visible to the north and south and a carpet runner had been laid along the centre of the room. The room was lit to the west by a three-light mullion window **FW39**, with a small rectangular skylight illuminating the northern part of the corridor.

Plate 29: Corridor **Room F14f**, facing south

Plate 29: Corridor **Room F14f**, facing south

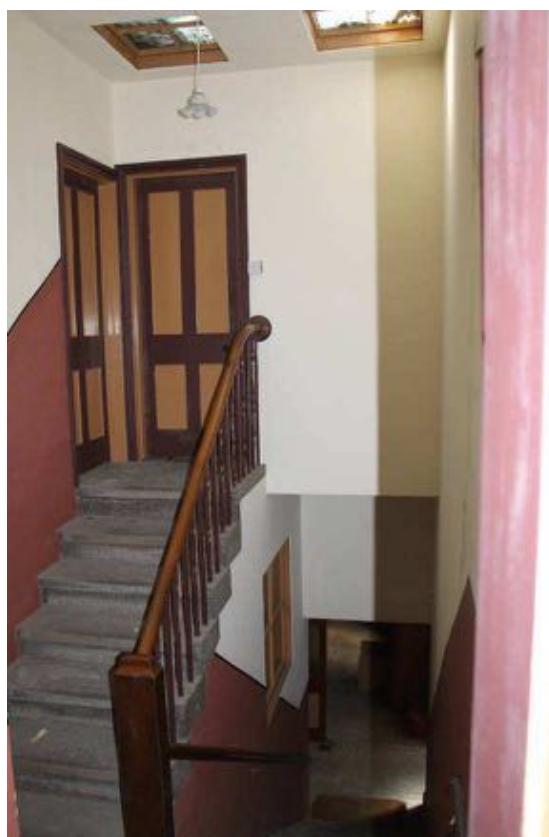
- 4.3.15 **Room F14g (Fig 3)**: this room served as a stone-built dogleg staircase with a half-pace mid-floor landing and connected the service rooms at ground-floor level to corridor **F14f** at first-floor level via doorway **FD28** (Plate 30). A second doorway to the east at first-floor landing height had been sealed shut to accommodate a change in the building's layout but it retained its four-panel door. The staircase also gave access to room **F21c** from a four-panel doorway that opened to the north from the mid-floor landing.

- 4.3.16 The room was decorated in the same red and white paint scheme commonly employed within the service corridors of the ground-floor and it had a timber hand-rail bolted to the inner wall of the lower flight and another on the inner string of the upper flight, set upon a series of twisted wrought iron spindles. The room was lit from above by a pair of four-light skylights and by a four-light window that illuminated the lower flight of steps from the east. A small access hatch was noted on the eastern wall of the mid floor landing, although its purpose was unclear.

*Plate 30: Stairwell **Room F14g**, facing south*

Plate 30: Stairwell **Room F14g**, facing south
