# **STANDEN HALL, WORSTON ROAD, CLITHEROE, LANCASHIRE**

## **Historic Building Survey Report**

**Oxford Archaeology North**

August 2017

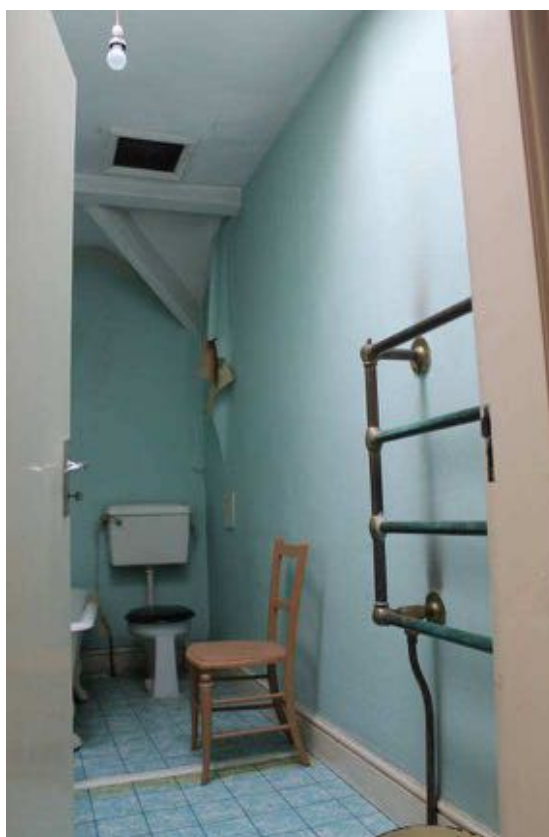
- 4.3.17 **Room F14h (Fig 3):** this was a small bathroom approached from corridor **Room F14f** through doorway **FD29**, a modern door at the southern end of the room. The room was decorated with blue wallpaper, white ceiling, vinyl covered floor and a skirting board. The toilet was set against the northern wall and a free-standing roll top bath occupied the north-western corner of the room along with a sink (Plate 31). There was a brass towel rail, opposite which was a blocked four-panel door also seen in **Room F14g**. The northern end of the ceiling contained a loft access hatch.

*Plate 31: **Room F14h**, facing north*

Plate 31: **Room F14h**, facing north

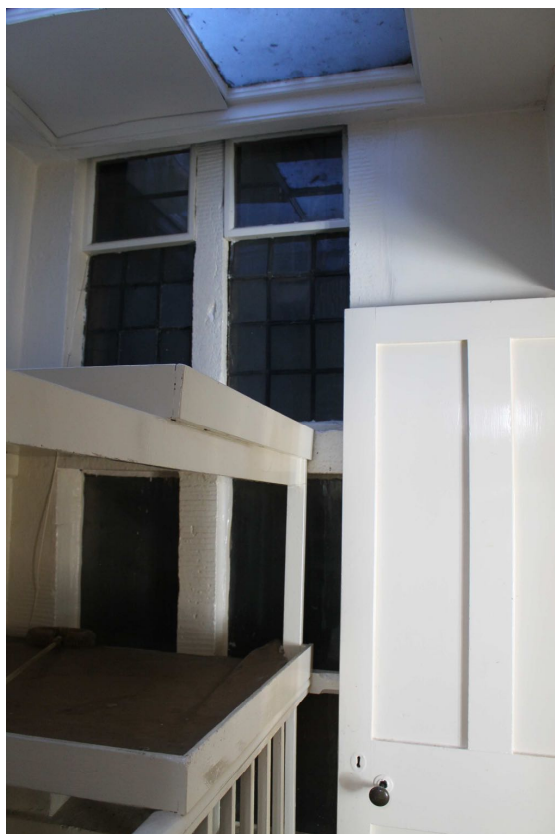
- 4.3.18 **Room F14i (Fig 3):** this room was a small rectangular space, linking corridor **Room F14f** to the west via doorway **FD35** to **Room F14j**, a service room to the north. The room was painted white, had a skirting board and was lit from above by a skylight. It also displayed the lower portion of a tall stone mullion and transom stair window on the south wall, indicating that this wall must once have been an external elevation (Plate 32). The floor was covered in vinyl, except to the east where it was glazed in an attempt to increase light to the room below from the skylight in the ceiling above. The glazed portion of the floor had been partitioned off with a timber rail set upon a series of square section spindles, and above this a set of shelves had been erected.

Plate 32: Mullion and transom window in **Room F14i**

Plate 32: Mullion and transom window in **Room F14i**

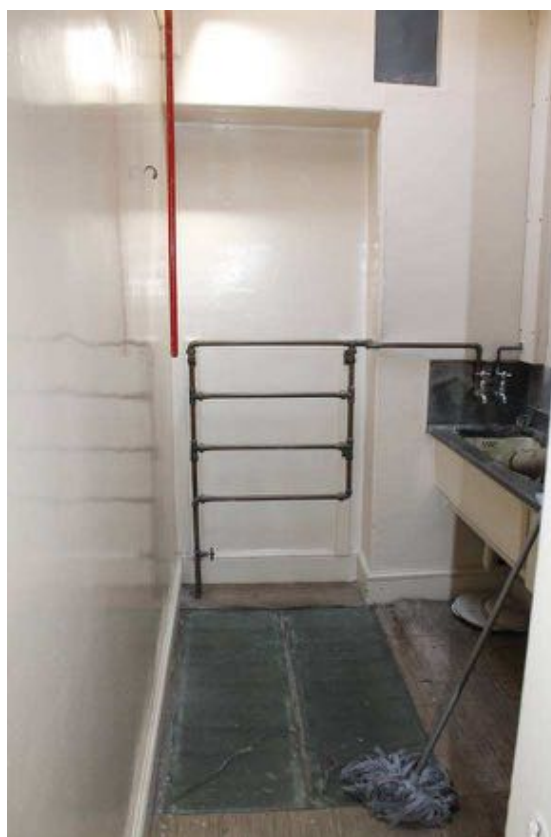
- 4.3.19 **Room F14j (Fig 3):** lay to the north of **Room F14i**, to which it was connected via a doorway at the south-west corner. It was a small rectangular functional space identical in decoration to **Room F14i** (Plate 33). A rectangular recess at the northern end suggested the previous existence of a doorway and the room was lit from above by a large rectangular skylight. In a similar manner to **Room F14i**, the western half of the floor was glazed to provide light for the floor below. A brass towel rail had been fitted to the northern wall and a Belfast sink with a lead shroud occupied the north-east corner. High on the northern wall was an additional small rectangular vertically-set aperture, the function of which was not clear.

Plate 33: **Room F14j**, facing north

Plate 33: **Room F14j**, facing north

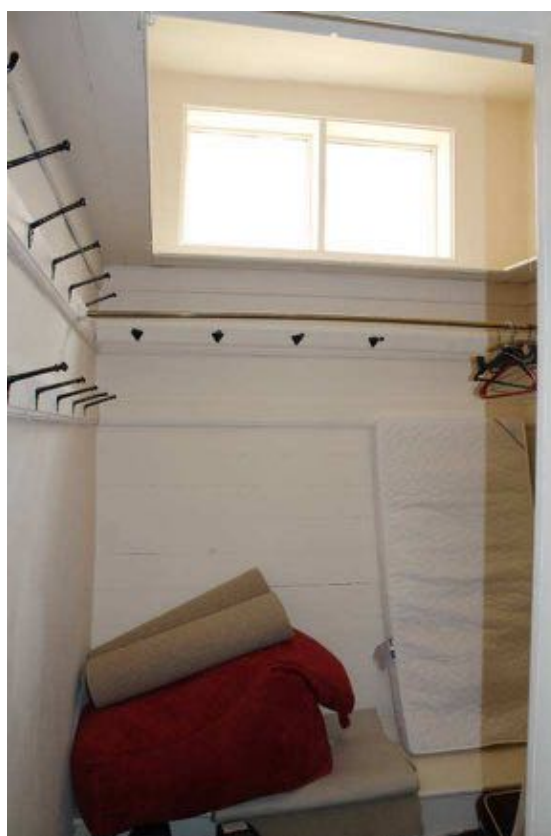
Plate 34: Cupboard **Room F20**, facing east

4.3.20 **Room F20 (Fig 3):** this room formed a small square walk-in wardrobe accessed from doorway **FD24** at the north-east corner of **Room F17a** (Plate 34). The lower three quarters of each wall was lined with horizontal boards and a wooden bench had been erected at the base of the eastern wall. The upper parts of the walls were plastered and all the surfaces were white painted. A shelf ran across all four walls above the height of the timber lining and beneath this coat hooks had been attached to battens in rows. Lighting was provided by a twin-light fixed-frame window high on the eastern wall.

Plate 34: Cupboard **Room F20**, facing east

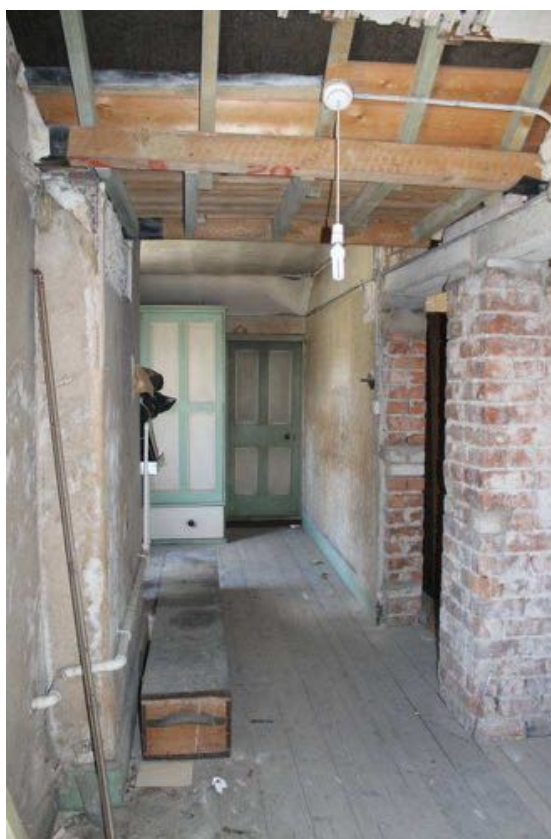
4.4.1 **Room S3 (Fig 4):** this room formed a north/south-aligned corridor that provided access to a range of rooms that once functioned as night nurseries in the north-western corner of the house (Plate 35). It was accessed from the south by **Room S1** via doorway **SD4** and a doorway **SD8** in its northern wall led into room **S9**. On its western wall there were three doorways, the southern leading into room **S4**, the central leading along corridor **Room S5** and the northernmost leading, via doorway **SD7**, into **Room S8**. The room was lit to the east by a pair of two-over-two sash windows, one at the northern end **SW14** and another to the south **SW13**.

Plate 35: Corridor **Room S3**, facing south

4.4.2 The room was partially decorated with plaster removed from portions of the west wall to reveal brick construction. A small area of plaster had been removed from the eastern wall exposing rubblestone construction, and the surviving parts of the

ceiling were lathe and plaster. The walls were papered and the skirting painted light green. At its northern end, the wall dividing wall between **Room S9** had been built in timber panelling, also painted green with white detailing. The southern wall was plastered and largely hidden behind a free-standing green and white panel cupboard

Plate 35: Corridor **Room S3**, facing south

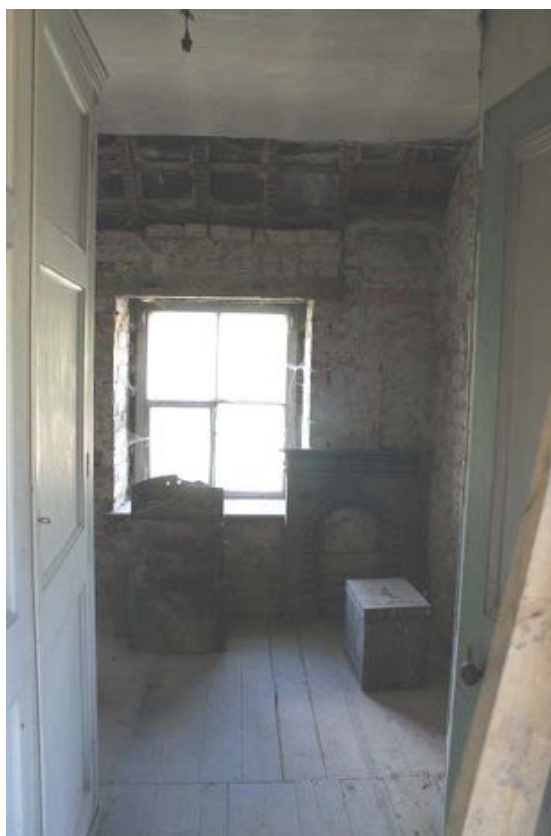
- 4.4.3 **Room S9 (Fig 4):** was a small rectangular room to the north of **Room S3**, to which it was connected via doorway **SD8** (Plate 36). Plaster had been stripped from much of the northern and eastern walls exposing the red brick beneath. The ceiling was again of lathe and plaster and the floor laid down to boards. A straight joint was noted in the floorboards towards the southern end of the floor, running in an east/west direction. The room was lit by a single four light window **SD15** located at the centre of the northern wall.

Plate 36: **Room S9**, facing north

Plate 36: **Room S9**, facing north

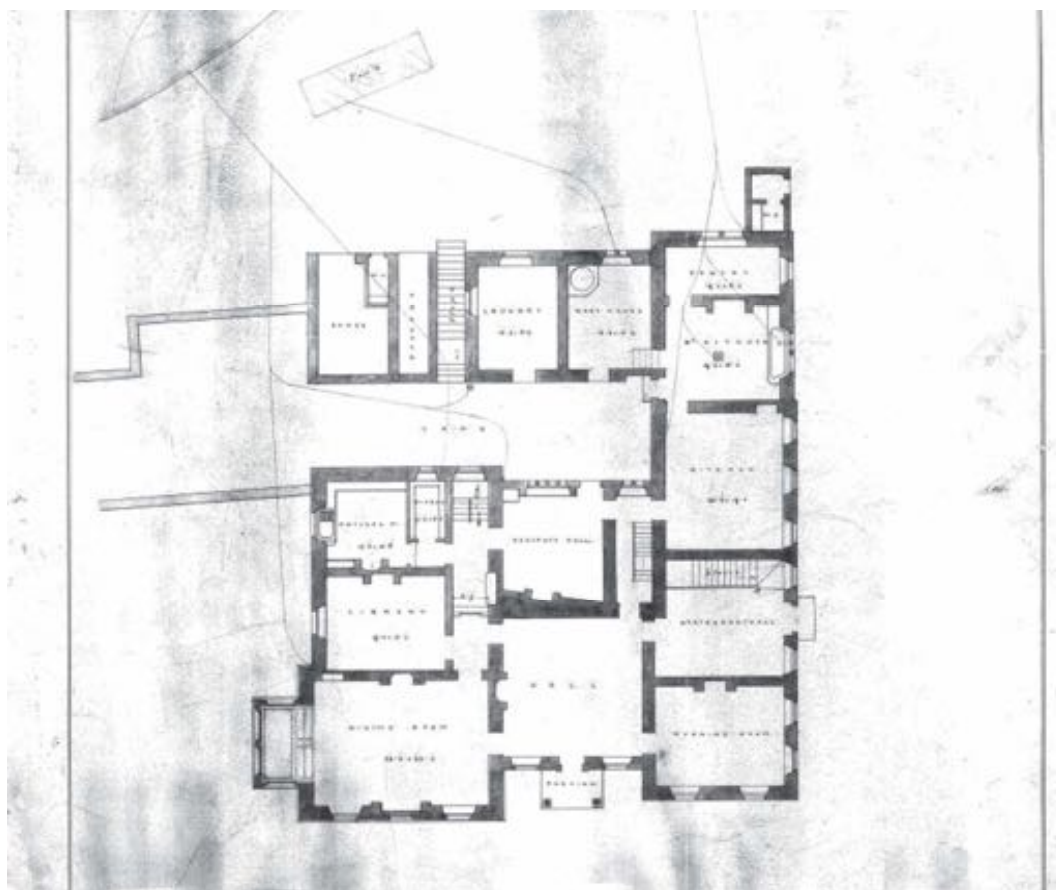
- 5.2.6 **Phase III - Early Nineteenth Century:** Paley's 1856 architectural plan of the ground-floor (Plate 37) depicts the kitchen as being located within the northern three bays of the eighteenth century east wing, with a secondary kitchen or scullery to the north and pantry beyond. A northern service wing extends westwards from the western elevation of the latter two rooms, housing a wash house to the east and laundry to the west. An external staircase at the western end, connected the grounds to the north of the house to a yard located between the service wing and remainder of the house, with adjoining open fronted sheds to the west.

Plate 37: 1856 design proposal for the partial rebuilding of the west wing, showing the layout of the ground-floor (Reproduced from Bridan 2015)

**5.3.2 *Eighteenth to Mid-Nineteenth Centuries:*** This period probably saw the Aspinall's achieve full gentry status, perhaps occasioning the construction of the new eastern façade. As with other gentry families there was a concern with providing increased privacy, which could be achieved by concentrating the service rooms to the rear of the house and segregating the staff from the family. Typically, the period also saw an increase in the number of rooms assigned to specialised functions both for the family and the staff. The mid-nineteenth-century plan of Standen Hall demonstrates the range of service rooms required at this time and their concentration to the rear of the house around the open yard (Plate 37).

Plate 37: 1856 design proposal for the partial rebuilding of the west wing, showing the layout of the ground-floor (Reproduced from Bridan 2015)

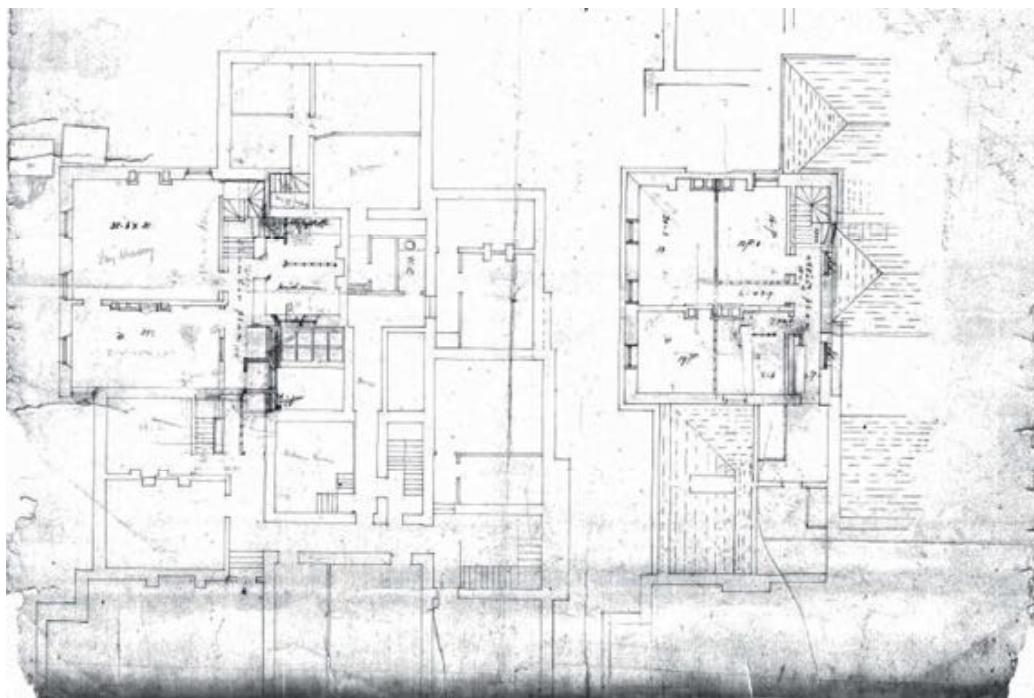
5.2.18 The night nurseries were located upon the second-floor immediately above the day nurseries. Their present layout matches up well with one of the undated plans of the late nineteenth century (Plate 38), with a north/south corridor (**Room S3**) to the east of four rectangular rooms. One interesting departure from this drawing is a staircase that is depicted on the plan at the northern end of the corridor which would have directly connected the first and second-floor nurseries. If it was built then the staircase does not survive, however a joint in the floorboards within **Room S9** was noted, and may correspond with the former position of such a feature. The existence of a staircase would also account for the slightly odd large walk-in wardrobe on the first-floor (**Room F20**).

Plate 38: Late nineteenth-century proposal drawing for service wing extension (Reproduced from Bridan 2015)

Plate 38: Late nineteenth-century proposal drawing for service wing extension (Reproduced from Bridan 2015)

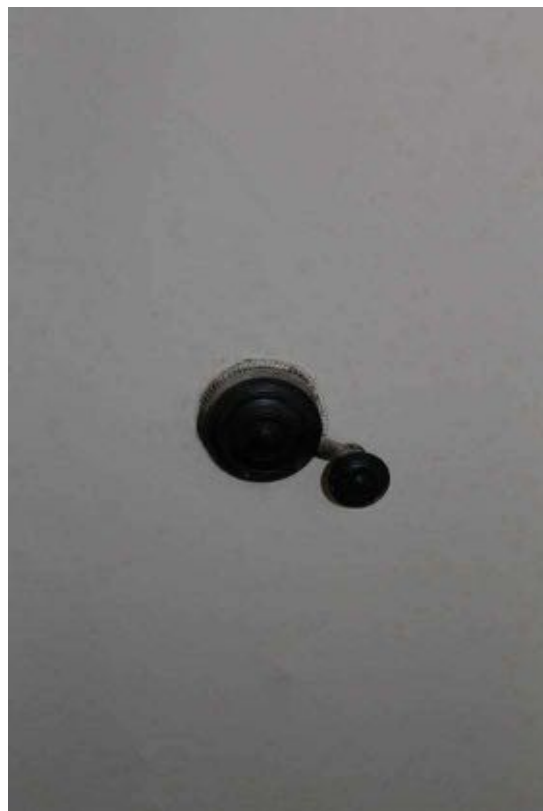
*Plate 44: Service bell in corridor **Room F18***

Plate 44: Service bell in corridor **Room F18**

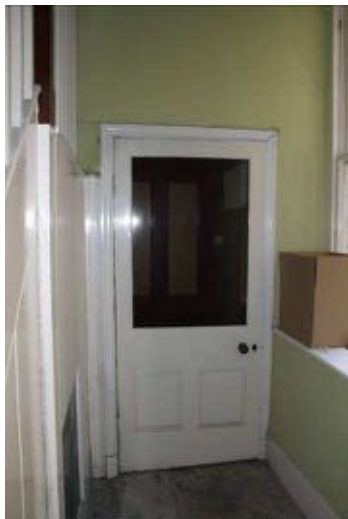
##### *GD17*

*Plate 56: One large glazed panel above two small panels with moulded margins. Hinged to the west, with brass door handle. Late 19th century*

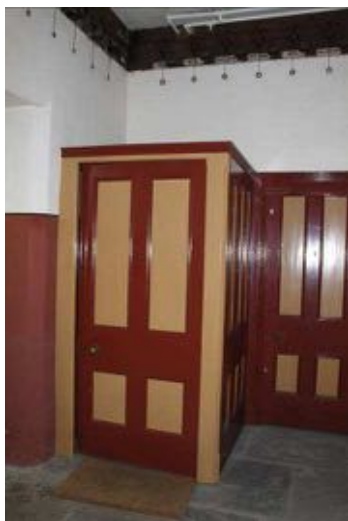
##### *GD18*

*Plate 57: Four panels, two larger upper panels over two small, all with moulded margins. Hinged to the west, fitted with brass door knobs. Late 19th century*

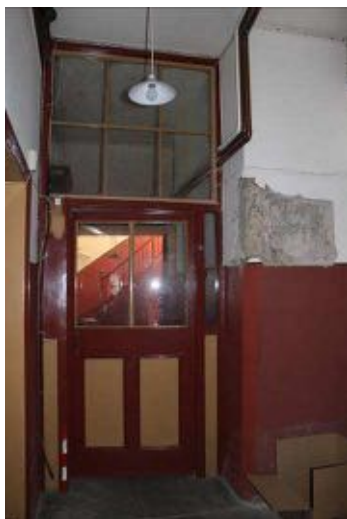
**GD25**

*Plate 58: Four panel timber door, lower panels with moulded margins, upper panels slightly wider and glazed with slender narrow mullion between. Hinged to east with wrought iron upright handle on north side. Narrow side-light to east and six panel over-lighter arranged in two rows of three. Late 19th century*

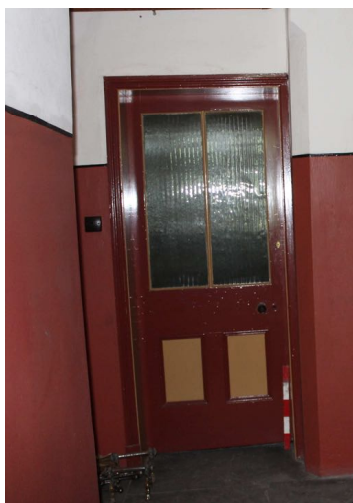
**GD26**

*Plate 59: Four-panel timber door, with two larger glazed panels above two smaller panels with moulded margins. The upper panels have fluted glass and a slender central mullion. Iron locking plate on east face, fitted with metal knobs. Late 19th century*

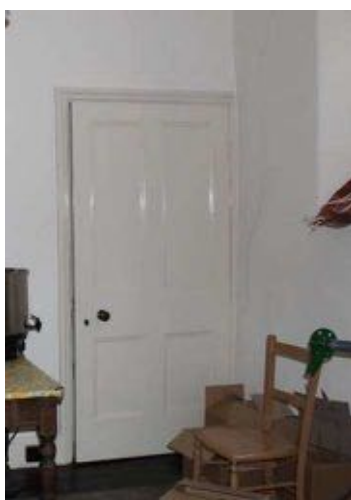
**GD27**

*Plate 60: Four-panel timber door, fitted to built-in cupboard two larger panels above two smaller panels with moulded margins. Hinged to south with brass door knob fitted to west face and locking plate to east. Late 19th century*

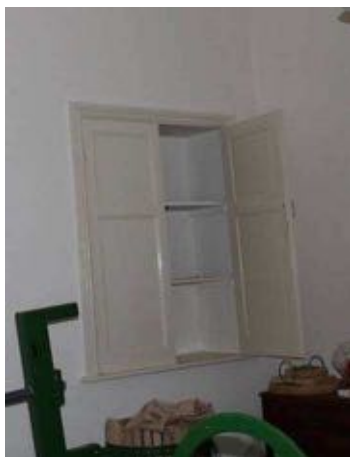
**GD28**

*Plate 61: Pair of two-panel cupboard doors fitted to a built-in wall cupboard. Lower panels larger than upper panels, which are nearly square, all with moulded margins. Modern upright handle fitted to west door. Late 19th century*

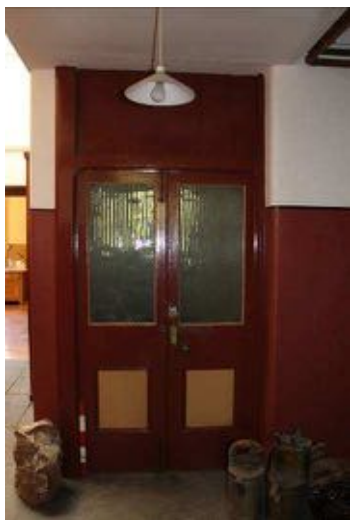
**GD30**

*Plate 62: Pair of double timber doors, each with large glazed upper panel fitted with fluted glass and smaller lower panel, both with moulded margins. Hinged to the north and south, with brass knob fitted to south door and vertical draw bolts to north door. Late 19th century*

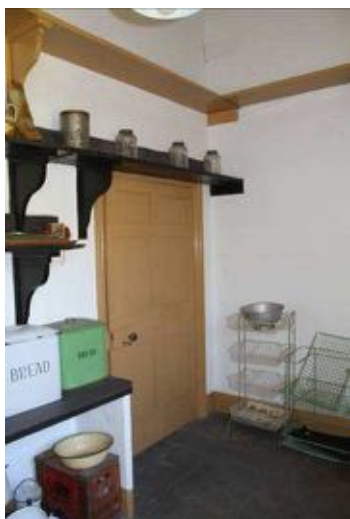
**GD35**

*Plate 63: Short six-panel timber door, with smallest panels at the top. Hinged to the north with locking plate on east face and brass knob. Early 19th century*

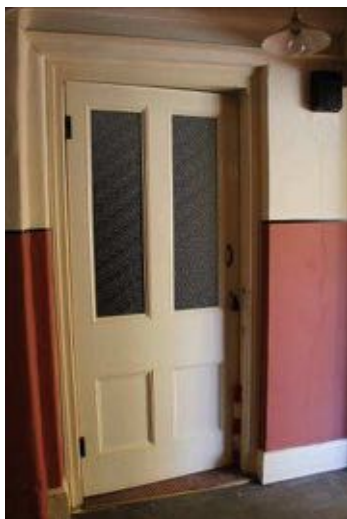
**GD37**

*Plate 64: Four-panel timber door with two larger glazed panels above two smaller panels, all with moulded margins. Textured glass, hinged to the south with upright iron handle on east and west faces. Late 19th century*

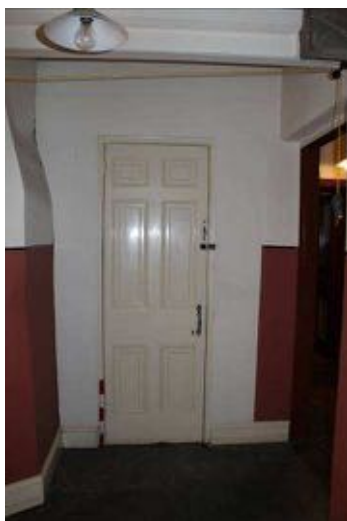
**GD38**

*Plate 65: Narrow six-panel timber door, fitted to walk-in wardrobe. Top panels smallest, with largest in centre, all have moulded margins and with insets. Hinged to the north, upright handle with leaf shaped ends and latch on west face. 19th century*

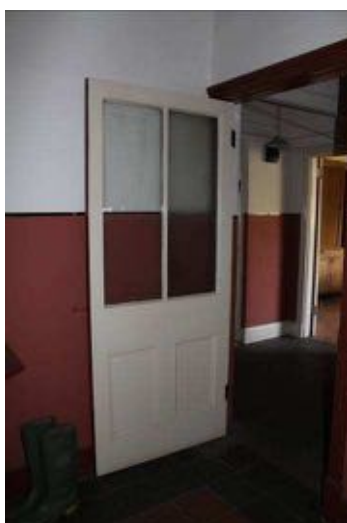
**GD39**

*Plate 66: Four-panel timber door, with moulded margins. Hinged to the west, with larger fluted glazed upper lights separated by a narrow mullion. Late 19th century*

- Plate 65: Door **GD38**, facing east
- Plate 66: Door **GD39**, facing south-east
- Plate 67: Door **GD41**, facing north-east
- Plate 68: Door **GD42**, facing south-east

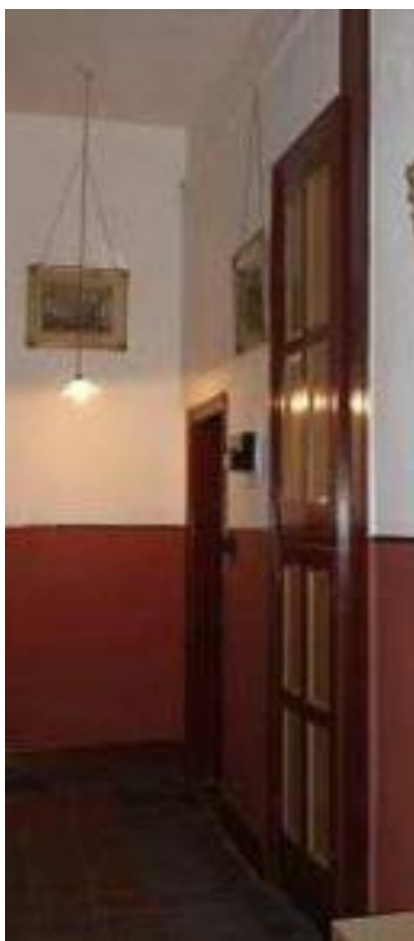
**GD41**

*Plate 67: Pair of four-panel doors fitted to a built-in cupboard, one set above the other. Panels have moulded margins and doors hinged to the north and south.*

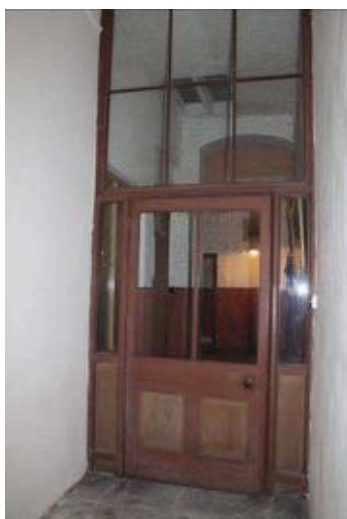
**GD42**

*Plate 68: Large four-panel door, its larger upper panels glazed with clear glass. Hinged to the west, fitted with brass door knobs and flanked by narrow side lights, with a bank of six rectangular over-lighters above arranged in rows of three. Late 19th century*

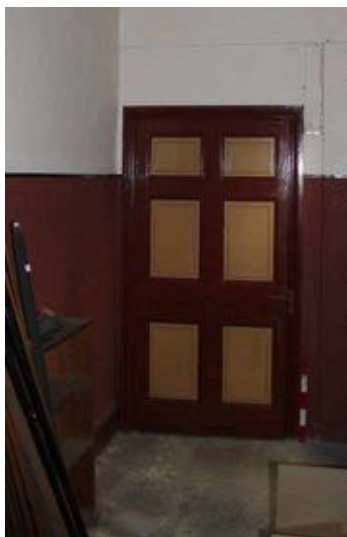
**GD45**

*Plate 69: Short six-panel moulded timber door, hinged to the east, with a metal lock case to the north. Although internal, its jambs were of stone and of plain square section. Possibly eighteenth/early nineteenth century but reset in the late 19th century.*

- Plate 69: Door **GD45**, facing south
- Plate 70: Door **GD47**, facing south-east
- Plate 71: Window **GW42**, facing west
- Plate 72: Window **GW43**, facing east

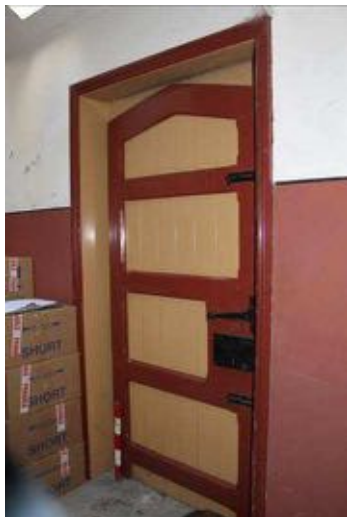
**GD47**

*Plate 70: Robust plank and batten, hinged to the east, with shallow pointed arch at the head and an internally mounted lock case above a wrought iron latch. Modern draw bolts added above and below these features at a later date. Internally painted red and yellow to match its timber surrounds. Externally painted yellow brown with wrought iron pear shaped knocker set upon a shaped base plate. External surrounds of stone, lintel cut to a shallow pointed arch and jambs being of single chamfer with regular, even tooling pattern visible across the surface. Late 19th century*

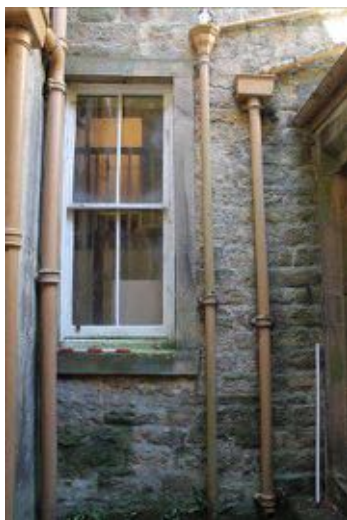
### GW42

*Plate 71: Narrow two-over-two timber sash window with external stone surrounds of plain square section. Regular even tooling applied to the flat faces. Sash fastener on interior mid rail. Late 19th century.*

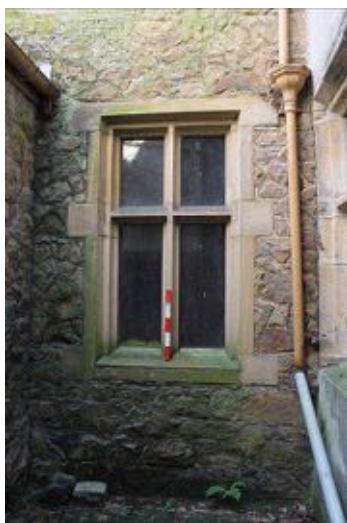
### GW43

*Plate 72: Four-light fixed-frame cross window GW43, with its stone surrounds, mullion and transom featuring hollow chamfers and the sill plain chamfered on both faces. The cream coloured stone was relatively fine grained in texture and regular even tooling had been applied to the flat faces both internally and external. Late 19th century.*

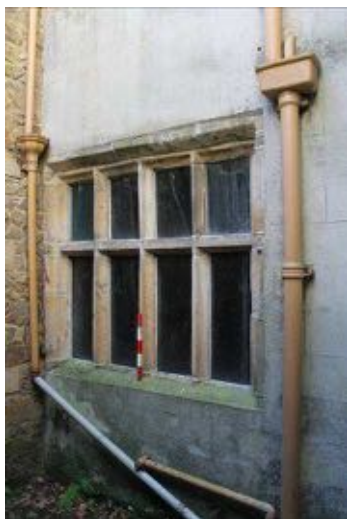
**GW44**

*Plate 73: Eight-light cross window with stone surrounds. Mullions cut with hollow chamfers, transoms with single plain chamfers both internally and externally. The cream coloured stone is heavily weathered to the north revealing a relatively coarse texture. Thick joints and worn arrises suggest an earlier period as does the semi-regular off perpendicular tooling where it survives. Early 17th century.*

Plate 73: Window **GW44**, facing south-east

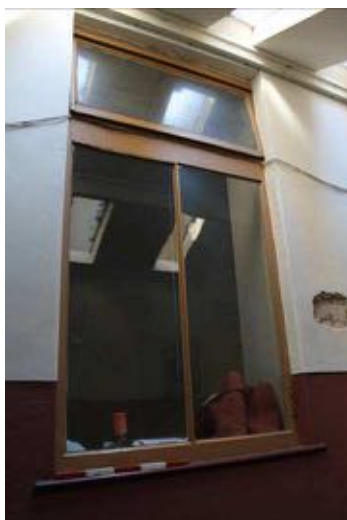
**GW45**

*Plate 74: Two-light fixed-frame window with timber surrounds and a slender vertical mullion. Lights set vertically and topped by a horizontal ventilator with a curving brass guide on the northern side. Windows jambs plastered and splayed to the north. Late 19th century*

Plate 74: Window **GW45**, facing north

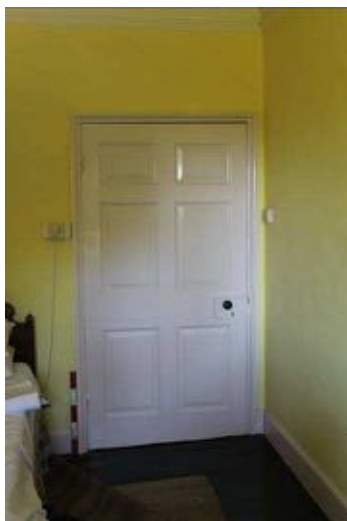
#### ***FD3***

*Plate 75: Wide six-panel timber door, with simple moulded margins and raised insets. Upper two panels smaller than the lower two pairs. Hinged to the west with brass door knobs and a metal locking plate attached to the south face. Late 18th-19th century.*

Plate 75: Door **FD3**, facing north

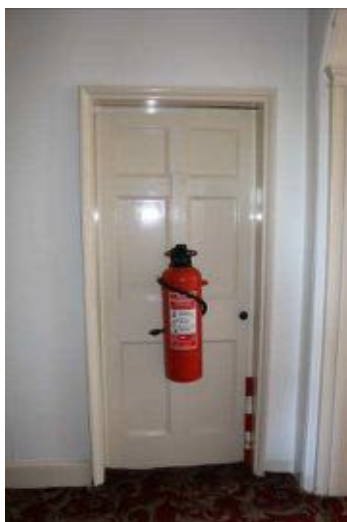
#### ***FD4***

*Plate 76: Narrow six-panel door, with simple moulded margins. Upper two panels smaller than the lower two pairs. Hinged to the west with brass door knobs. 19th century*

Plate 76: Door **FD4**, facing north

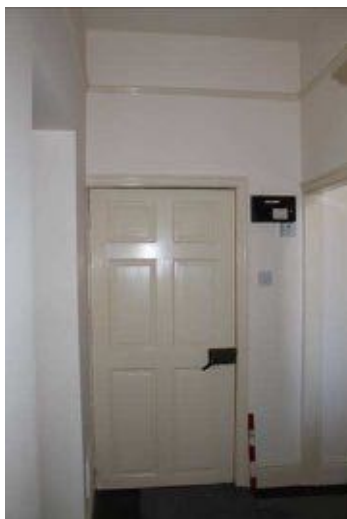
**FD5**

*Plate 77: Six-panel timber door, with simple moulded margins and raised insets. Upper two panels smaller than the lower two pairs. Hinged to the west with locking plate attached to north face and door handle. Late 18th-19th century.*

Plate 77: Door **FD5**, facing south

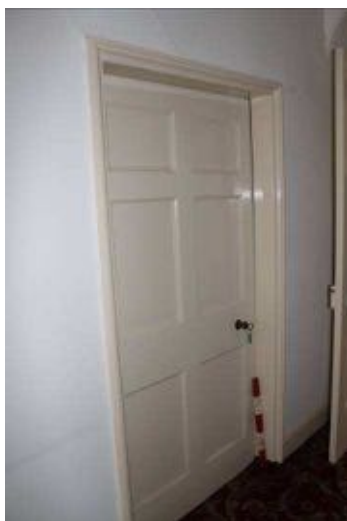
**FD6**

*Plate 78: Wide six-panel timber door, with simple moulded margins and raised insets. Upper two panels smaller than the lower two pairs. Hinged to the east with brass door knobs and a metal locking plate attached to the south face. Late 18th-19th century.*

Plate 78: Door **FD6**, facing south-west

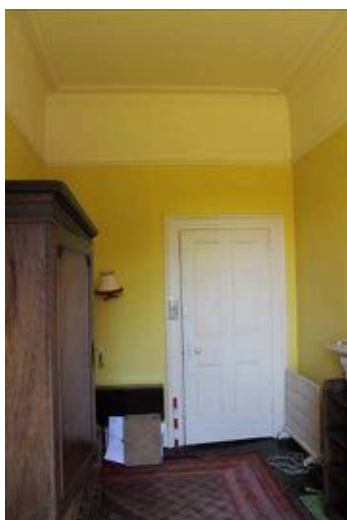
**FD9**

*Plate 79: Four-panel timber door, with moulded margins. Upper panels larger than lower panels. Hinged to the east, with brass door knobs and finger plates on the southern face. Late 19th century.*

Plate 79: Door **FD9**, facing north

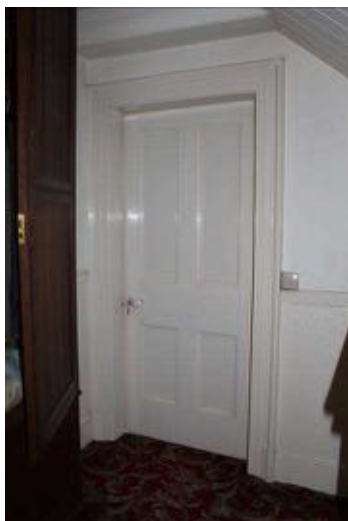
**FD11**

*Plate 80: Four-panel timber door, with moulded margins. Upper panels larger than lower panels. Hinged to the south, with brass door knobs. Late 19th century.*

Plate 80: Door **FD11**, facing west

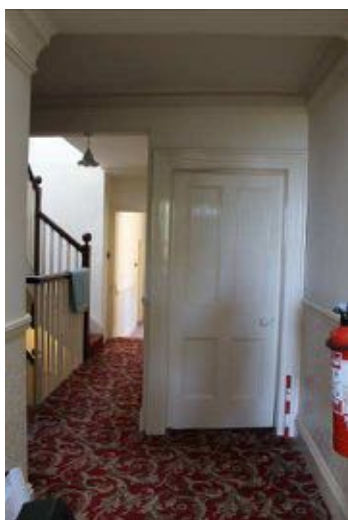
**FD15**

*Plate 81: Four-panel timber door, with moulded margins. Upper panels larger than lower panels. Hinged to the west, with brass door knobs. Late 19th century.*

Plate 81: Door **FD15**, facing north

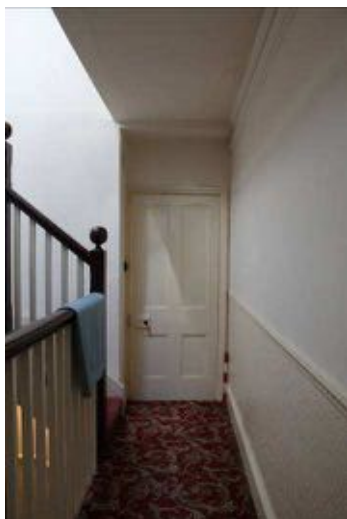
**FD16**

*Plate 82: Four-panel timber door, with moulded margins. Upper panels larger than lower panels. Hinged to the east, with brass door knobs and locking plate on the south face. Late 19th century.*

Plate 82: Door **FD16**, facing north

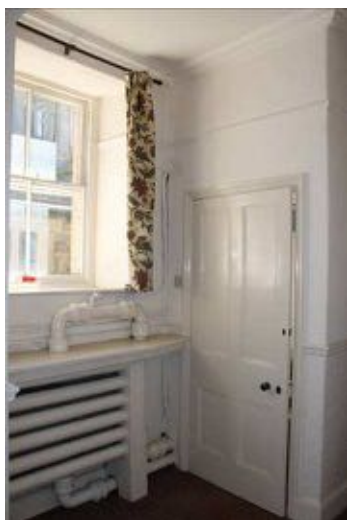
**FD17**

*Plate 83: Four-panel timber door, with moulded margins. Upper panels larger than lower panels. Hinged to the east, with brass door knobs and locking plate on the south face. Late 19th century.*

Plate 83: Door **FD17**, facing south-east

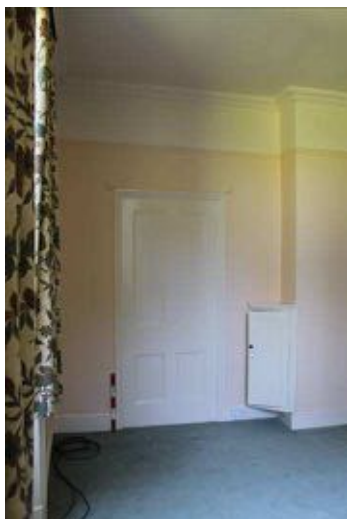
**FD19**

*Plate 84: Four-panel timber door, with moulded margins. Upper panels larger than lower panels. Hinged to the east, all door furniture removed and door sealed. Late 18th – 19th century. Late 19th century.*

Plate 84: Door **FD19**, facing north

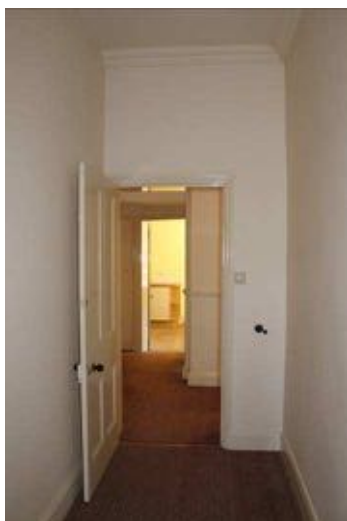
**FD20**

*Plate 85: Four-panel timber door, with moulded margins. Upper panels larger than lower panels. Hinged to the north, with brass door knobs and locking plate on the east face. Late 19th century.*

Plate 85: Door **FD20**, facing east

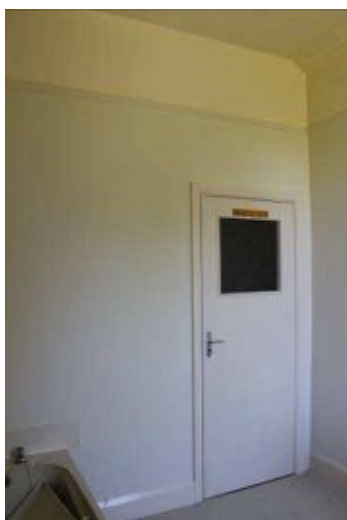
**FD21**

*Plate 86: Hollow core timber door with frosted glass panel to upper third. Hinged to the south with modern door handles to east and west. 20th century.*

Plate 86: Door **FD21**, facing south-east

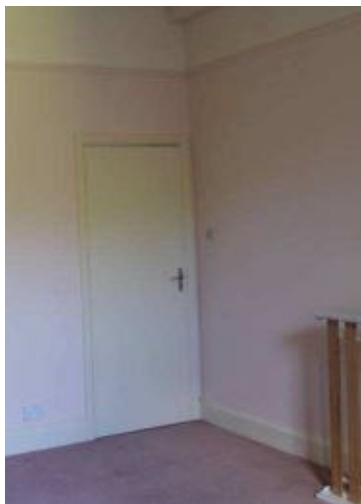
**FD23**

*Plate 87: Hollow core timber door. Hinged to the east with modern door handles to north and south. 20th century.*

Plate 87: Door **FD23**, facing south-west

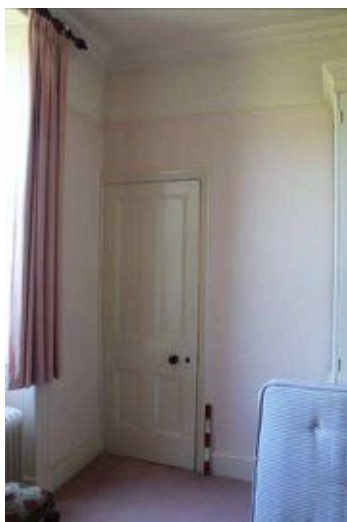
**FD24**

*Plate 88: Four-panel timber door, with moulded margins fitted to walk in wardrobe. Upper panels larger than lower panels. Hinged to the north, with brass door knobs. Late 19th century.*

Plate 88: Door **FD24**, facing north-east

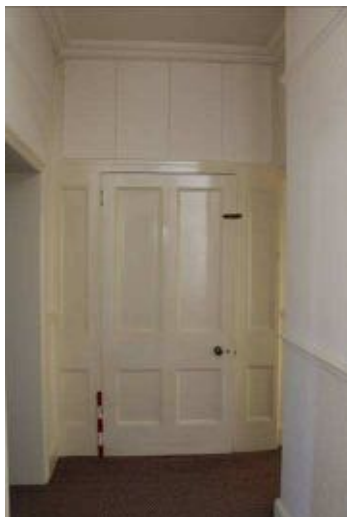
**FD25**

*Plate 89: Large four-panel timber door, with moulded margins. Upper panels larger than lower panels. Hinged to the west, with brass door knobs, draw bolt on south face towards top. Late 19th century.*

Plate 89: Door **FD25**, facing north

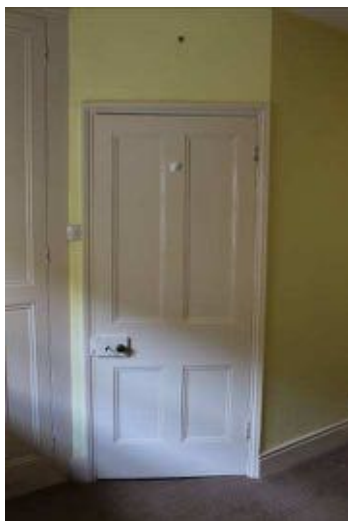
**FD26**

*Plate 90: Four-panel timber door, with moulded margins. Upper panels larger than lower panels. Hinged to the north, with brass door knobs and locking plate on the east face. Late 19th century.*

Plate 90: Door **FD26**, facing north-west

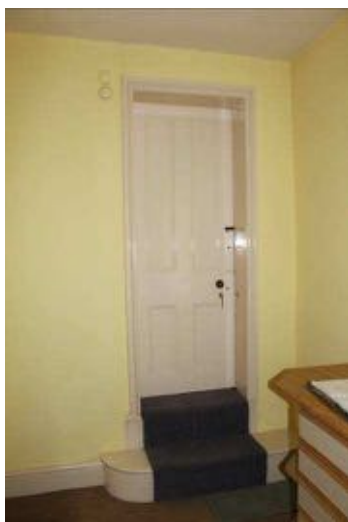
**FD27**

*Plate 91: Narrow four-panel timber door, with moulded margins. Upper panels larger than lower panels. Hinged to the north, with brass door knobs and locking plate on the east face. Late 19th century.*

Plate 91: Door **FD27**, facing south-east

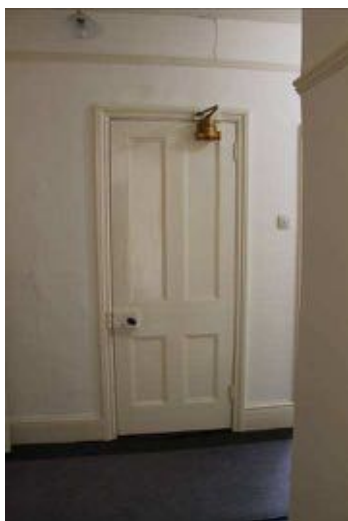
**FD28**

*Plate 92: Four-panel timber door, with moulded margins. Upper panels larger than lower panels. Hinged to the east, with ovoid brass door knobs, locking plate on the south face over a draw bolt. Late 19th century.*

Plate 92: Door **FD28**, facing north

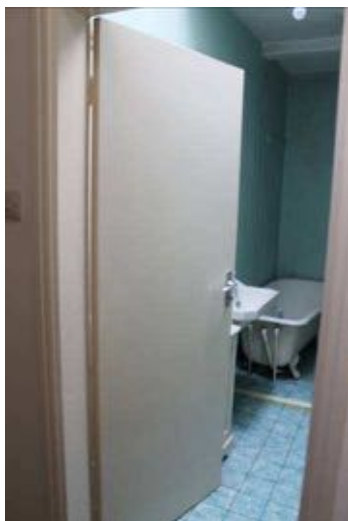
**FD29**

*Plate 93: Hollow core timber door. Hinged to the west with modern door handles. 20th century.*

Plate 93: Door **FD29**, facing north

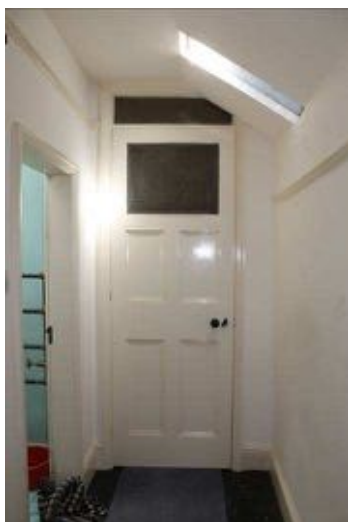
**FD30**

*Plate 94: Tall, five-panel timber door, with glazed and frosted rectangular top panel. Panels below mid rail larger than those above, both pairs with moulded margins. Hinged to the north with brass door knobs. Frosted over-lighter above. Late 19th century*

Plate 94: Door **FD30**, facing east

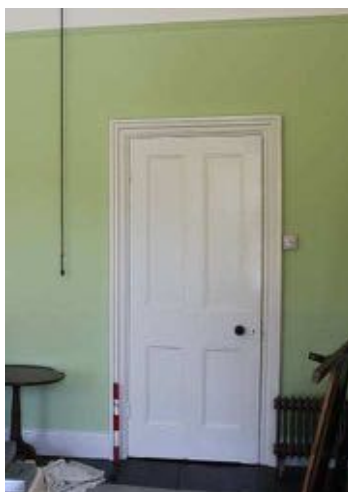
**FD32**

*Plate 95: Four-panel timber door, with moulded margins. Upper panels larger than lower panels. Hinged to the south, with brass door knobs. 19th century.*

Plate 95: Door **FD32**, facing west

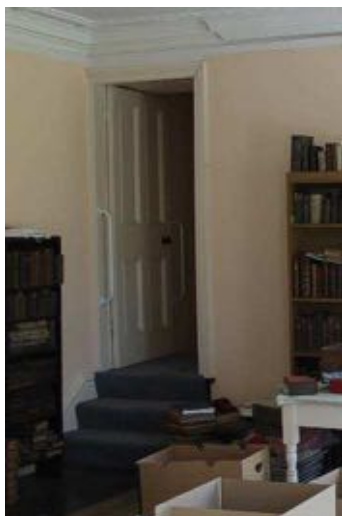
**FD33**

*Plate 96: Four-panel timber door, with moulded margins. Upper panels larger than lower panels. Hinged to the west, with brass door knobs. Late 19th century.*

Plate 96: Door **FD33**, facing north-west

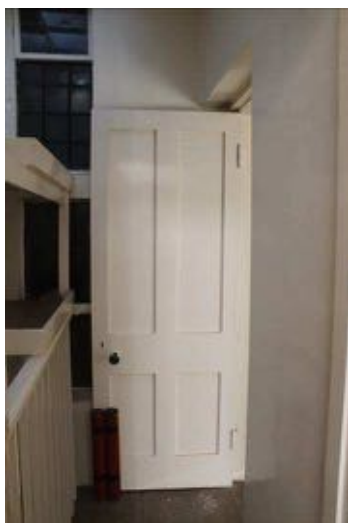
**FD35**

*Plate 97: Plain four-panel timber door, without moulded margins. Upper panels larger than lower panels. Hinged to the south, with brass door knobs. Late 19th century.*

Plate 97: Door **FD35**, facing south

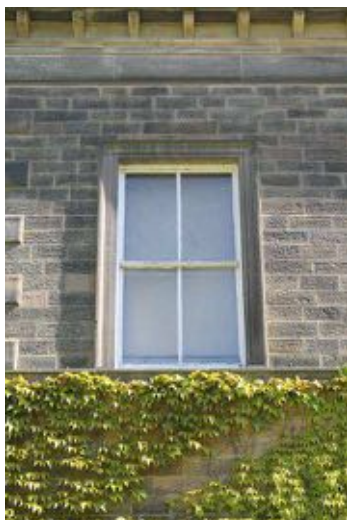
### FW27

*Plate 98: Two-over-two light timber sash window. Moulded external stone surrounds, with regular perpendicular tooling pattern. No evidence of the window internally, although it is unclear if it was built as a dummy or later blocked on the interior face. Mid-19th century.*

Plate 98: Window **FW27**, facing north

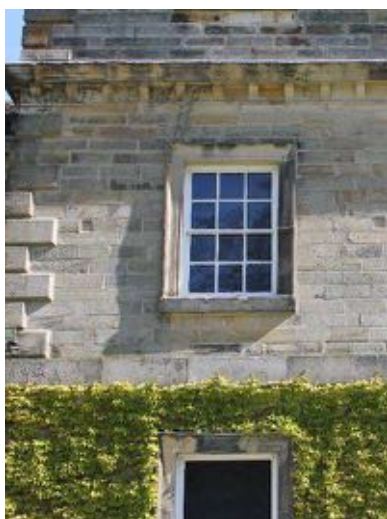
### FW33

*Plate 99: Six-over-six light timber frame sash window. Moulded external stone surrounds with projecting stone sill. No evidence of the window internally, although it is unclear if it was built as a dummy or later blocked on the interior face. Mid-eighteenth century.*

Plate 99: Window **FW33**, facing north

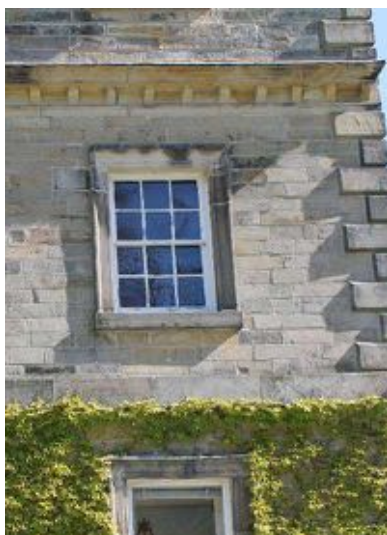
### FW34

*Plate 100: Six-over-six light timber frame sash window. Moulded external stone surrounds with projecting stone sill. No evidence of the window internally, although it is unclear if it was built as a dummy or later blocked on the interior face. Mid-eighteenth century.*

Plate 100: Window **FW34**, facing north

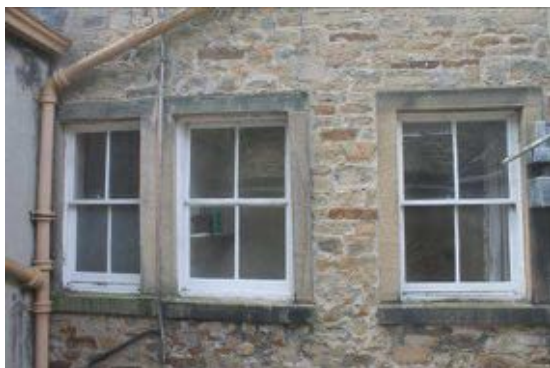
**FW35**

*Plate 101: Narrow two-over-two light timber sash window. Plain square section external stone surrounds, with regular tooling pattern. Shares its northern jamb with window **FW36**. Sash fastener on interior meeting rail. Late 19th century.*

Plate 101: Window **FW35**, facing west

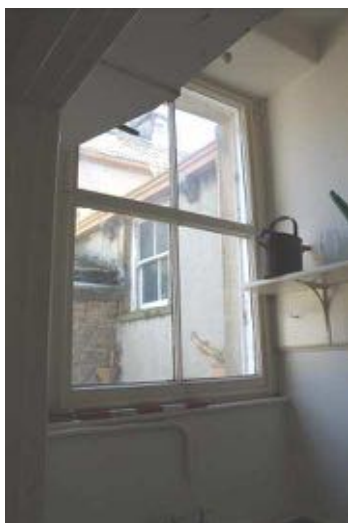
**FW36**

*Plate 102: Faux two-over-two light timber sash window. Plain square section external stone surrounds, with regular tooling pattern. Shares its northern jamb with window **FW35**. Hinged on the meeting rail to allow the two upper lights to open inwards as a ventilator. Late 19th century.*

Plate 102: Window **FW36**, facing east

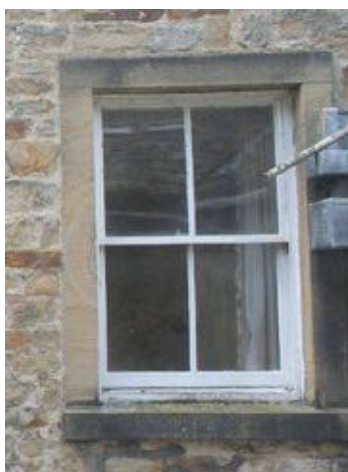
**FW37**

*Plate 103: Two-over-two light timber sash window. Plain square section external stone surrounds, with regular tooling pattern. The sash fastener on interior meeting rail has been replaced with a modern example. Late 19th century.*

Plate 103: Window **FW37**, facing west

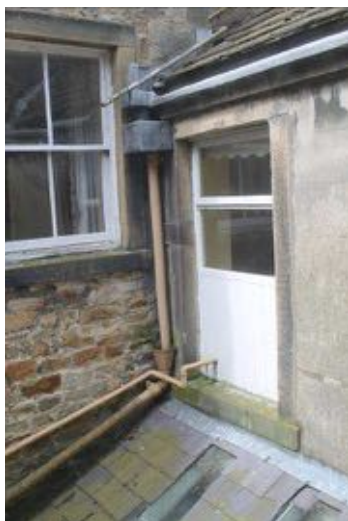
**FW38**

*Plate 104: The original window has been replaced by a modern fixed frame rectangular horizontal light with ventilator above. The lower half of the opening has been blocked but the exterior stone surrounds survive, being of plain square section. Diagonal tooling pattern visible externally. Twentieth century window with early 19th century opening.*

5.2.19 **Phase VI - Twentieth Century:** During the twentieth century alterations within the service blocks appear to have been few. On the ground floor, the walls must have been repainted but may well retain their original nineteenth-century decorative scheme. On the first floor, alterations have been made to **Room F14e**, which was converted into a modern kitchen. This appears to have resulted in the replacement of window **FW38**, although the dimensions of the original opening may survive.

Plate 104: Window **FW38**, facing north-west

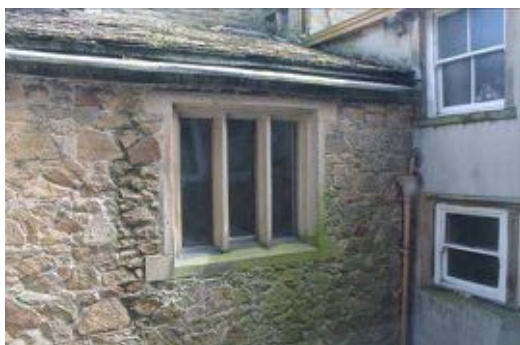
**FW39**

*Plate 105: Three-light window with stone surrounds to interior and exterior. Mullions have hollow chamfers on both faces and regular perpendicular tooling pattern. Central light hinged as a casement, with window stay on sill. Late 19th century.*

Plate 105: Window **FW39**, facing south-east

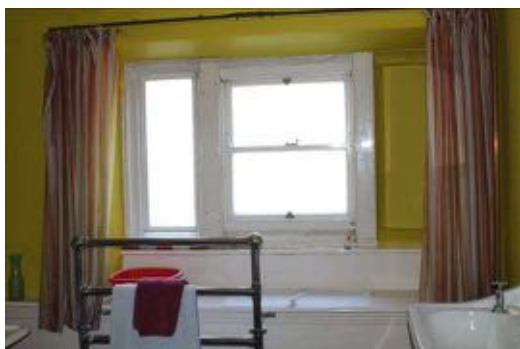
**FW40**

*Plate 106: Four-light window with stone surrounds modified to two lights with the removal of the central mullion and blocking of the eastern light. Eastern mullion replaced. Original surviving mullion hollow chamfered on both faces. Early 17th century.*

Plate 106: Window **FW40**, facing north

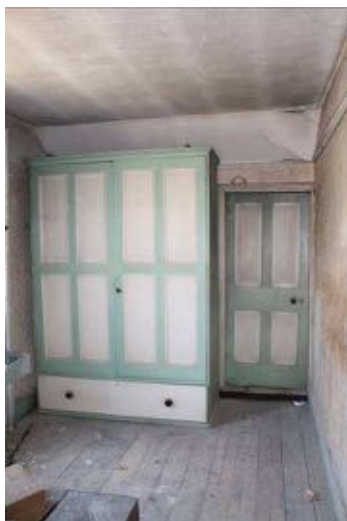
#### SD4

*Plate 107: Plain four-panel timber door, without moulded margins. Upper panels larger than lower panels. Hinged to the east, with brass door knobs. Late 19th century.*

Plate 107: Door **SD4**, facing south

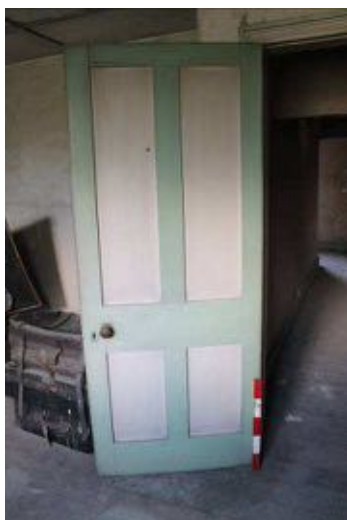
#### SD6

*Plate 108: Plain four-panel timber door, without moulded margins. Upper panels larger than lower panels. Hinged to the north, with brass door knobs and a locking plate on the western face. Late 19th century.*

Plate 108: Door **SD6**, facing east

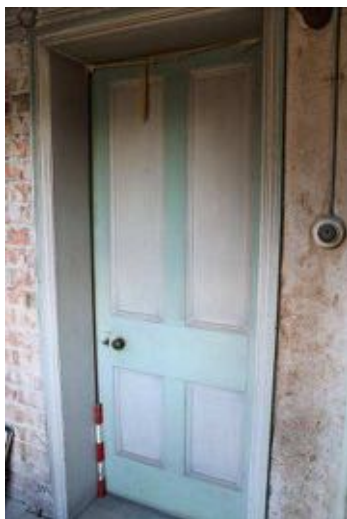
**SD7**

*Plate 109: Four-panel timber door, with moulded margins to the east. Upper panels larger than lower panels. Hinged to the north, with brass door knobs and a locking plate on the western face. Late 19th century.*

Plate 109: Door **SD7**, facing south-west

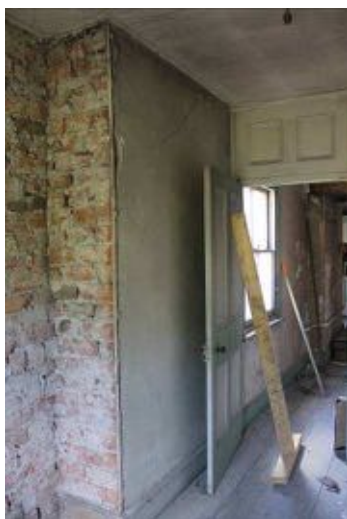
**SD8**

*Plate 110: Four-panel timber door, with moulded margins to the south. Upper panels larger than lower panels. Hinged to the east, with brass door knobs and a locking plate on the northern face. Late 19th century.*

Plate 110: Door **SD8**, facing south

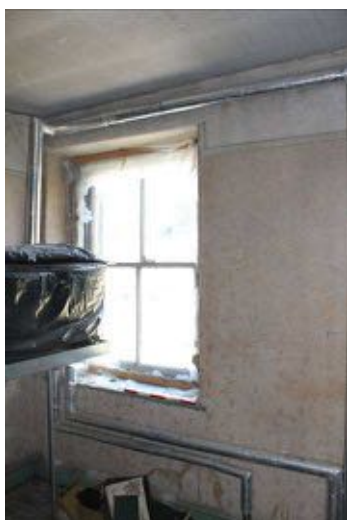
**Windows****SW13**

*Plate 111: Two-over-two light timber sash window. Plain square section external stone surrounds, not closely inspected but appear similar to those on the floor below. Sash fastener on interior meeting rail. Late 19th century.*

Plate 111: Window **SW13**, facing east

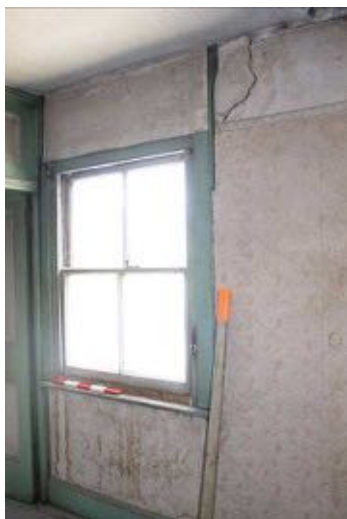
**SW14**

*Plate 112: Two-over-two light timber sash window. Plain square section external stone surrounds, not closely inspected but appear similar to SW13. Sash fastener on interior meeting rail. Mid- late 19th century.*

Plate 112: Window **SW14**, facing east

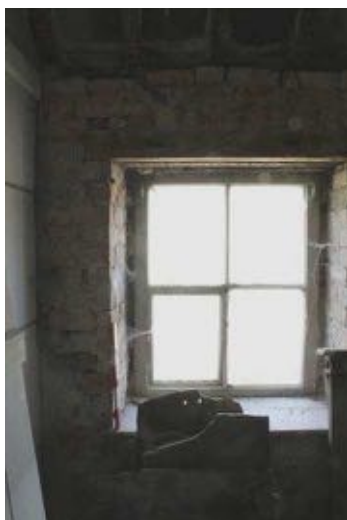
**SW15**

*Plate 113: Faux two-over-two light timber sash window. Only the lower western light opens upon a central pivot hinge. Not observed externally. Late 19th century*

Plate 113: Window **SW15**, facing north
