## INTRODUCTION

Mr and Mrs Frankish have recently purchased this listed property along with their two children as a long-term family home. They are keen, whilst respecting the listed status, to safeguard and improve the property making it more suited to their modern lifestyle.

Replacing a 1970s flat roof link with glass; conversion of detached garage into guest accommodation and playroom including glass link to house; re-roofing; replacement of 1970s windows and doors; re-sizing 1970s windows to former pig sty; internal alterations including: new limecrete floor to include underfloor heating and dpc lining to 1m above finished floor, insulated linings to external walls, improvement to ceiling insulation, installation of en-suite bathrooms, removal of cylinder cupboard, raising ceiling in master bedroom, removal of a section of wall to original cart shed.

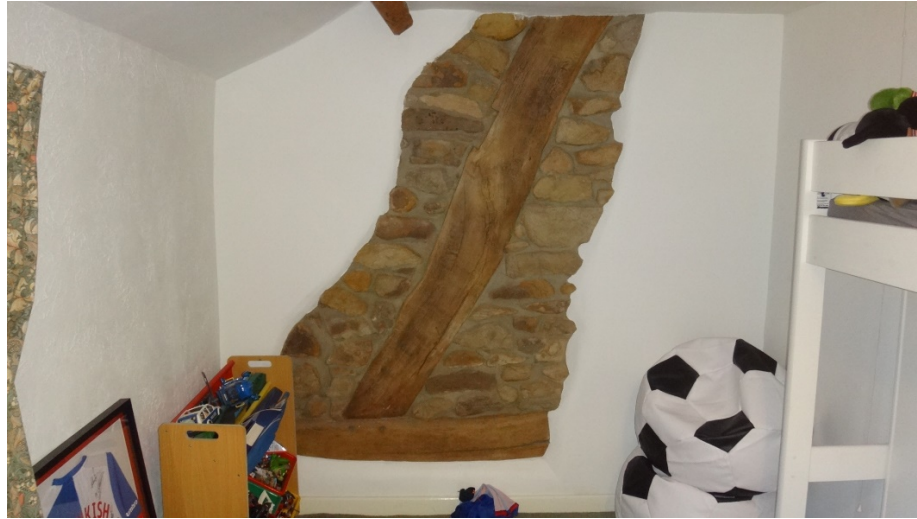
*Figure 1 Part cruck frame in west wall of central bay towards the front of house at first floor*

The building is simple in its design and is notable internally for the part cruck frame at first floor suggesting an earlier form of the building (Not picked up in its original listing in the 1980s). Considerable alterations were made to the building in the 70s under planning approval but prior to the building's listing.

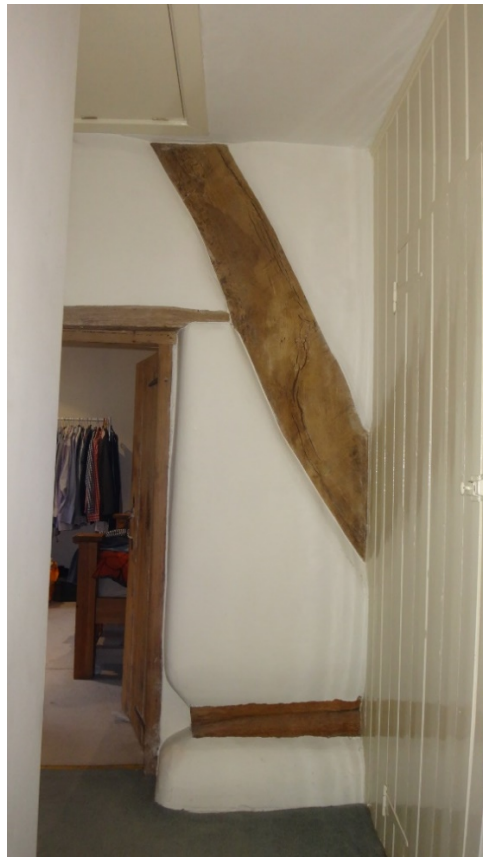
*Figure 2 Part cruck frame in west wall towards rear wall of central bay of house on first floor landing; partly concealed by a later airing cupboard and; broken by the insertion of a doorway*

A new heating installation will include an oil-fired combi boiler negating the need for a cylinder cupboard. This application seeks to remove the existing cylinder cupboard which is lined internally, on the 'cruck wall', with hardboard. It is hoped that removing the hardboard will reveal more of the cruck frame. The resultant space will become a study area.

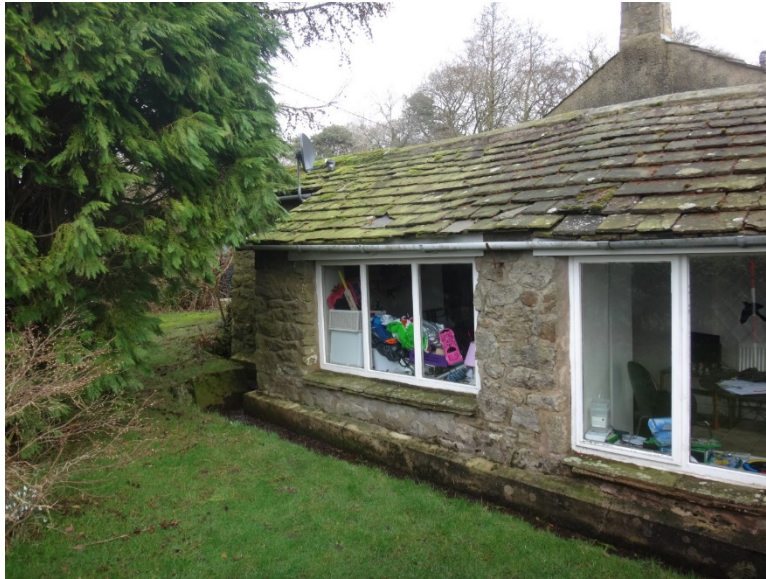
*Figure 3 Large windows inserted in outbuildings to west of property in the 70s*

The centre of the house is a three-bay form with a later stable/coach house added to the West and further west; detached outbuildings (possibly former pig sty or stable and outside 'privy'). In the 70s extensive 'modernisation' has taken place linking the outbuildings to the stable with a flat roof structure which has drastically impacted on the appearance of the outbuildings further exacerbated by the insertion of large windows.

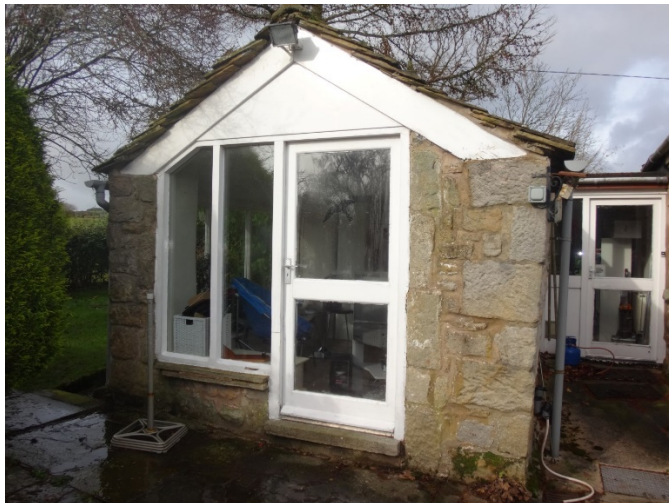
*Figure 4 Large window and door inserted into outbuilding in the 70s - South Elevation*

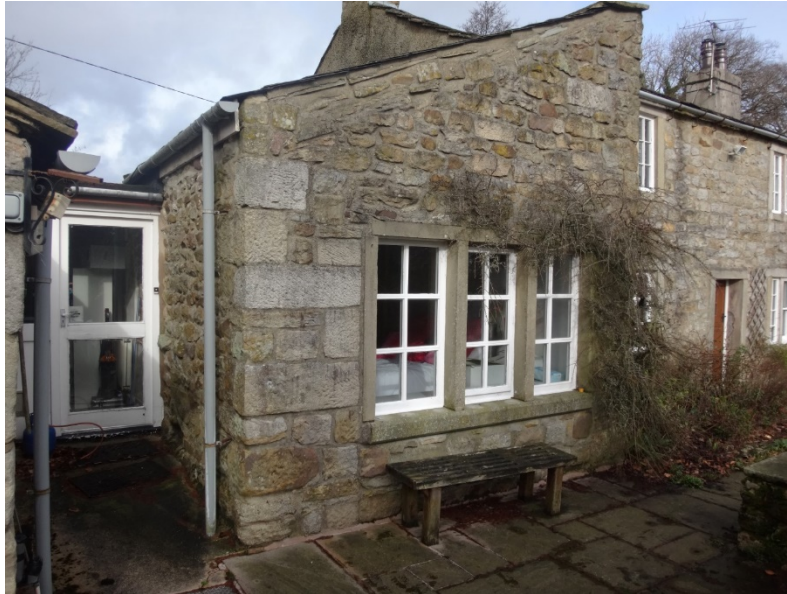
*Figure 5 Existing coach house/stable door infilled with mullioned window and stone at lower level, along with flat roof link to outbuildings carried out in the 70s. The roof of the coach house appears to have been raised probably in the seventies (compare with figure 7 in the Heritage Assessment) to accommodate the flat roof link*

The stable/coach house doors have been lost by the insertion of a modern window with stone jambs, mullions and lintols.

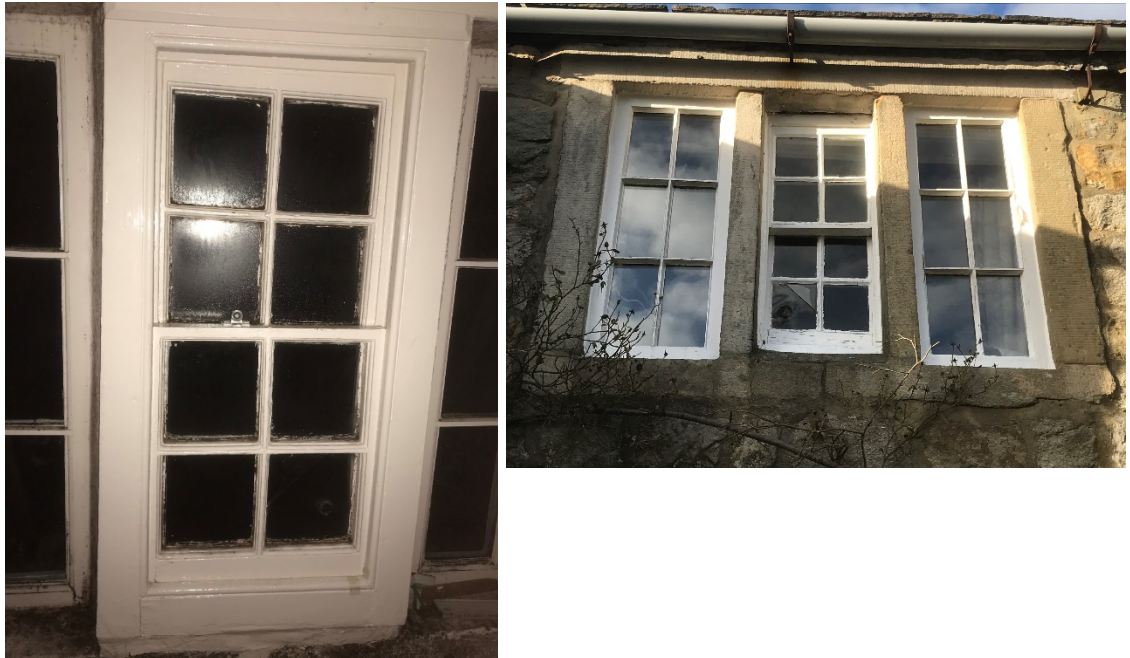
*Figure 7 Existing sliding sash in the centre of the 2 squared mullioned window WF01 to be retained – paint stripped, and cords and sashes put back to working order. Cement pointing replaced with compatible mastic*

The existing sliding sash (WF01) which includes float glass and a 'bull's eye' feature will be stripped of all paint, sashes eased, cords replaced and weights re-connected; glass very carefully removed and re-fitted using replacement putty and the whole unit re-painted including new mastic between the window and the stonework (mastic to be specified to work with stone and timber).

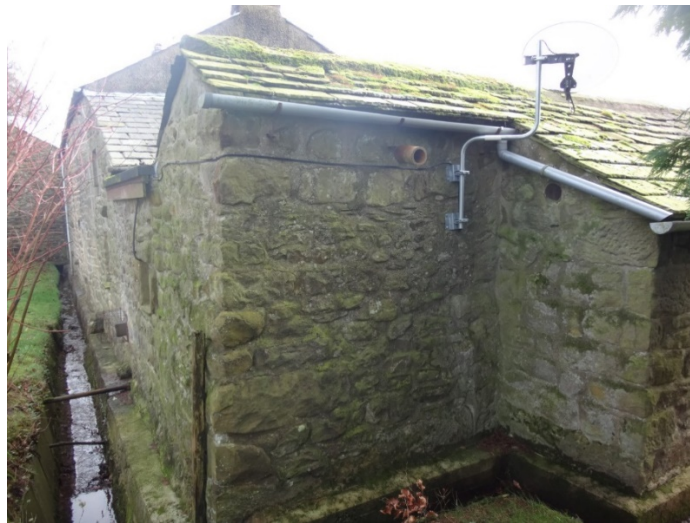
*Figure 8 Original corner and recess indicating possible 'privy' linked to 'pig sty' forming the original untouched part of the outbuildings to the West. Also noteworthy is the Moat which runs around the North and West of the buildings*

It has been particularly recognised that retaining the original stonework to the privy and its unusual roof form in connecting to the pig sty is important in maintaining the setting of the listed buildings. A modern replacement would have destroyed that character.

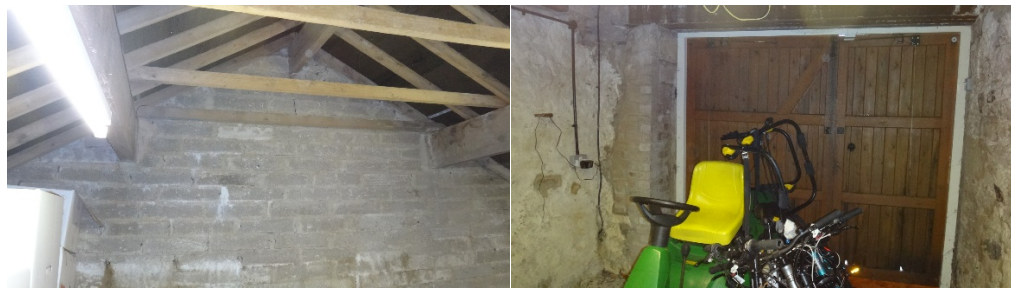
Conversion of this into guest accommodation and a play area/gym can be readily achieved without new external openings except for the proposal to have a glass link to the house. The siting of this link has been carefully considered to avoid chancing into any existing quoins in both the listed house and the garage. The link is also positioned on the North elevation and kept as short as possible to minimise its impact in this discreet corner of the listed building. To this end the opening into the house uses an existing window rather than making the link longer. Glass is chosen to ensure the existing wall elevations remain (i.e. un-plastered within the glass link)

It is subjective whether this building was for a cart shed or other use. Today it is used as a garage and domestic store. This two-storey building is already substantially modified to make it a sound building, with the Westerly gable lined in blockwork and the first-floor dividing wall in concrete blocks. The garage doors have been inserted using concrete bricks at the jambs and steel lintels internally. The ground floor is concreted, and a new timber first floor inserted in the Western bay. The remains of floor beams exist in the Easterly bay. The roof has sarking felt and modern rafters. The modifications were part of the 70s approval.
