# Arboricultural Impact Assessment

in Relation to Proposed Installation of Drainage Pipe at

**Land off Barley Close, Whalley,  
Lancashire, BB7 9XY**

October 2020

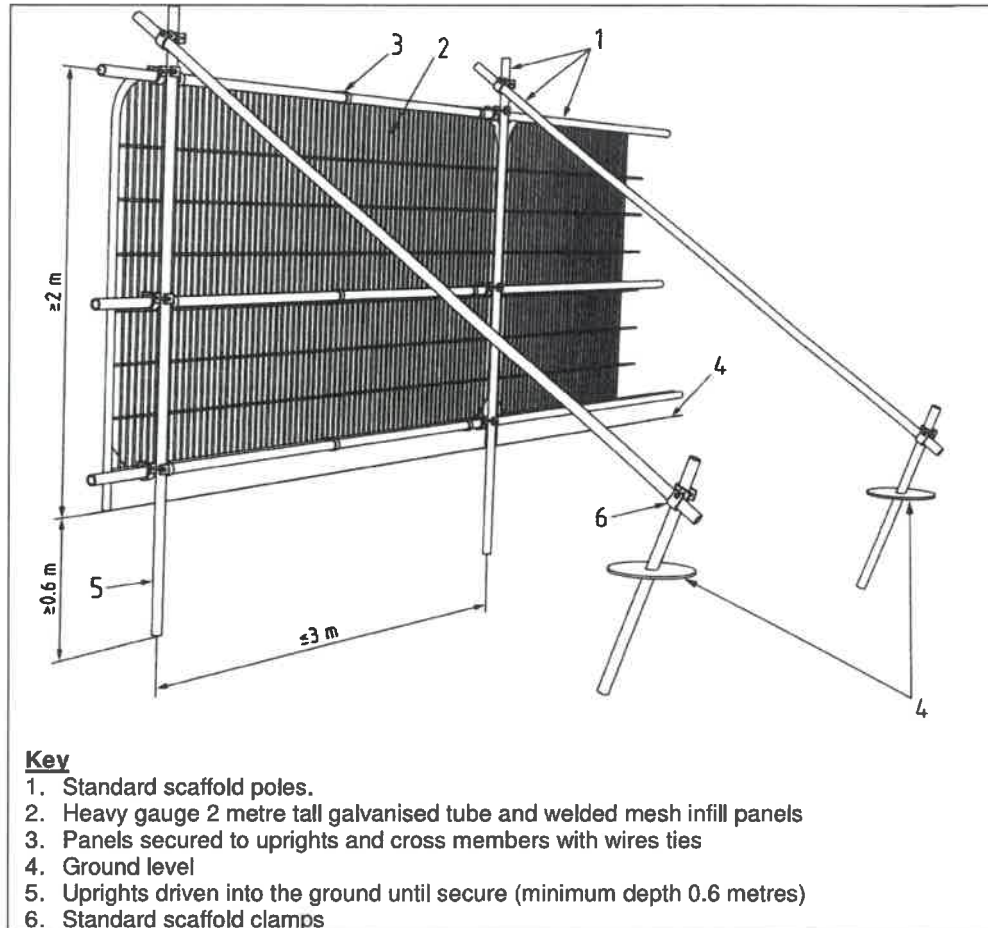
Figure 2: BS5837:2012 Default specification for protective barrier

1. be retained in place throughout the development process, as specified in the 'Temporary Protective Fencing Construction' section below and detailed in BS5837:2012 Figure 2 (overleaf);

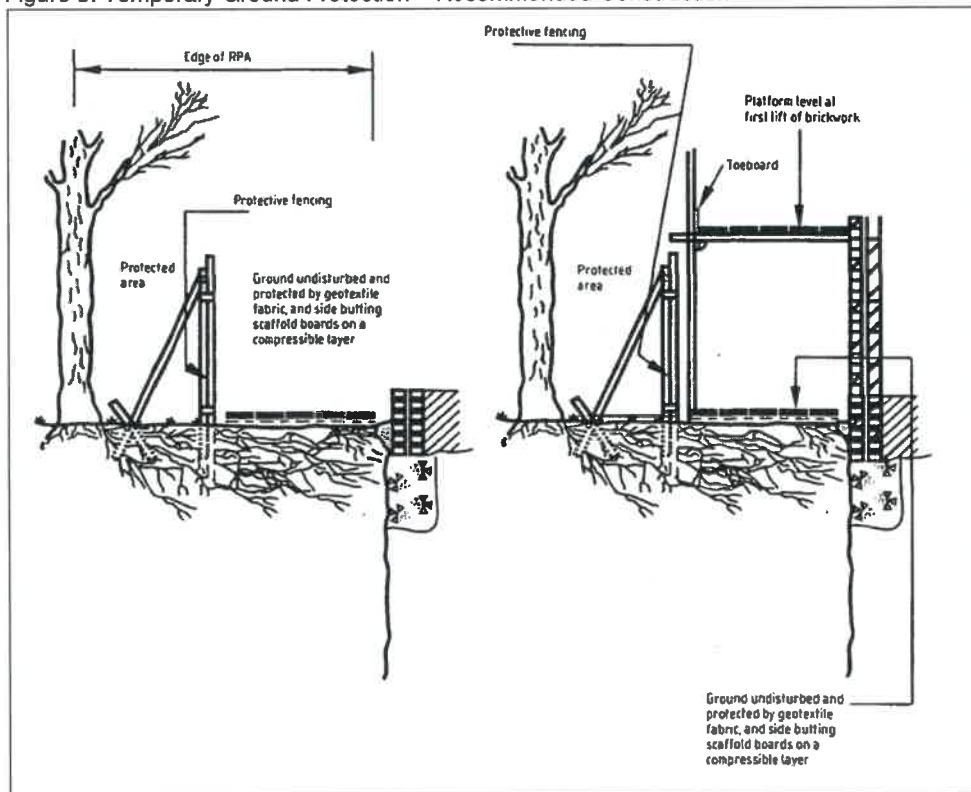
Figure 3: Temporary Ground Protection – Recommended Construction

1. Any necessary Temporary Ground Protection areas shall conform to Figure 3, below, unless otherwise agreed with the LPA.
2. The Ground Protection Area shall be left undisturbed and covered by a semi-permeable geotextile membrane which shall, in turn, be covered by a compressible layer consisting of a material such as woodchip.
3. Side-butting scaffold boards shall then be fitted to cover the Ground Protection Area.
4. On completion of installation, and prior to any demolition or construction works, site preparation, excavation or delivery of plant and materials, the Consulting Arboriculturist or the LPA Tree Officer, as agreed, shall inspect the Temporary Ground Protection.
5. The Temporary Ground Protection shall remain in place until completion of the project and only removed following receipt of written permission from the LPA.
