## Haweswater Aqueduct Resilience Programme

Proposed Marl Hill Section, Volume 6, Proposed Ribble Crossing

Protected Species Survey Report

Technical Appendix 9B.2

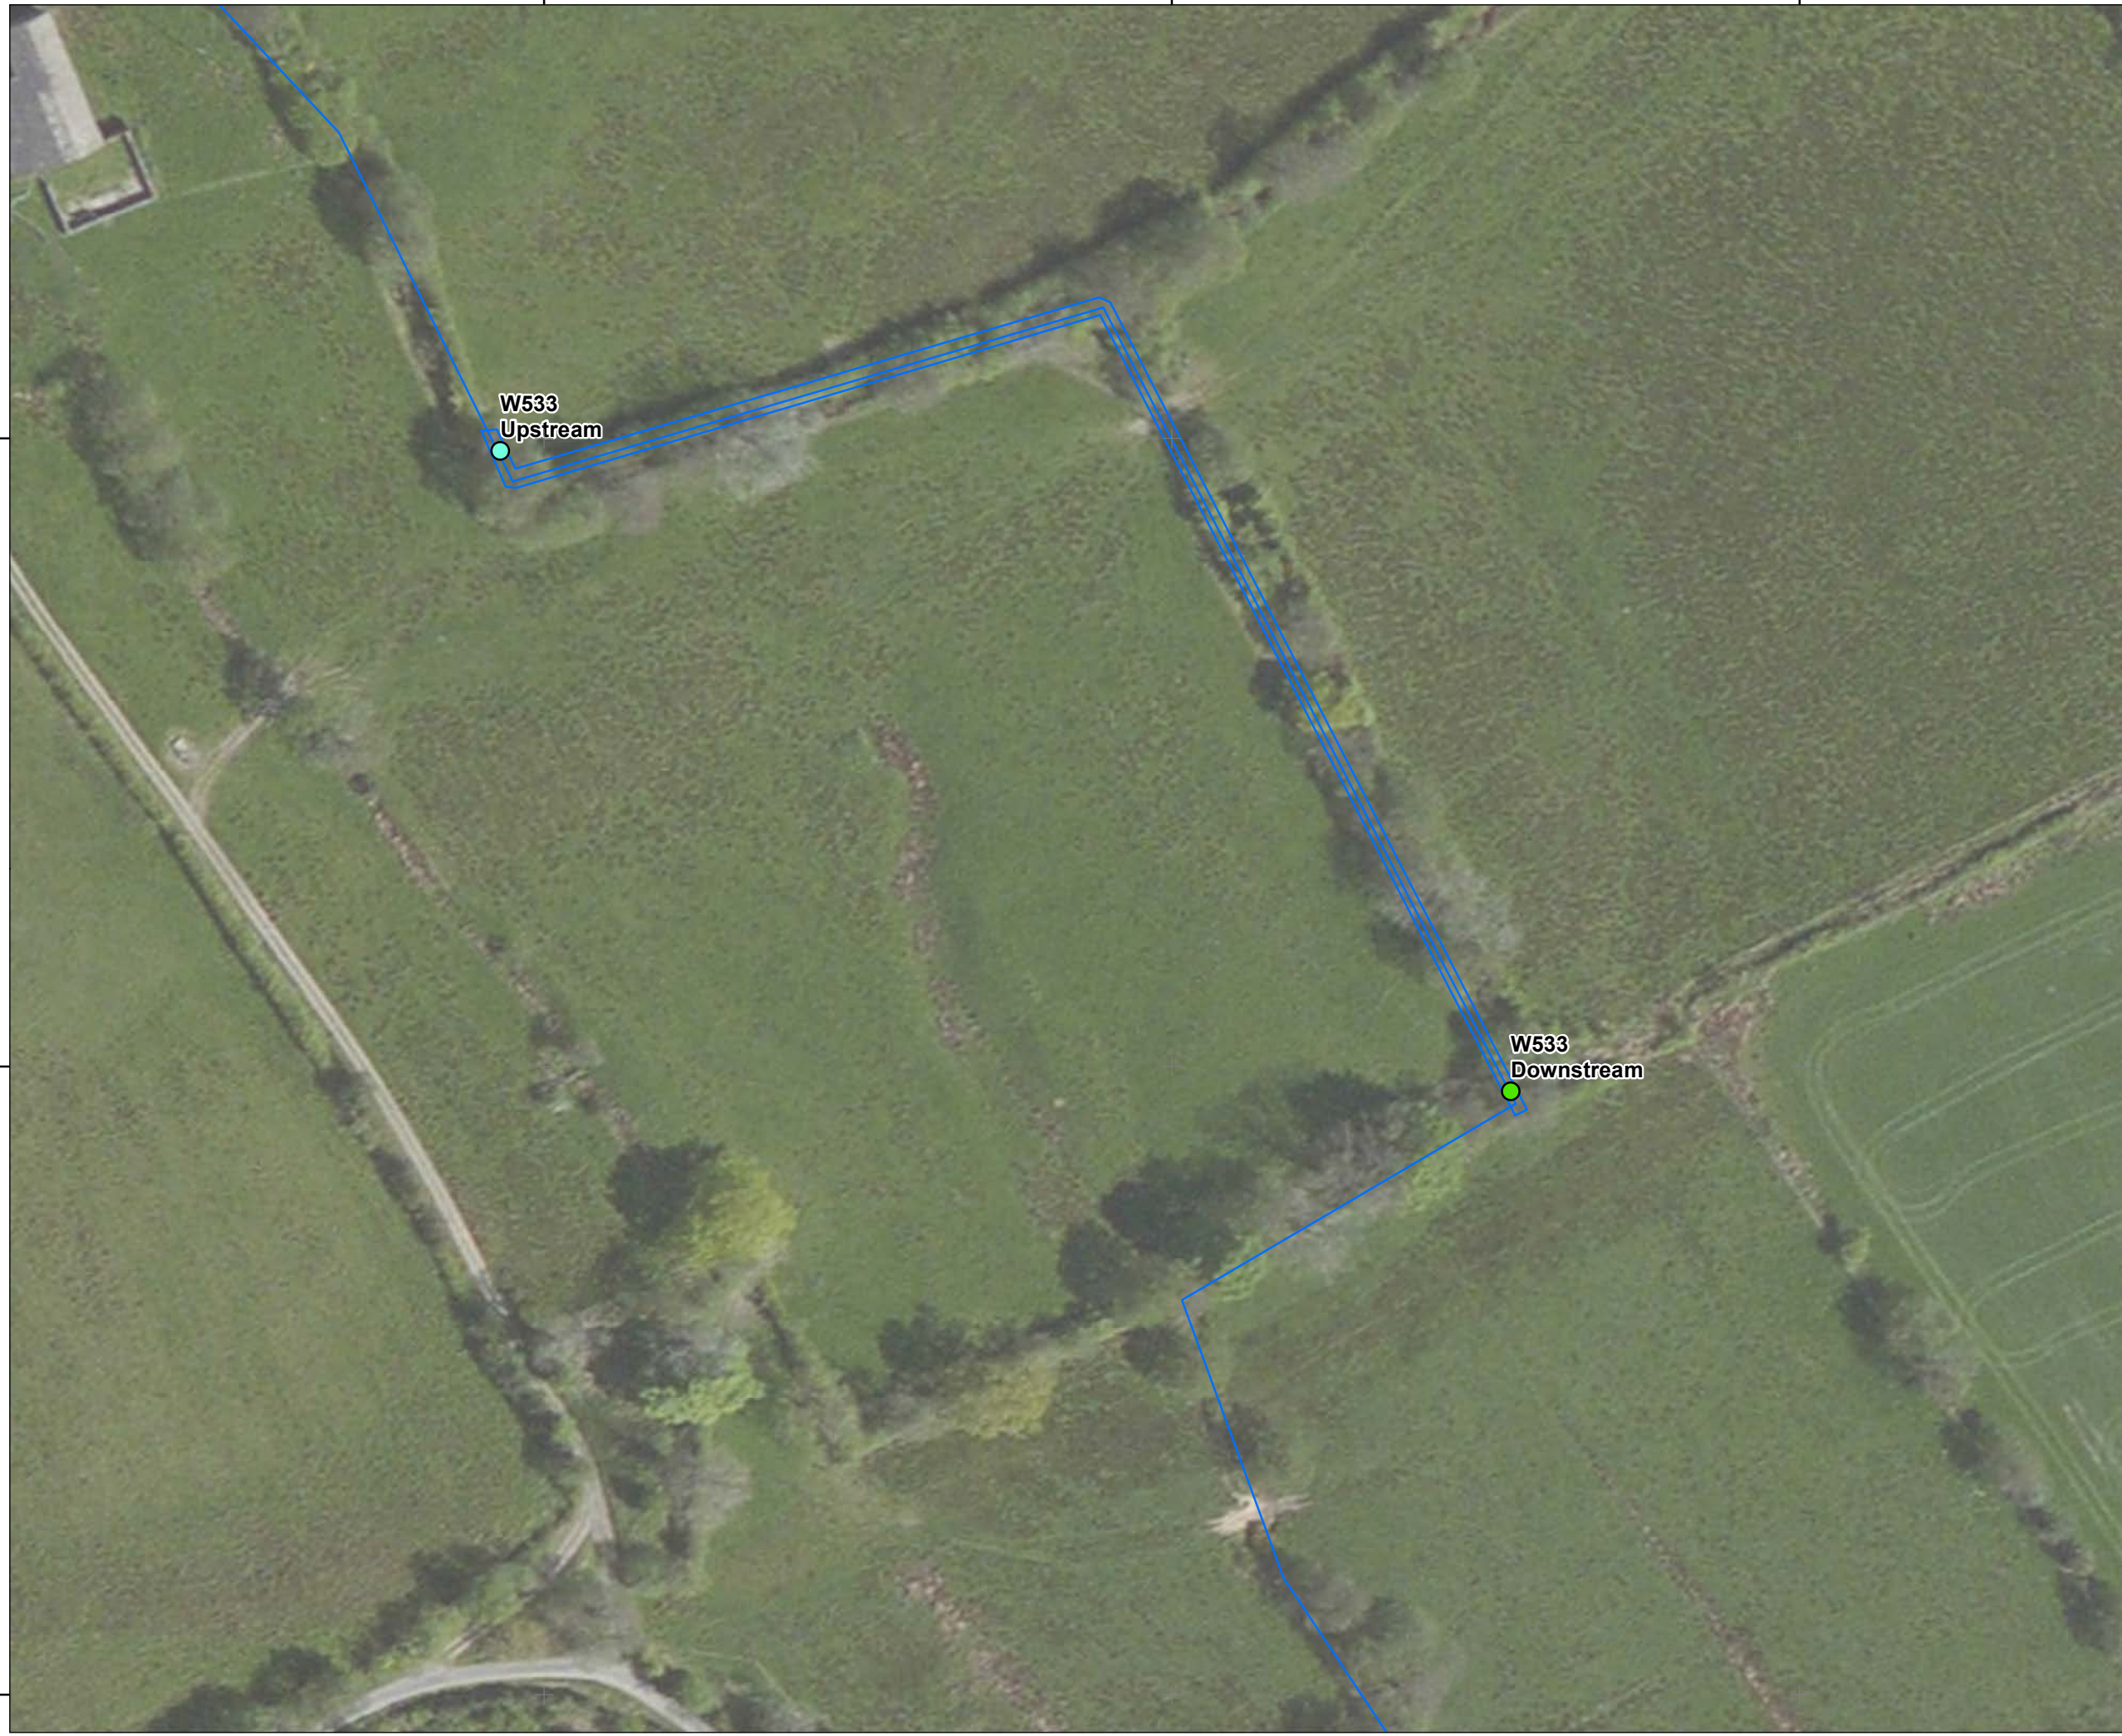
**TITLE: Figure 2:  
 No Otter or Water Vole Survey Results  
 Marl Hill (TR4) - Watercourse W533**

- Legend:**
- Waterbody
  - Upstream Survey Extent
  - Downstream Survey Extent

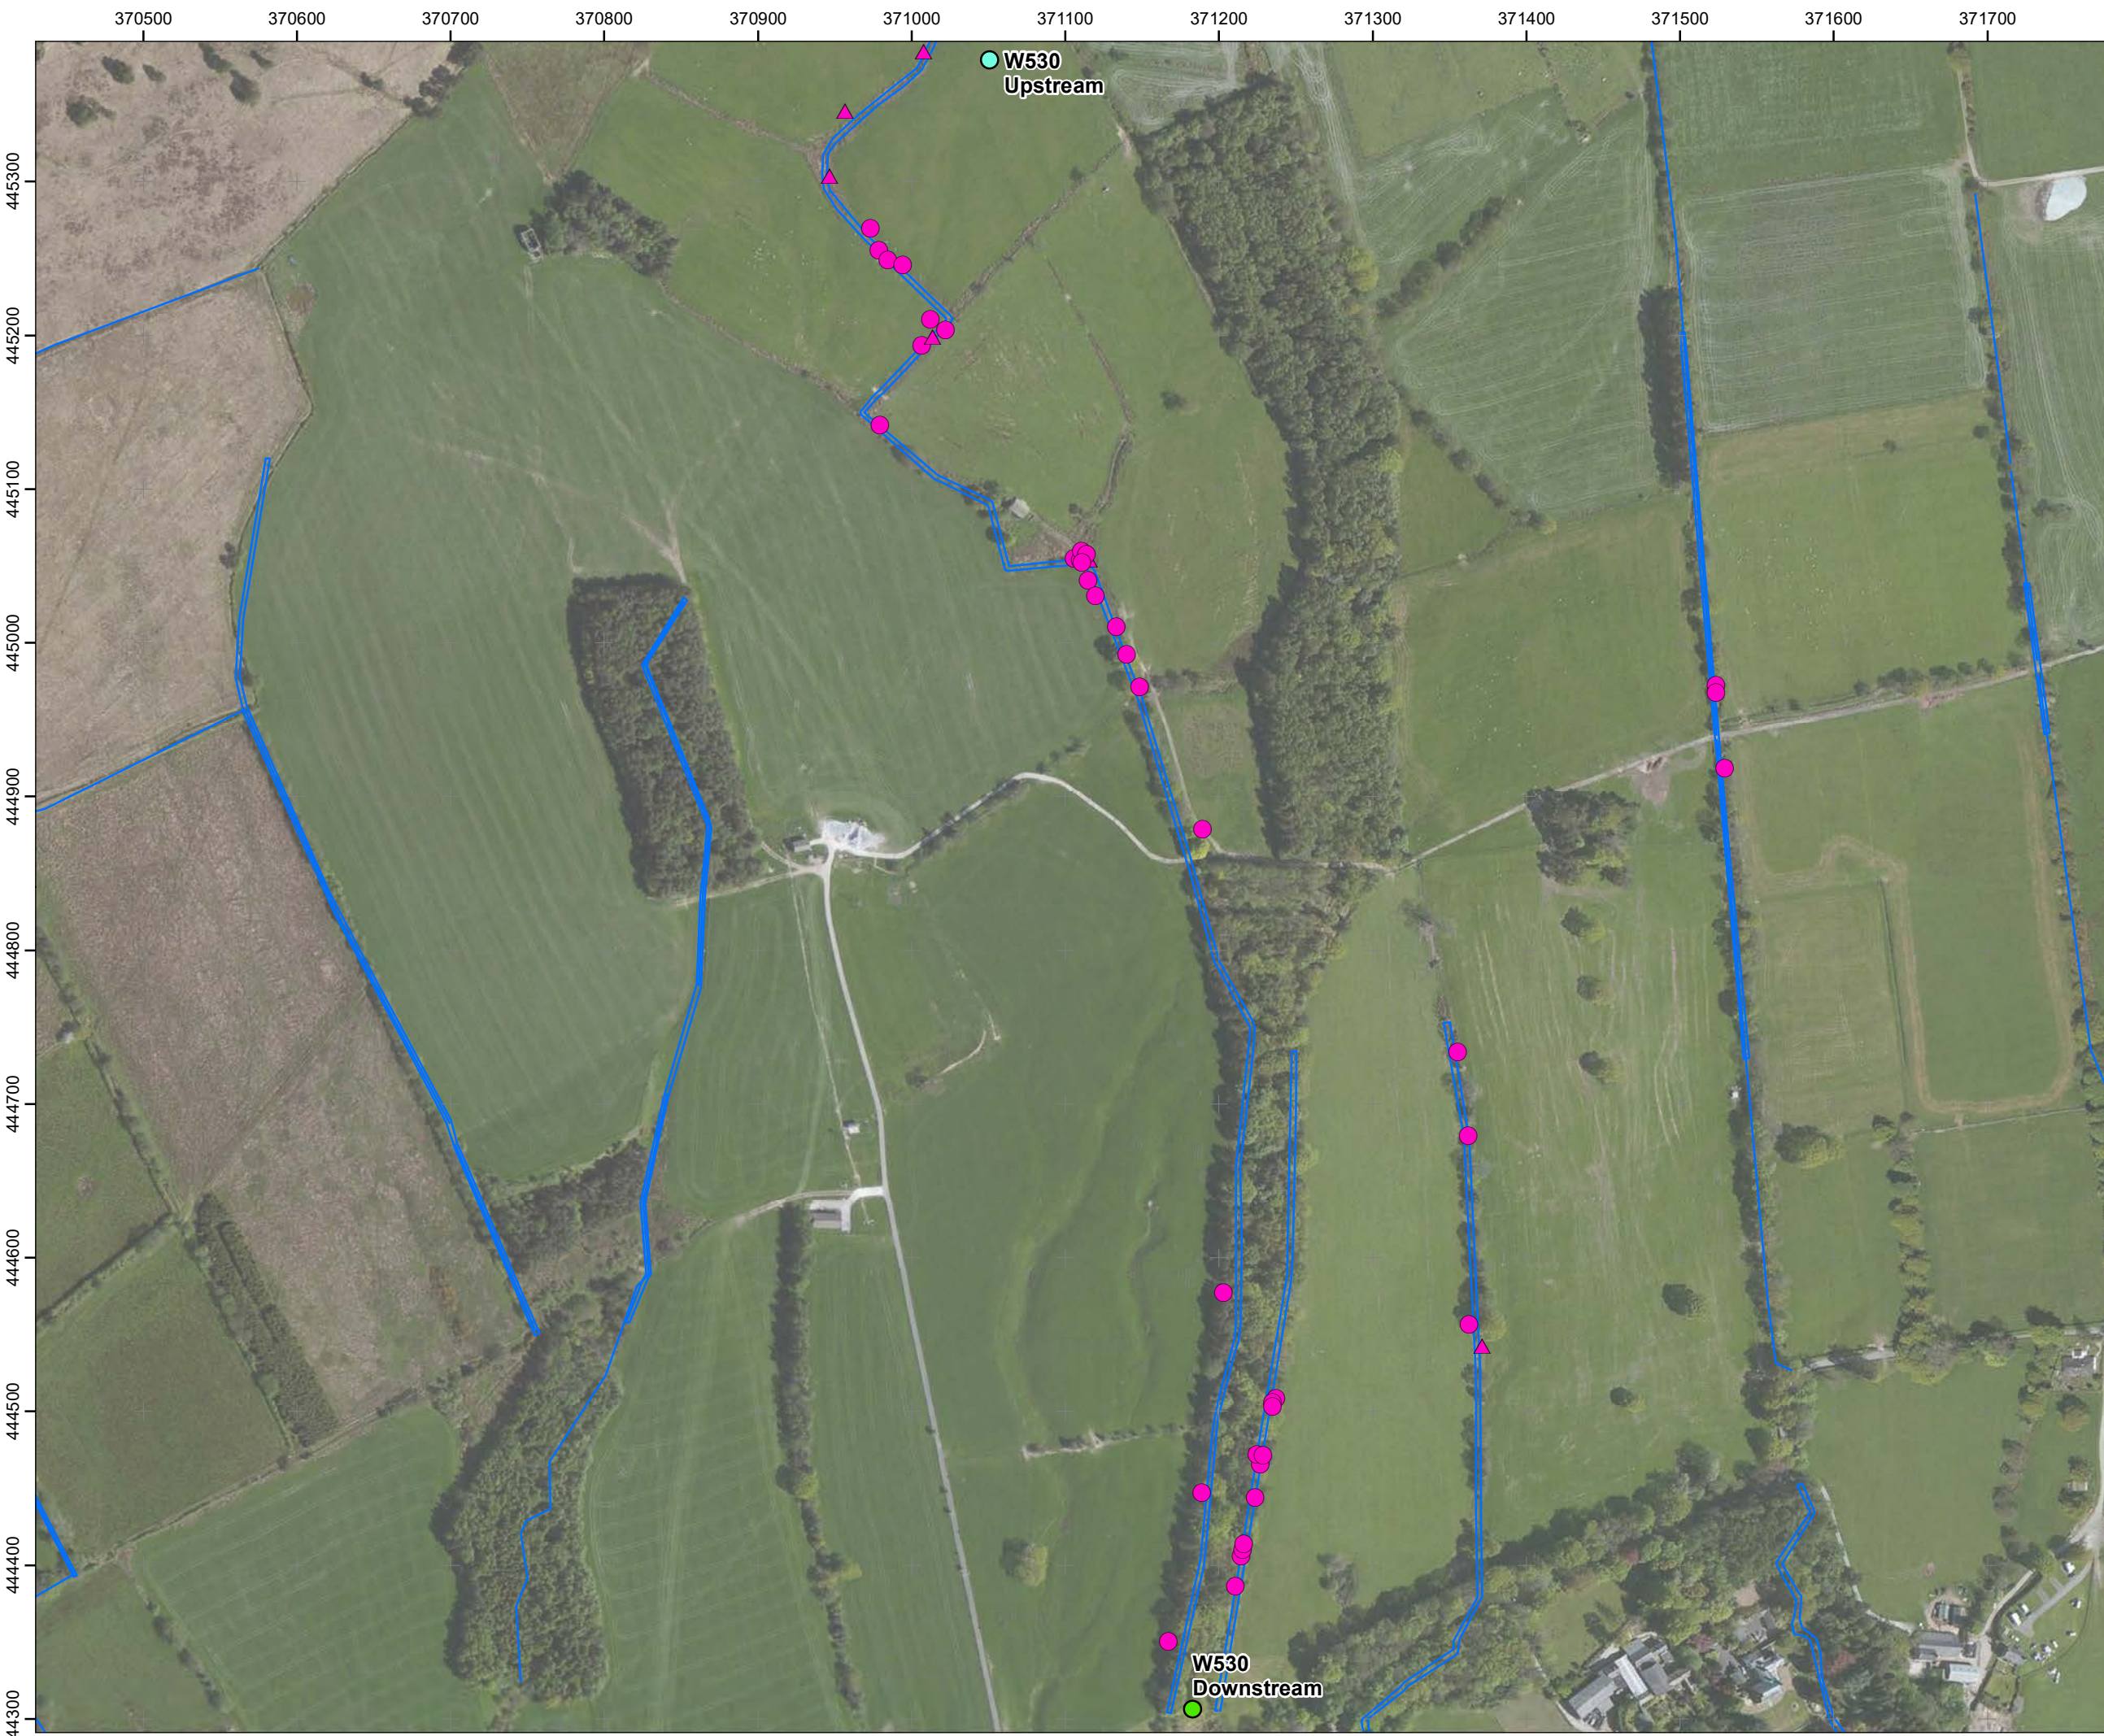
TITLE: Figure 2:  
 Water Vole Survey Results  
 Marl Hill (TR4) - Watercourse W530

- Legend:**
- Waterbody
  - Upstream Survey Extent
  - Downstream Survey Extent
- Potential Water Vole Evidence**
- Burrow
  - ▲ Feeding Signs

No evidence of otter was found at W530. The habitat was generally unsuitable for otter because, although suitable resting areas were identified (cavities under bankside trees), low flows currently limit aquatic foraging opportunities.

The upper section of W530 was potentially suitable for water vole with lush bankside vegetation present and bankside substrate for burrowing. Small mammal activity was observed in the form of burrows and feeding evidence (pictured) but this was characteristic of bank voles (*Myodes glareolus*).

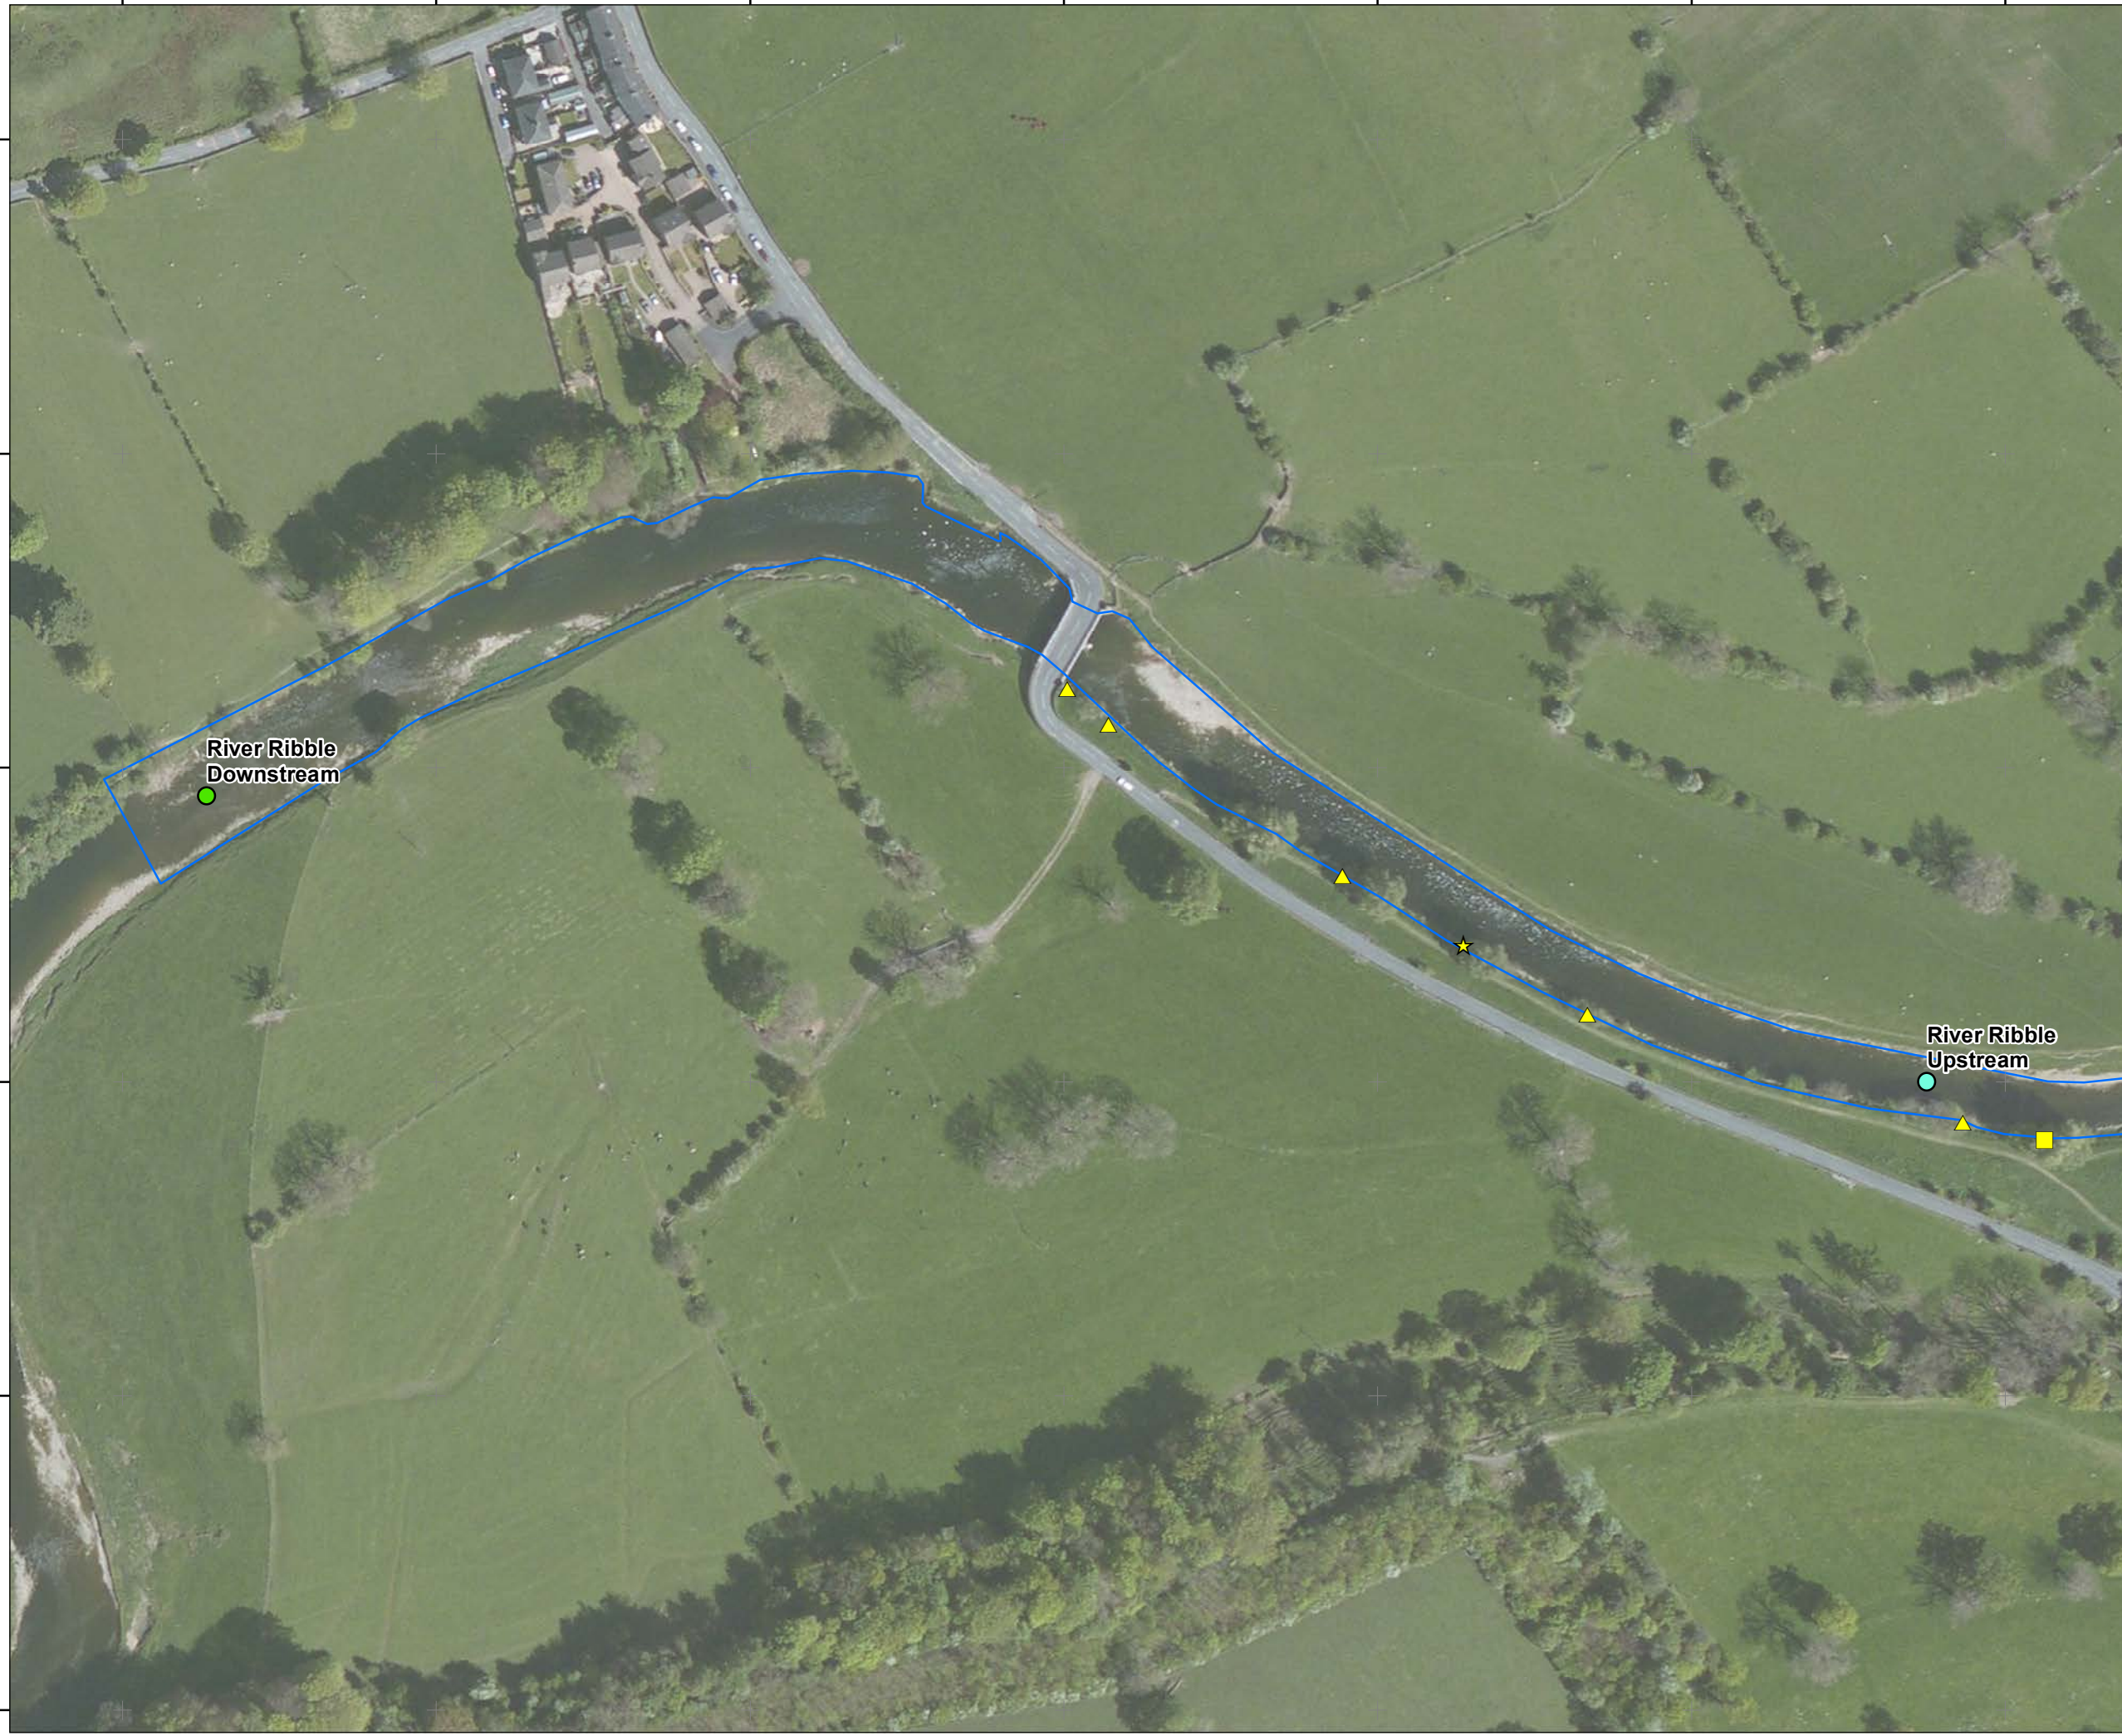
TITLE: Figure 2:  
 Otter Survey Results  
 Marl Hill (TR4) - Watercourse River Ribble

- Legend:**
- Waterbody
  - Upstream Survey Extent
  - Downstream Survey Extent
- Otter Evidence**
- Potential Otter Couch
  - ▲ Otter Spraint
  - ★ Otter Footprint

Evidence of otter was observed on the river Ribble at RW03-RW05 in the form of spraint and footprints (both pictured). No otter holts or resting areas (couches) were recorded (*Figure 2 – RW03-RW05*). A cavity was present beneath some tree roots at the upstream extent of the reach (left bank) but there was no evidence to suggest it was being used by otters as refuge.

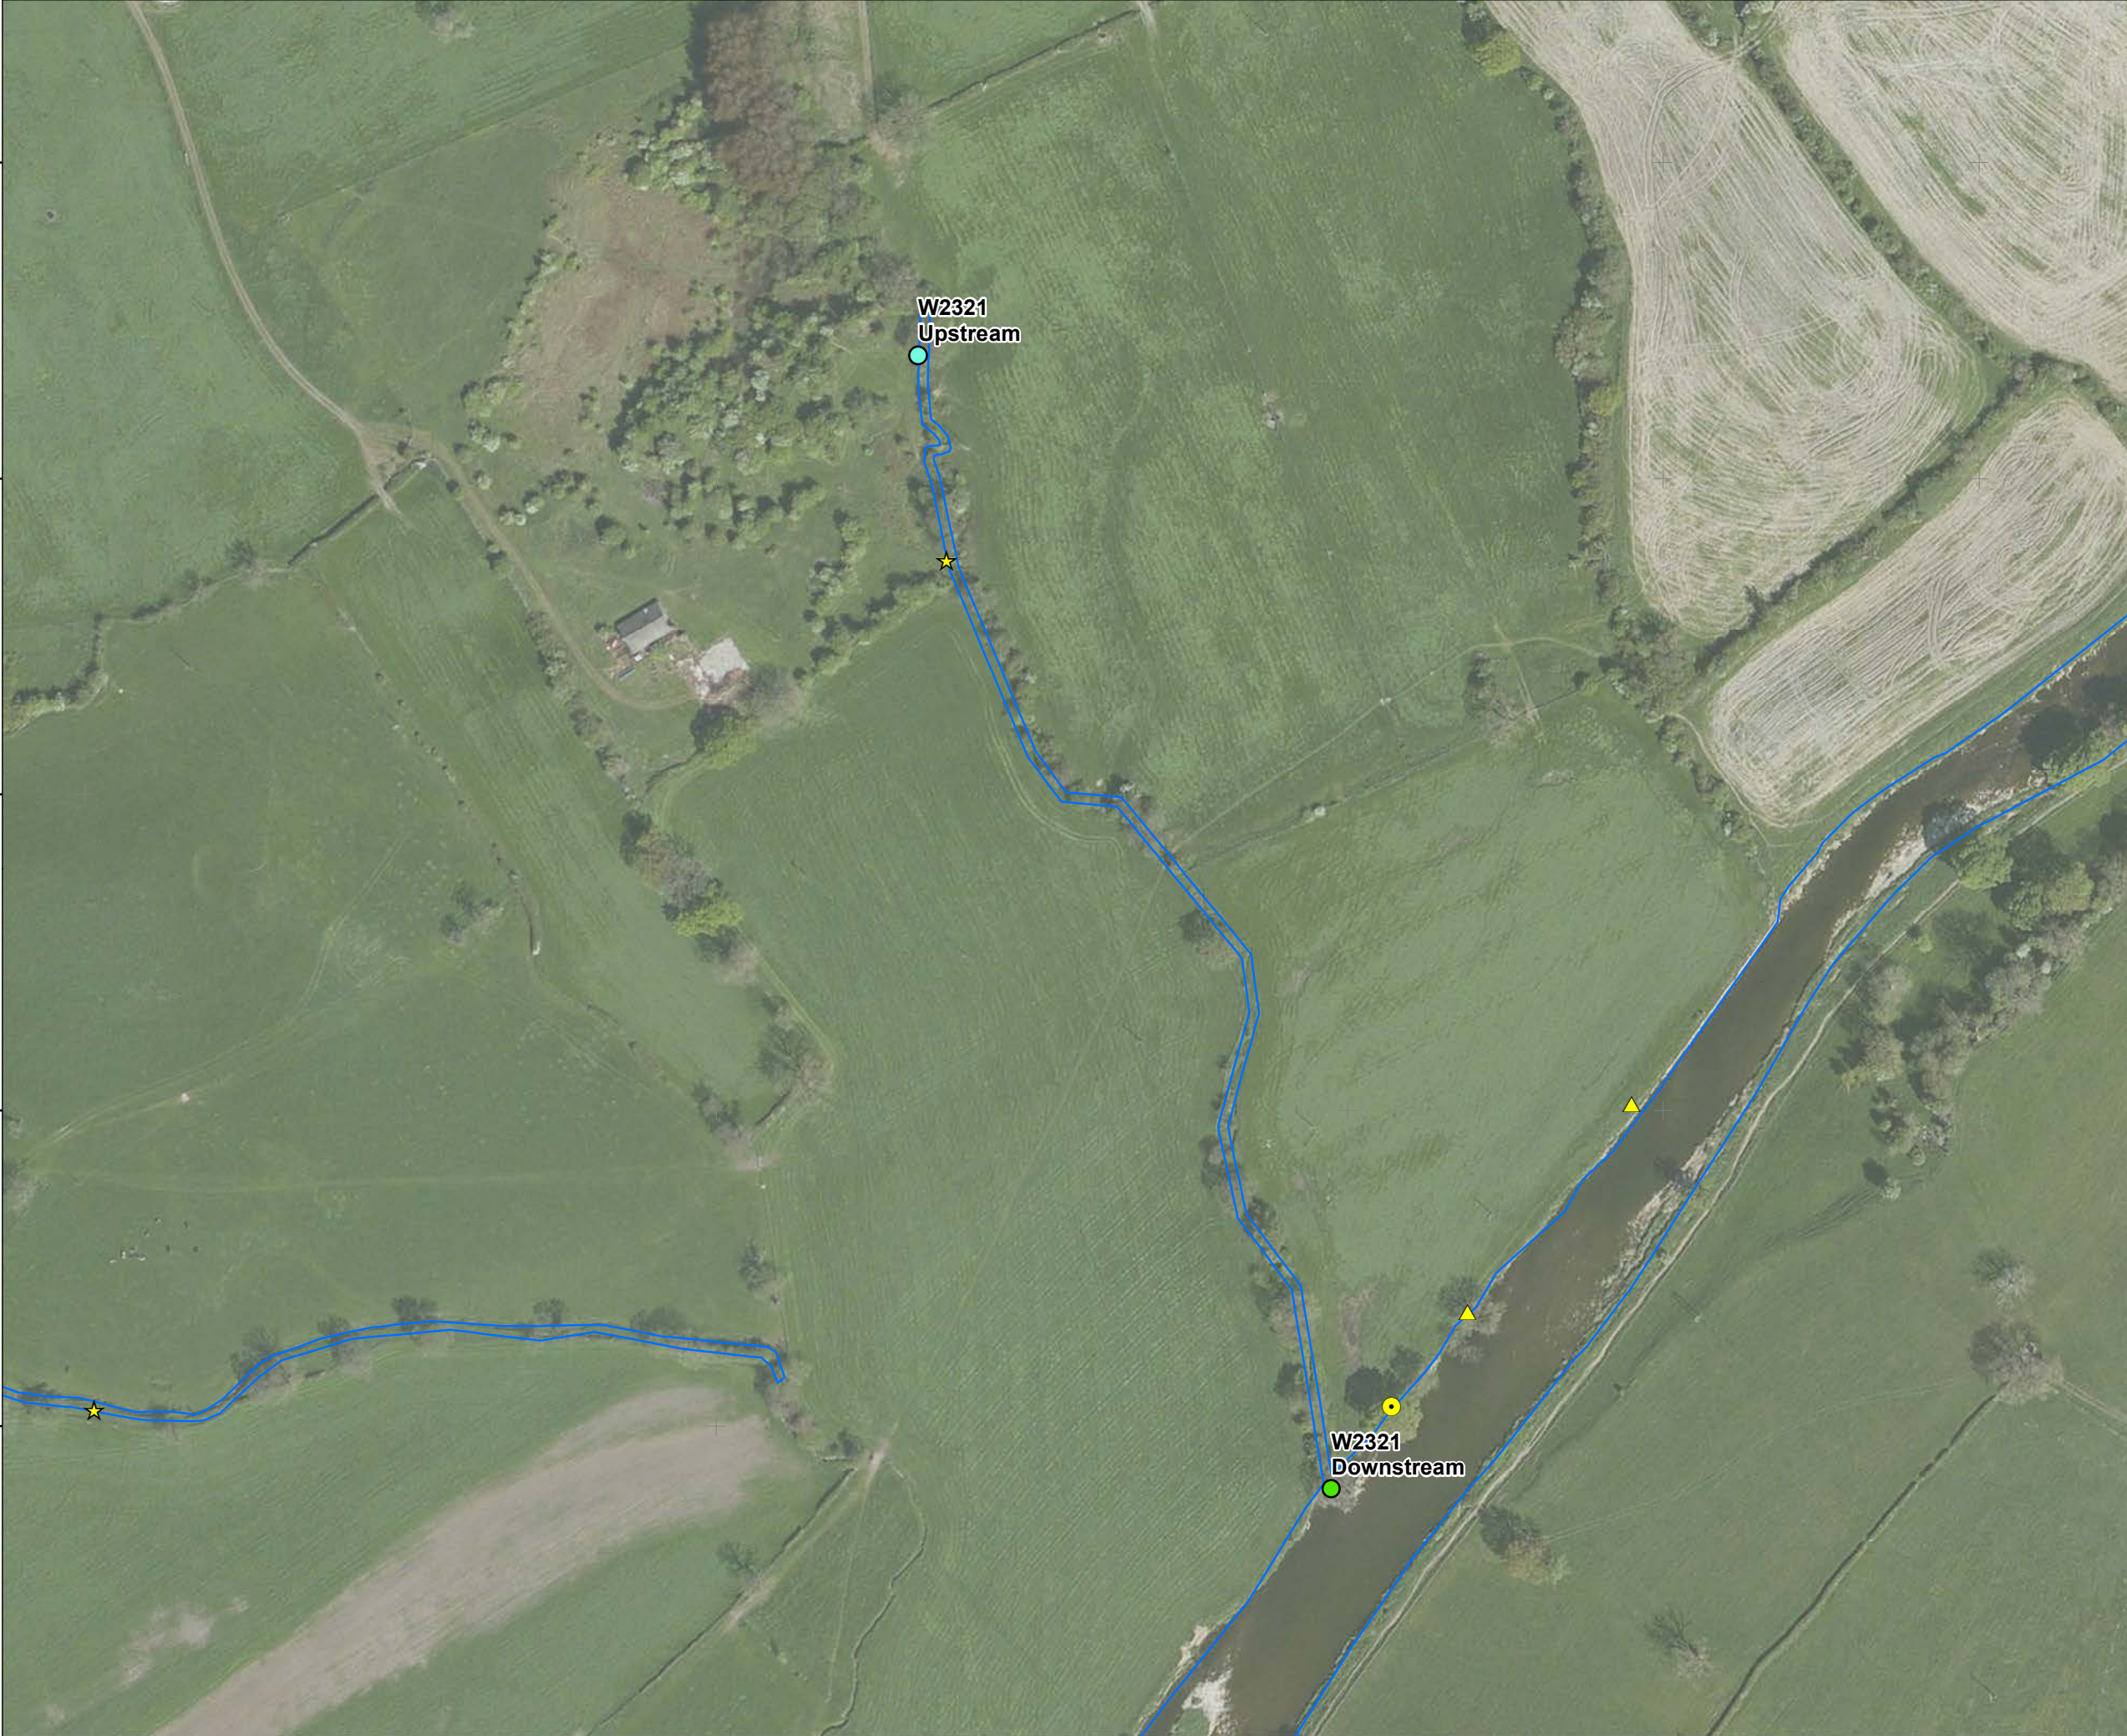
TITLE: Figure 2:  
 Otter Survey Results  
 Marl Hill (TR4) - Watercourse W2321

- Legend:**
- Waterbody
  - Upstream Survey Extent
  - Downstream Survey Extent
- Otter Evidence**
- Potential Otter Holt
  - ▲ Otter Spraint
  - ★ Otter Footprint

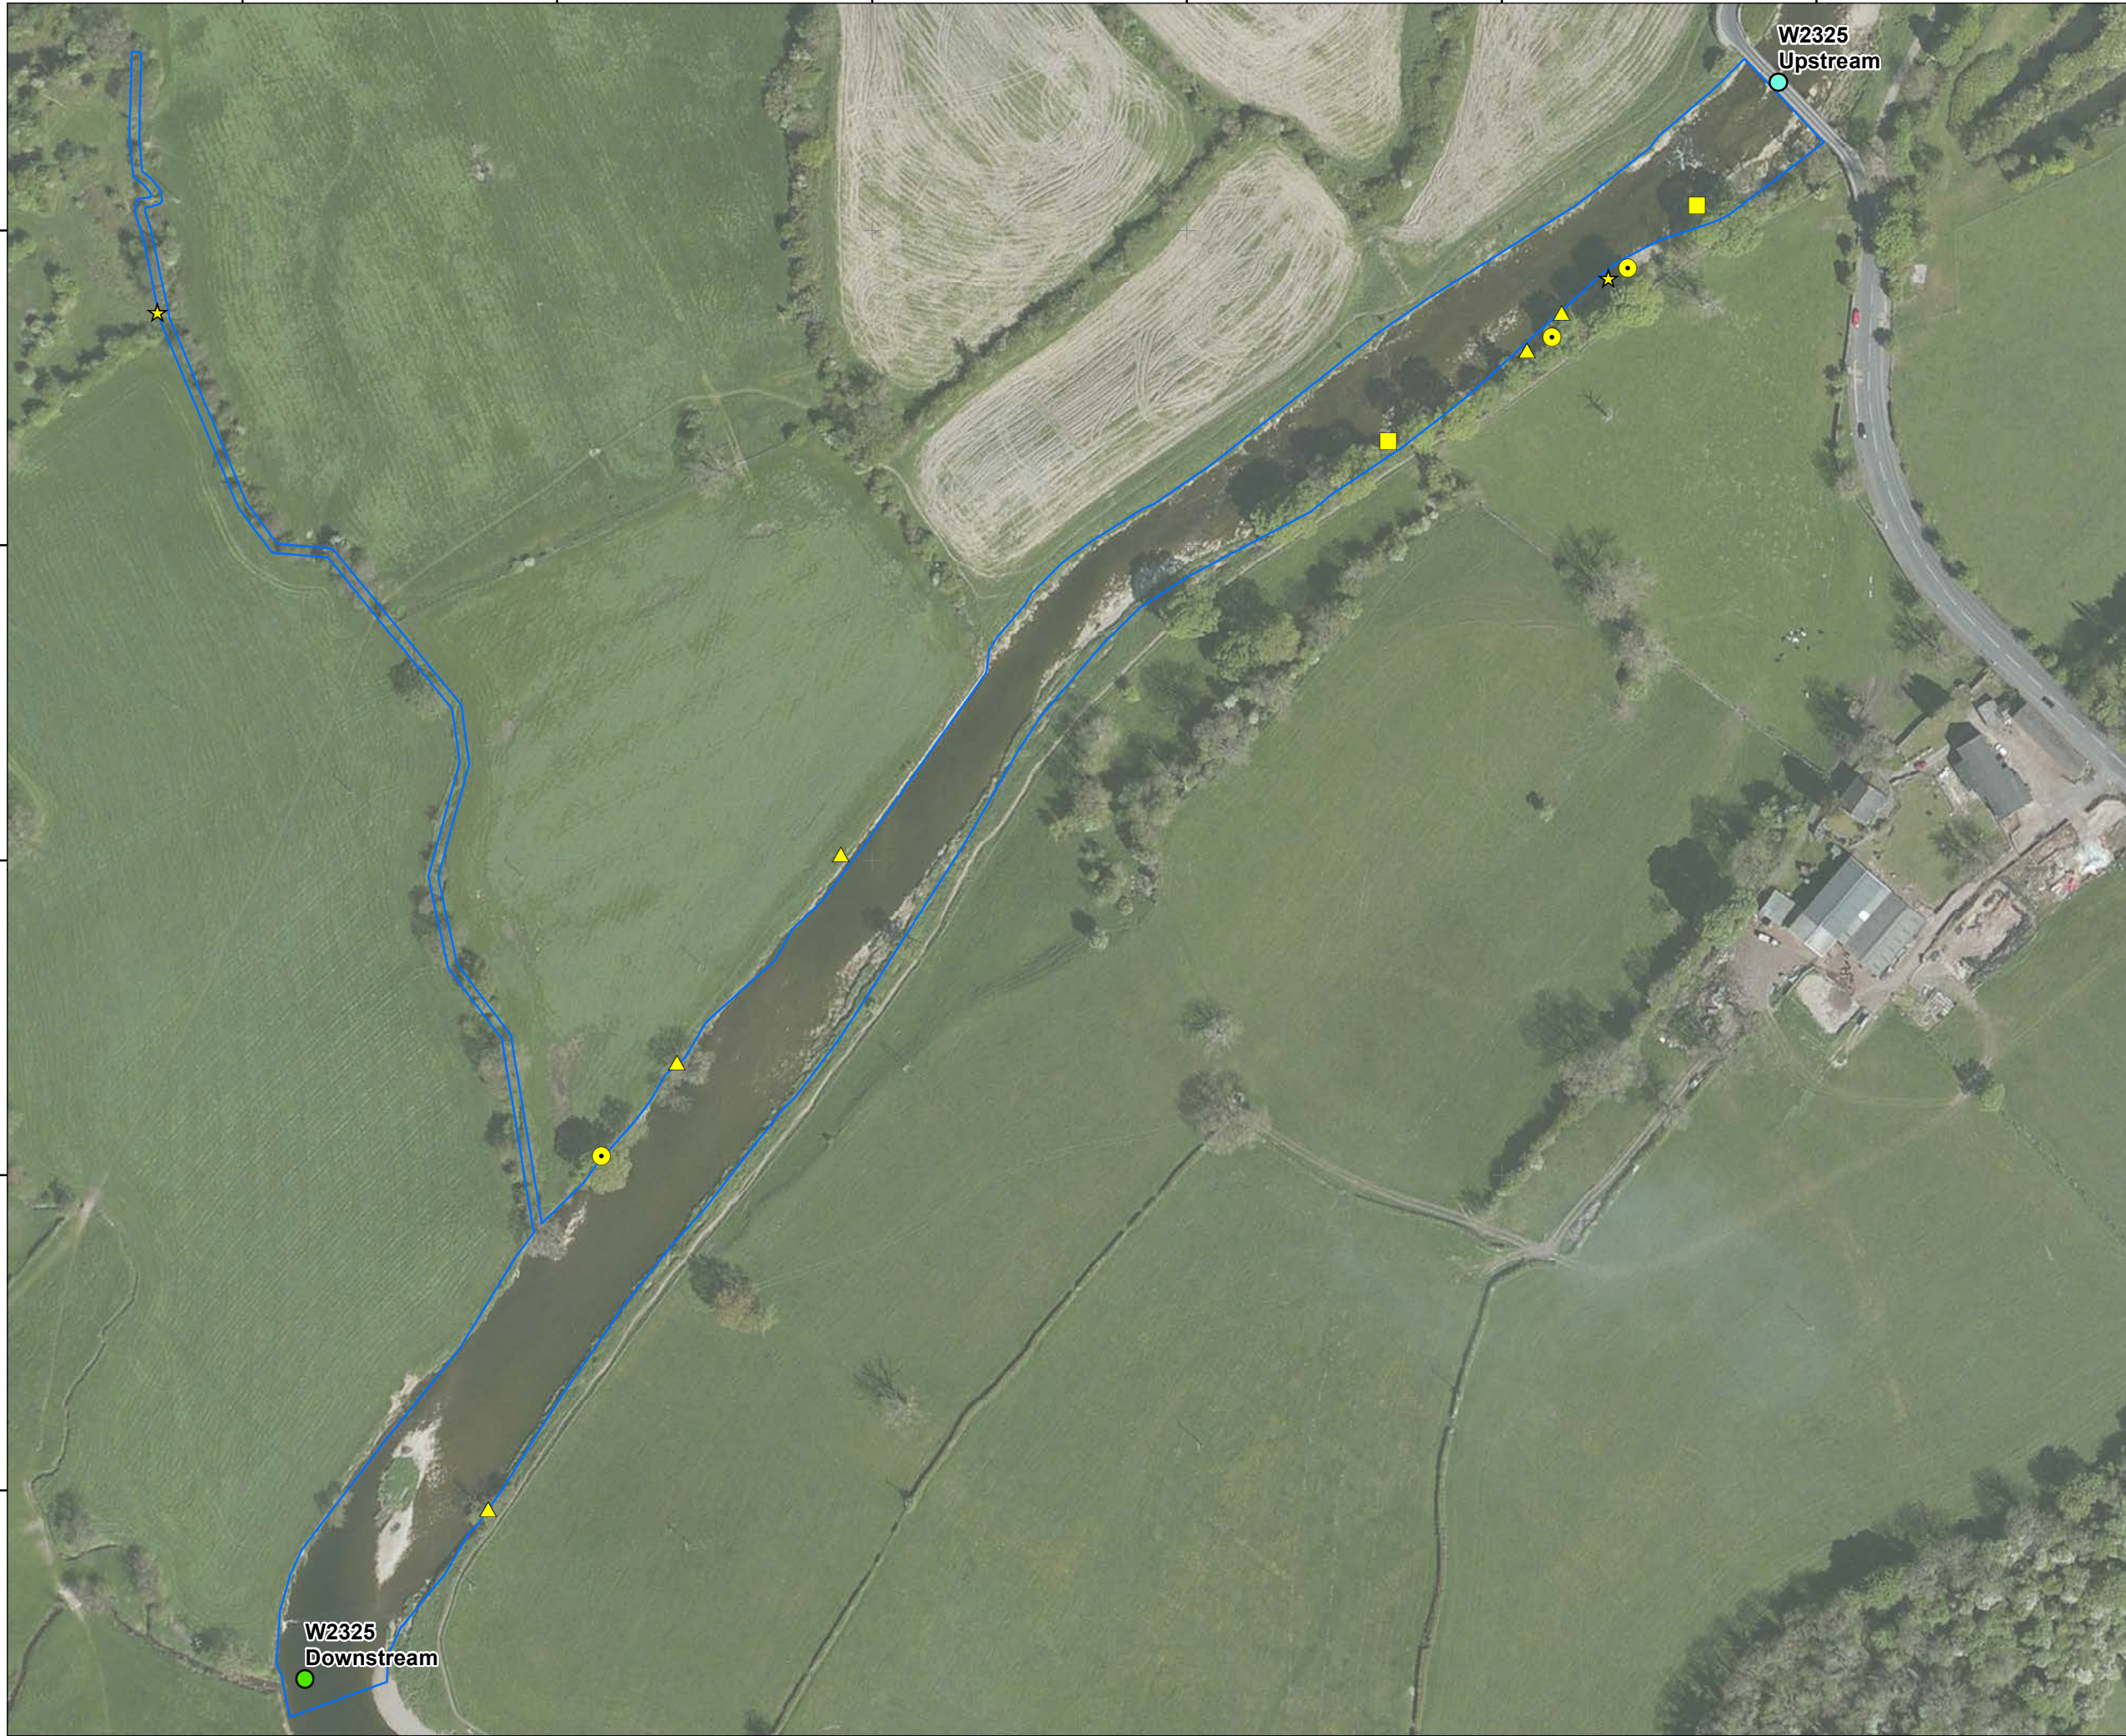
TITLE: Figure 2:  
 Otter Survey Results  
 Marl Hill (TR4) - Watercourse W2325

- Waterbody
- Upstream Survey Extent
- Downstream Survey Extent
- Otter Evidence**
- Potential Otter Holt
- Potential Otter Couch
- ▲ Otter Spraint
- ★ Otter Footprint

Evidence of otter was present in the form of spraint (5 separate locations), two suspected couches and 3 potential holts (*Figure 2 – W2325*). Otter footprints were observed that lead from beneath one of the potential holts (cavity beneath tree roots – pictured left), heading towards the watercourse (*Figure 2 – W2325*).

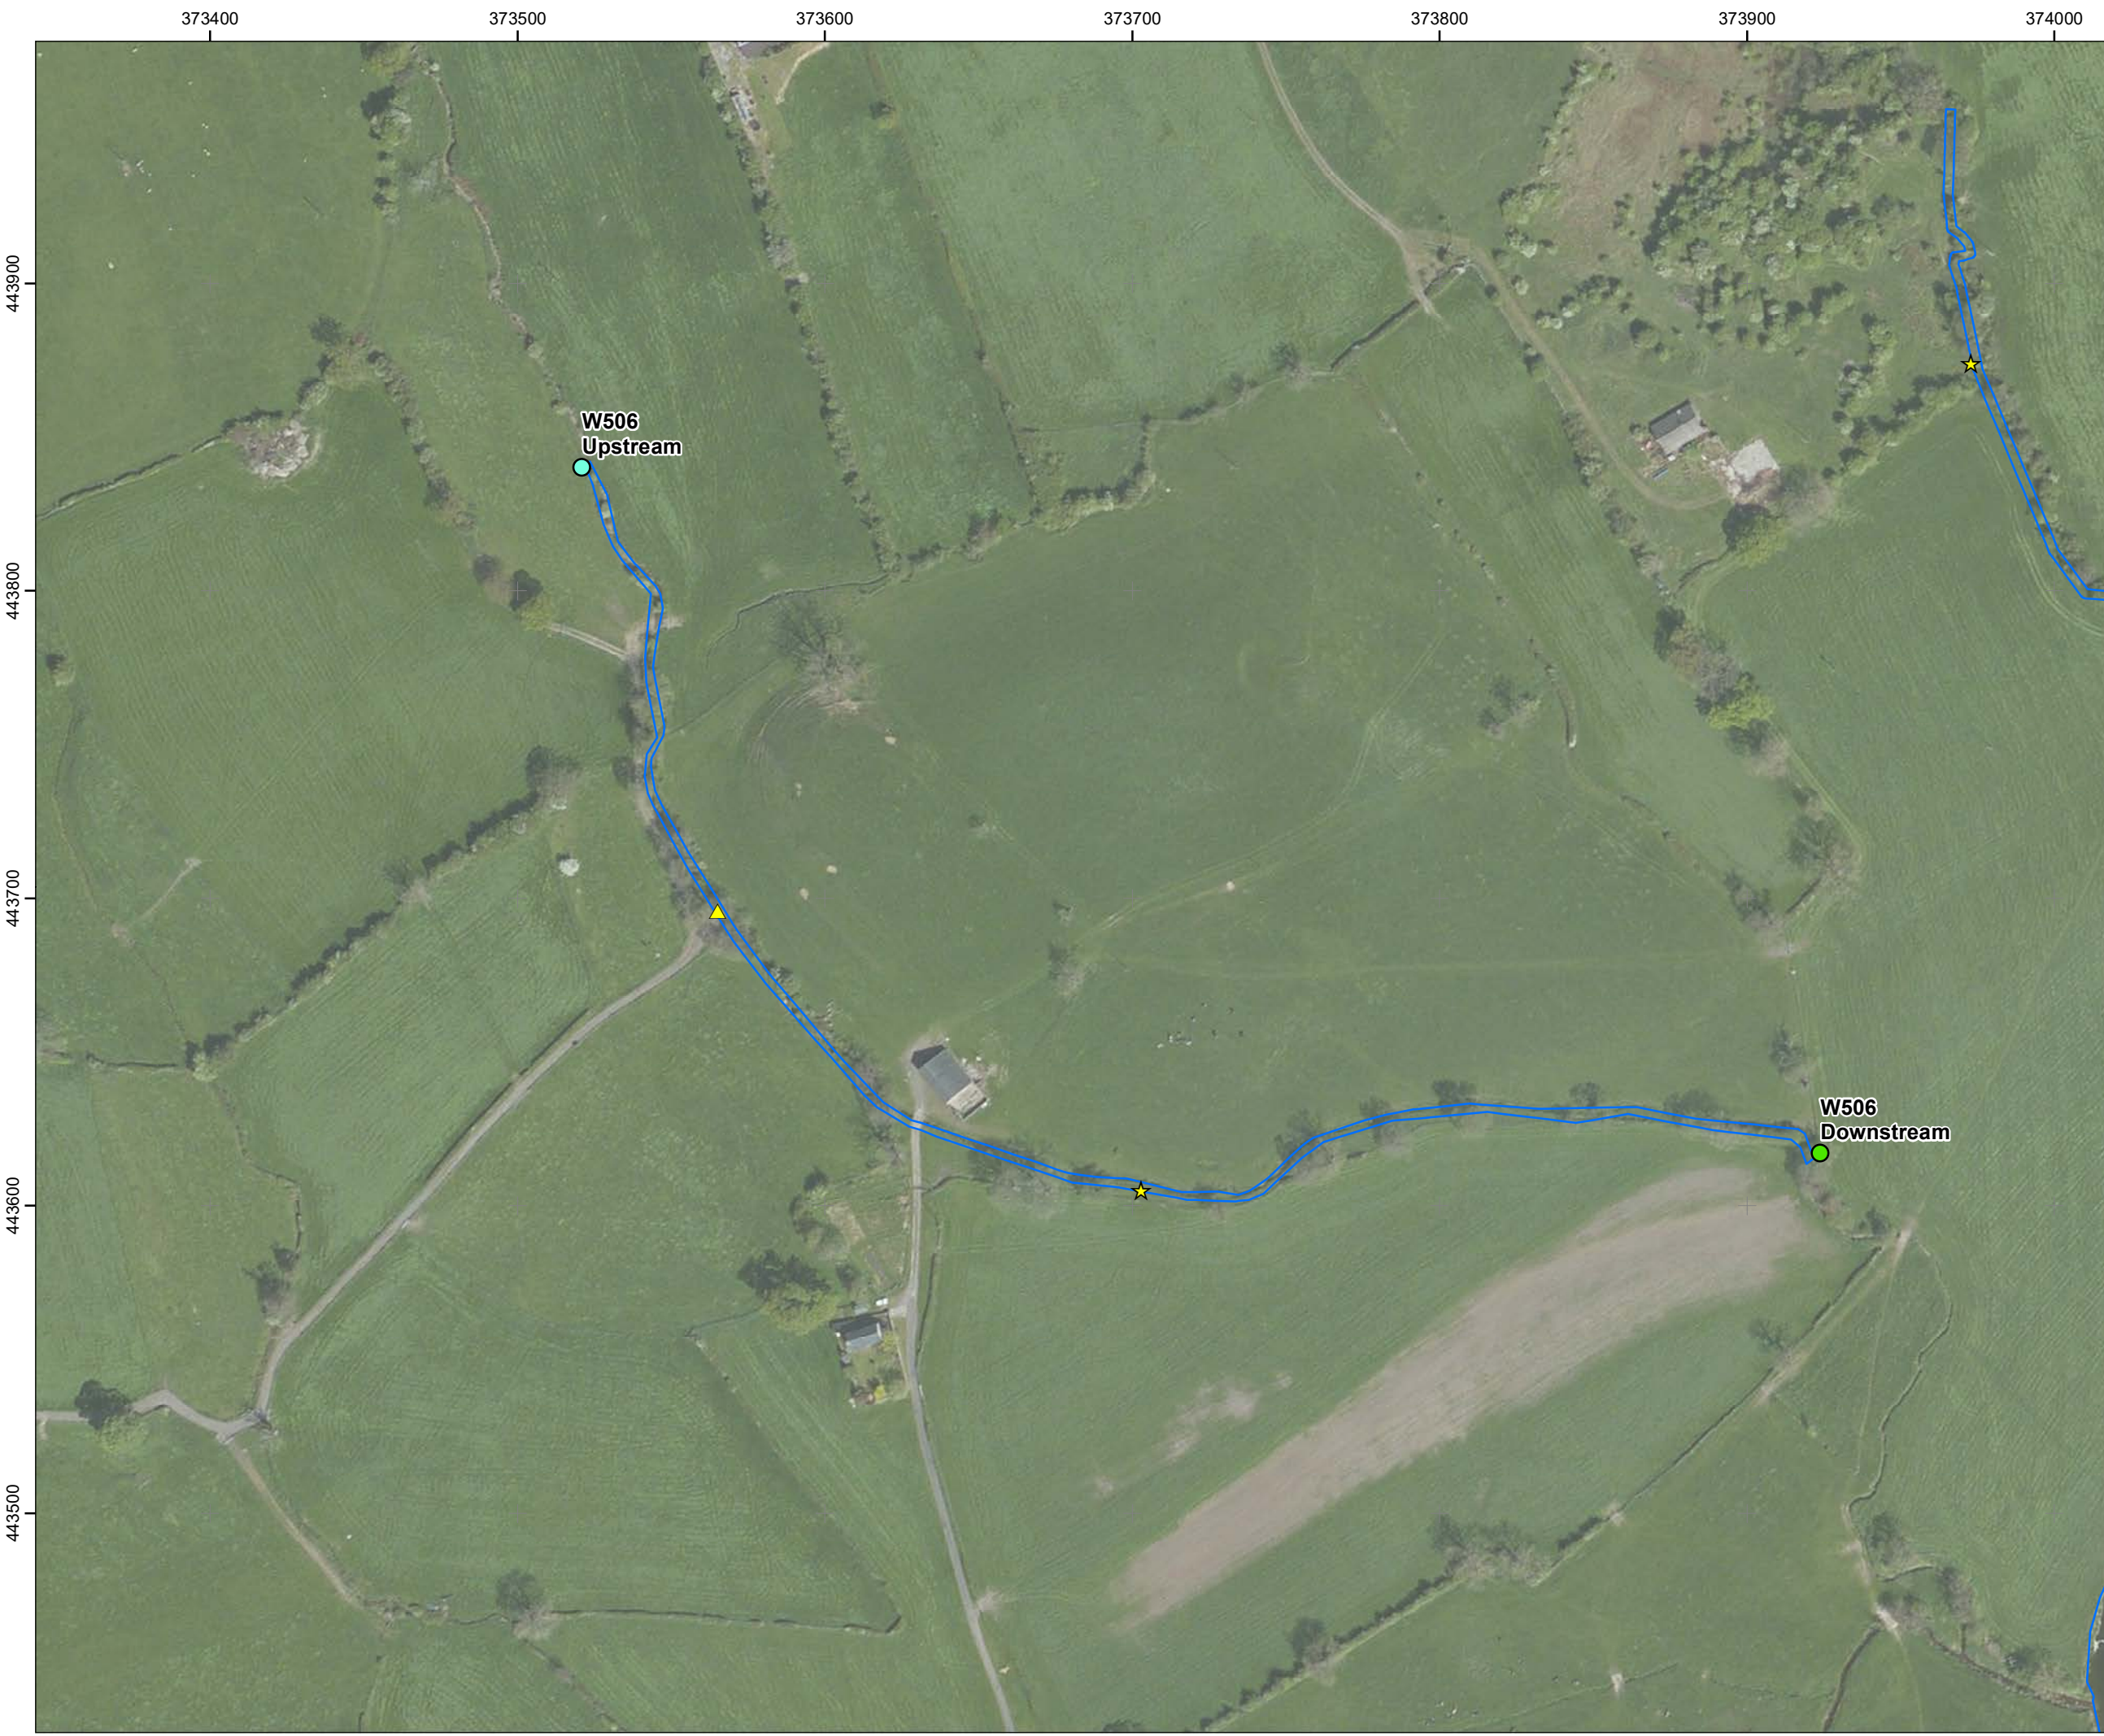
TITLE: Figure 2:  
 Otter Survey Results  
 Marl Hill (TR4) - Watercourse W506

- Legend:**
- Waterbody
  - Upstream Survey Extent
  - Downstream Survey Extent
- Otter Evidence**
- ▲ Otter Spraint
  - ★ Otter Footprint
