## Haweswater Aqueduct Resilience Programme

Proposed Marl Hill Section, Volume 6, Proposed Ribble Crossing

Protected Species Survey Report

Technical Appendix 9B.2

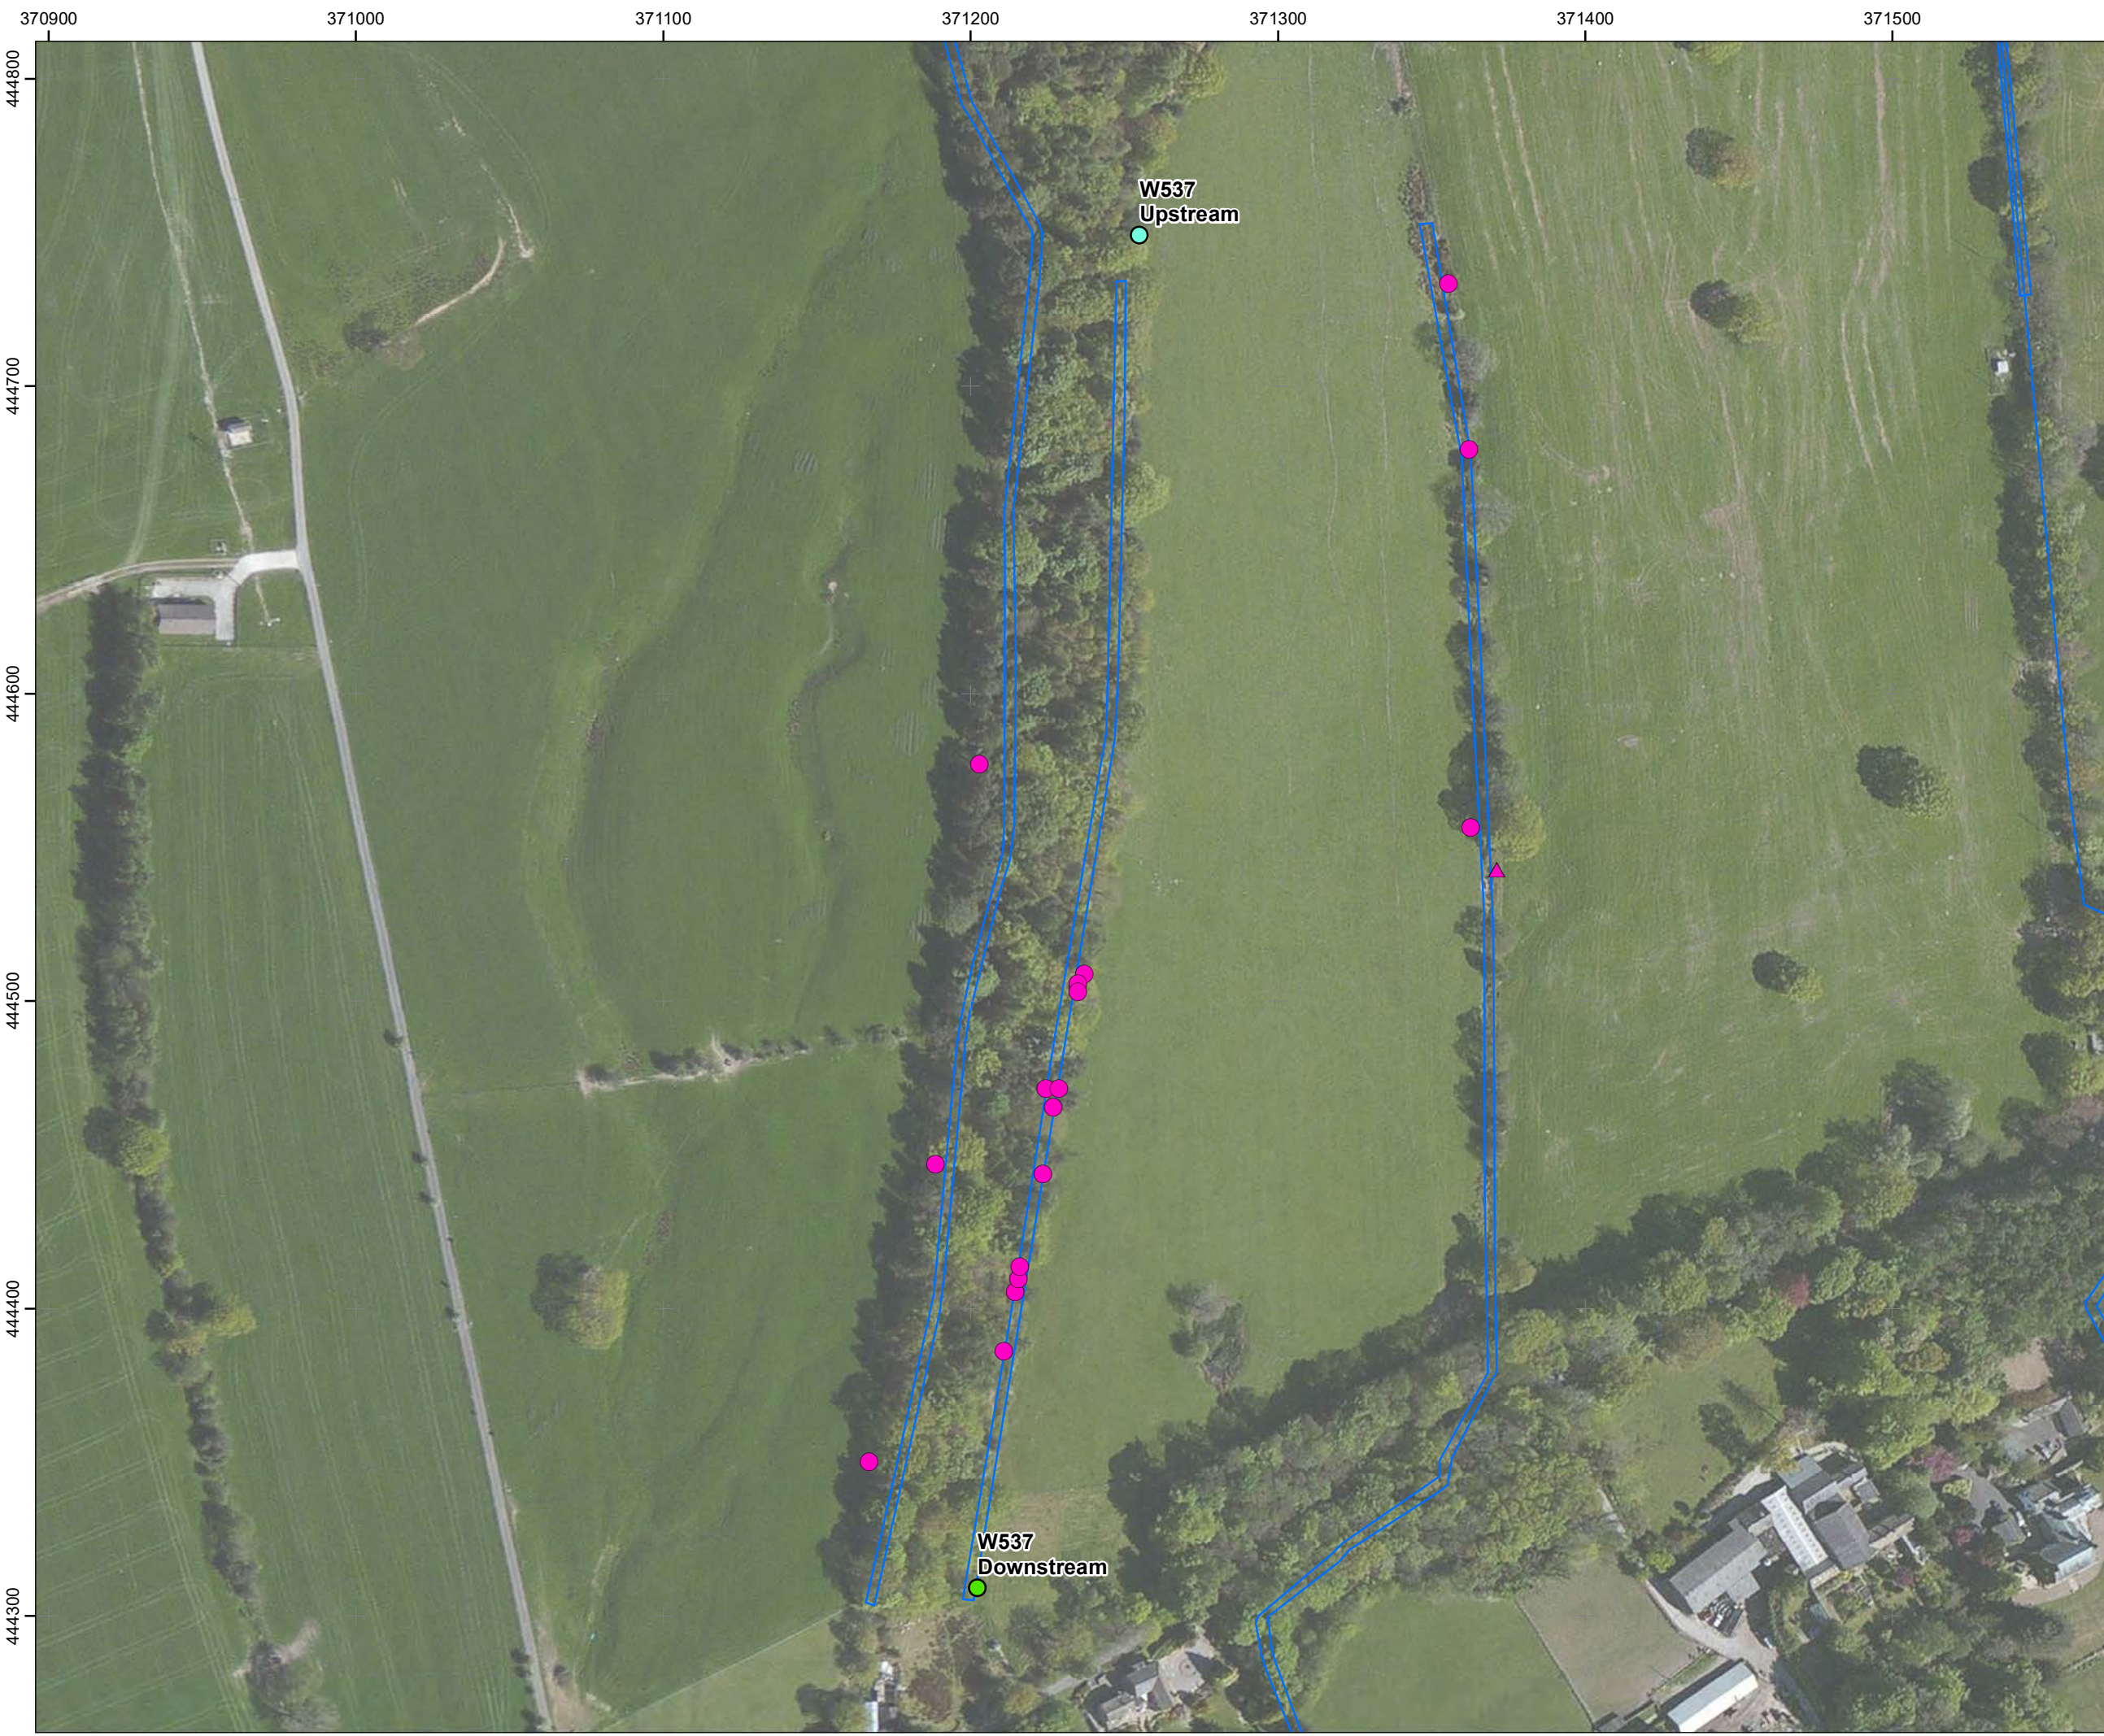
TITLE: Figure 2:  
 Water Vole Survey Results  
 Marl Hill (TR4) - Watercourse W537

- Legend:**
- Waterbody
  - Upstream Survey Extent
  - Downstream Survey Extent
- Potential Water Vole Evidence
- Burrow
  - ▲ Feeding Signs

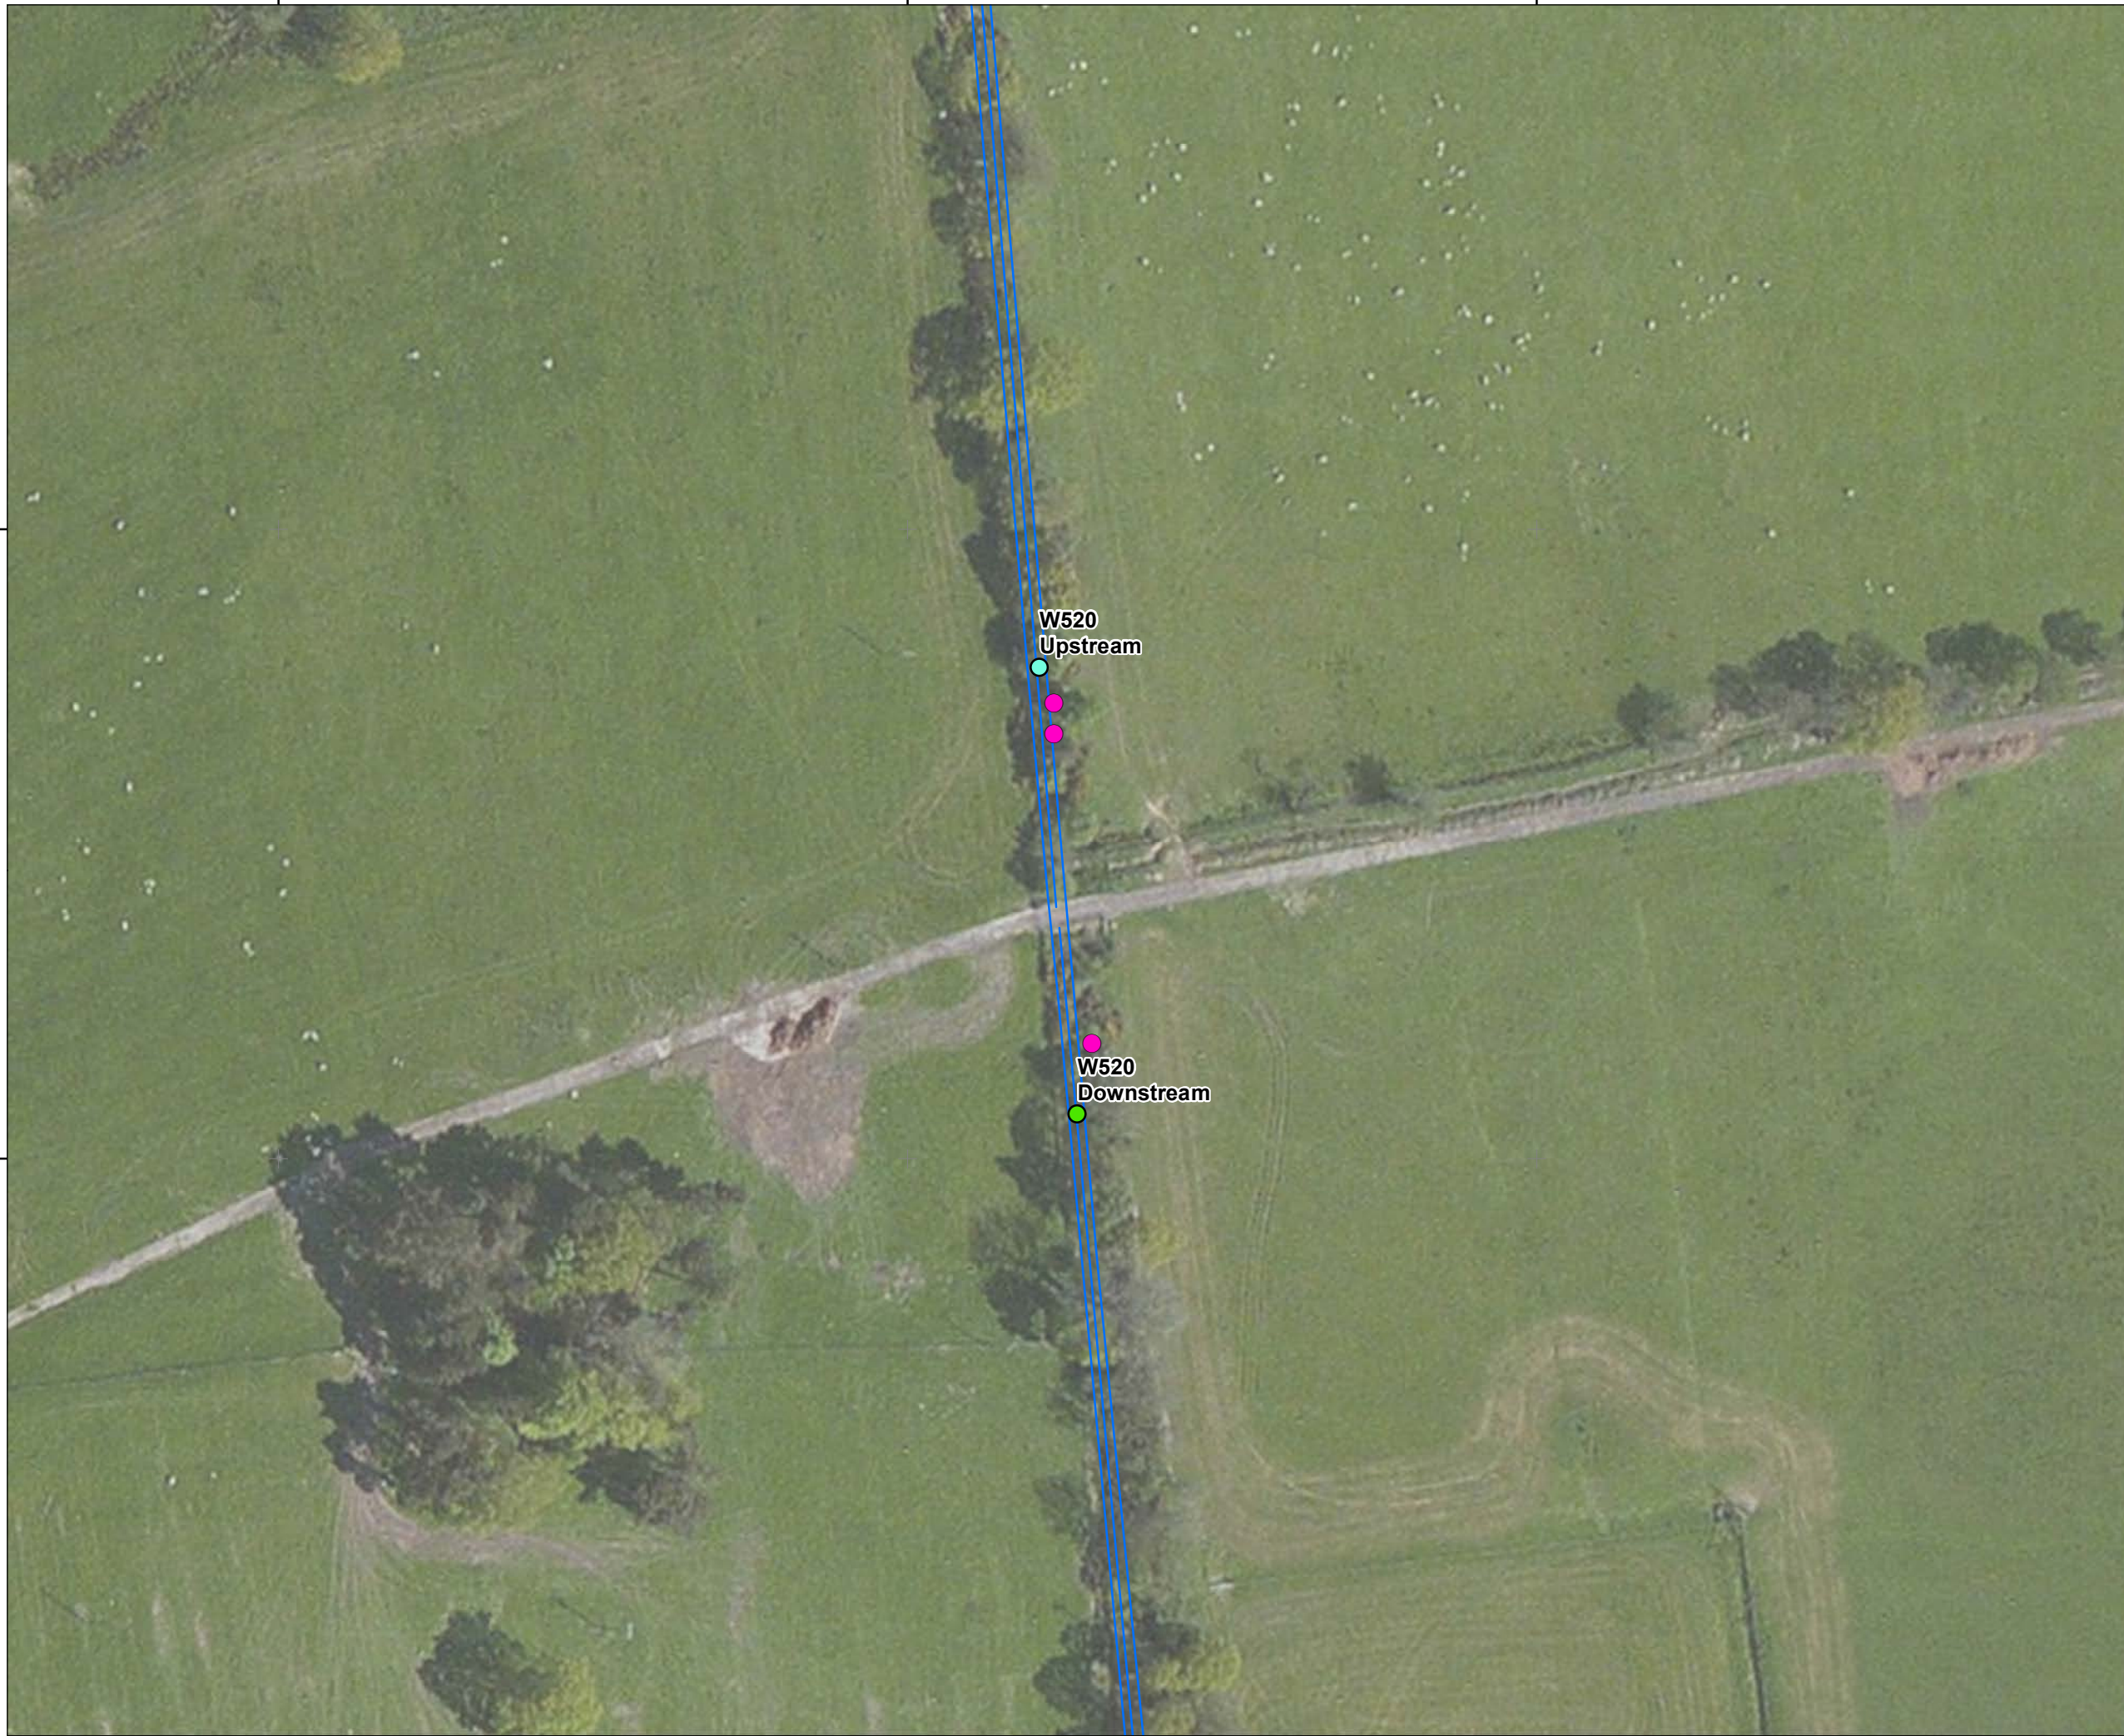
TITLE: Figure 2:  
 Water Vole Survey Results  
 Marl Hill (TR4) - Watercourse W520

- Waterbody
- Upstream Survey Extent
- Downstream Survey Extent
- Potential Water Vole Evidence**
- Burrow

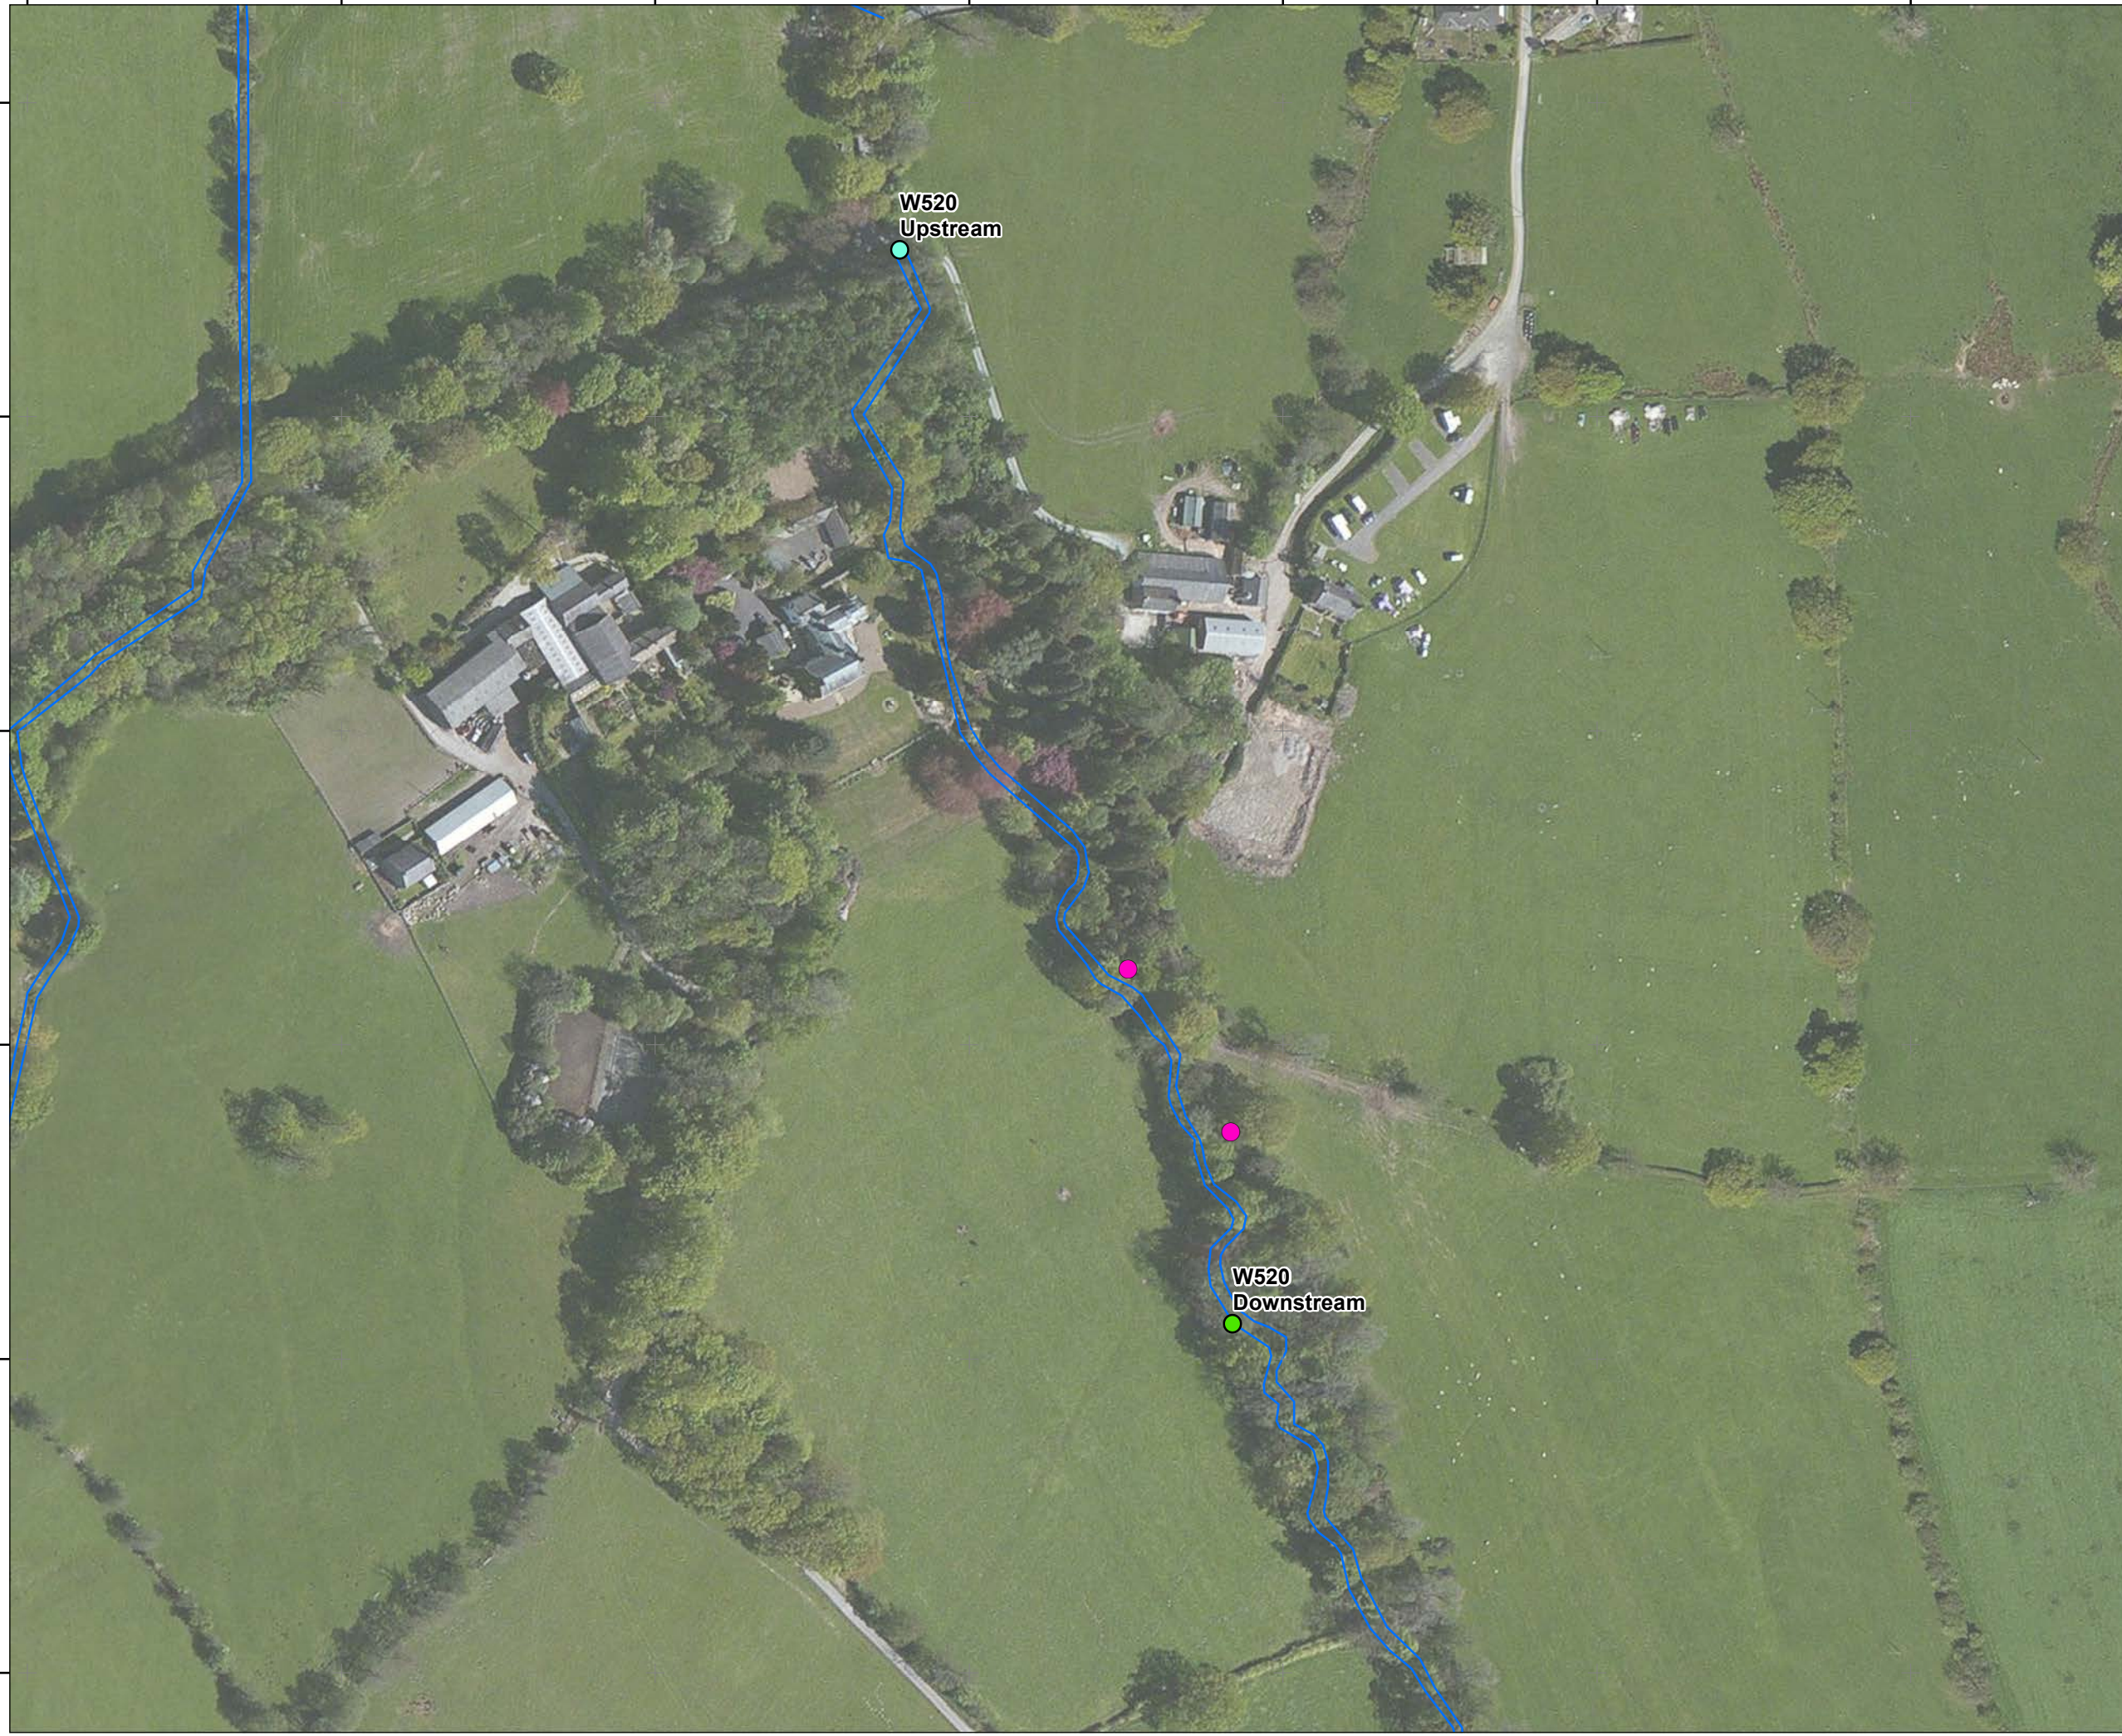
TITLE: Figure 2:  
 Water Vole Survey Results  
 Marl Hill (TR4) - Watercourse W520

- Legend:**
- Waterbody
  - Upstream Survey Extent
  - Downstream Survey Extent
- Potential Water Vole Evidence
- Burrow
