## **Heritage Statement**

### **Stydd Almshouses, Ribchester**

**Arcus Consulting LLP**

**Your Housing Group**

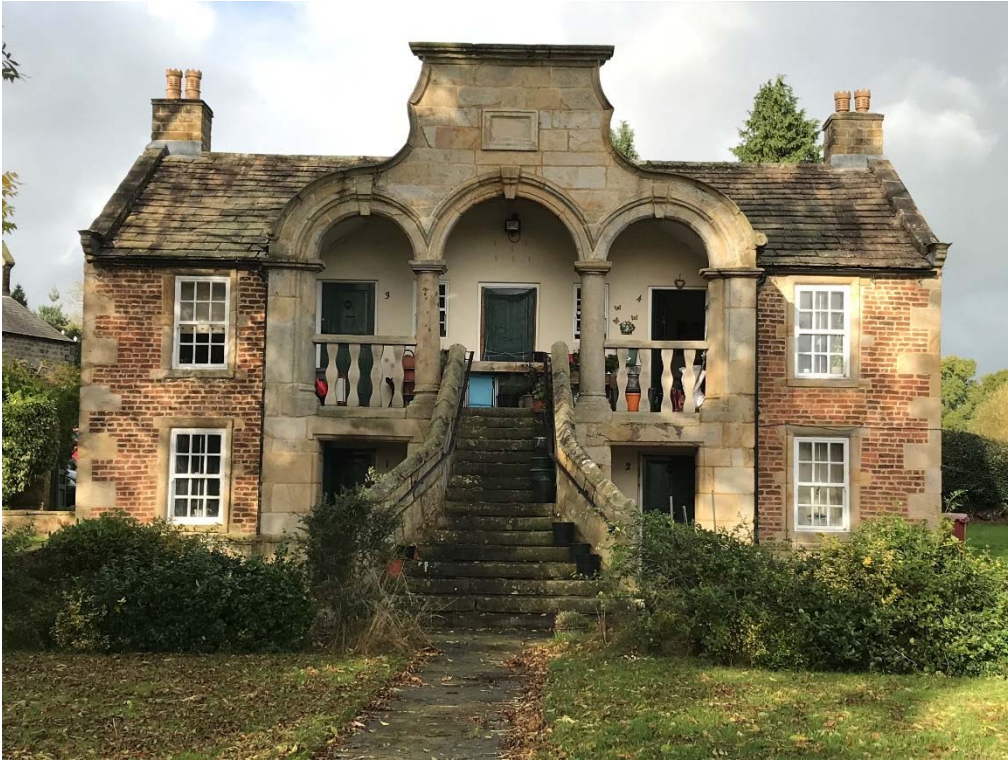
**Image 2: Front Elevation**

- 3.6 Access to the property to carry out internal works is via an entrance door to the front elevation. The front elevation has stepped access only.

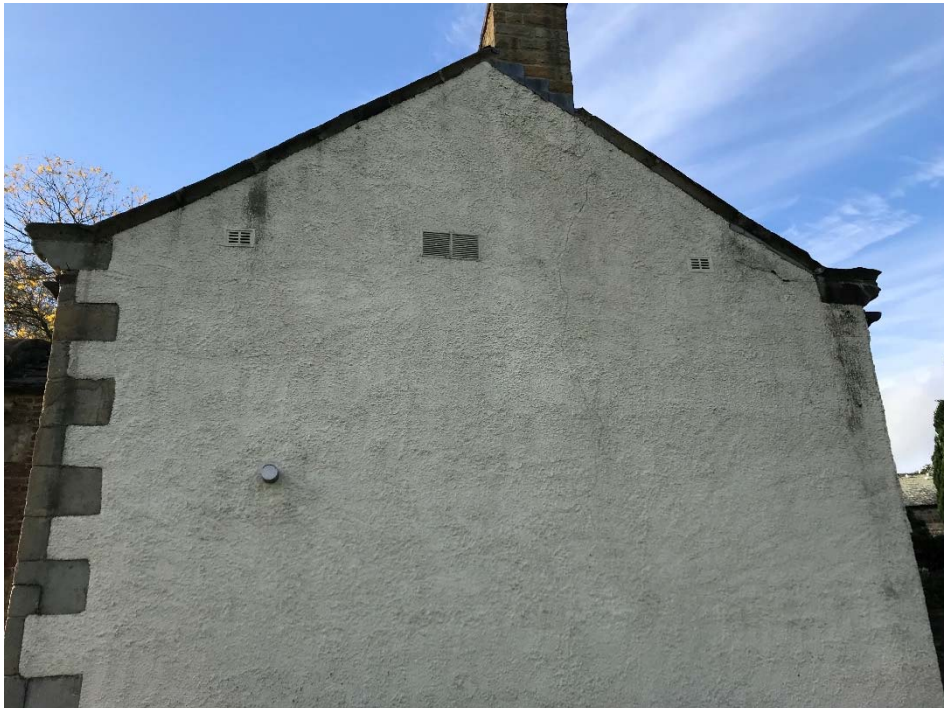
**Image 3: Side Elevation of Almshouses**

- 3.1 The proposal will look to carefully remove existing sections of render to the gable where cracking has taken place, with render to be removed using hand tools only, and the waste to be disposed of appropriately offsite. The condition of the exposed brickwork will be assessed, and any repairs required identified. At this stage we would invite the Council's conservation officer down to discuss the requirements and any further action they believe is necessary prior to re-rendering. The existing render will be tested to determine the type and thickness, with the identified type used to re-render all areas where render was previously removed across the gable wall. Once the render has cured, the wall will be treated with BBA Approved Sovereign Weather-chek Façade Cream, with the product impregnating the surface of the render, adding additional water repellent properties whilst not affected the appearance of breathability of the wall.

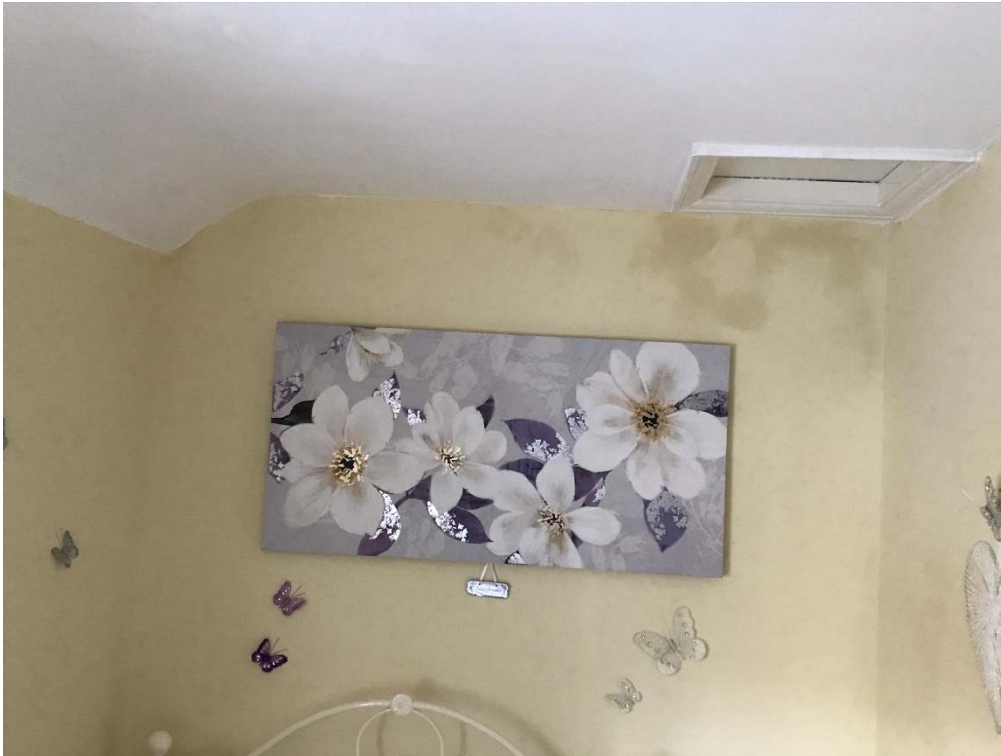
**Image 4: Water Staining to Internal Wall**

- 3.3 Internally, the existing plaster to the gable wall is to be retained, with the insulated plasterboard fixed over the top of both wall and skirting boards. Plasterboard joints are to be tapered and edges of the wall sealed, followed by a skim finish and decoration. New skirting boards are to be installed to gable wall and tied in with existing at corners. These works will ensure that any potential risk of condensation / mould growth is eliminated.

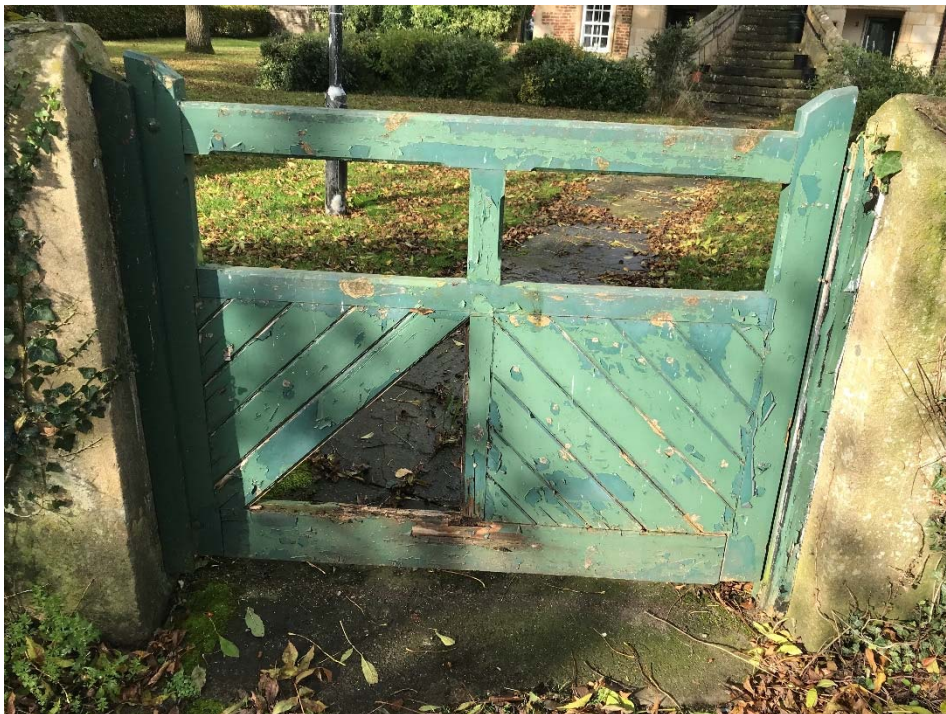
**Image 5: External Gate to Property**

- 3.4 The replacement of the garden gate and frame is necessary as there are missing sections of panelling, whilst both the frame and gate are rotting. The new gate and frame are to match that of the existing in style and colour.
