YEW TREE AND GARDENS

**Client: The Duchy of Lancaster
– Former Garage Site,
Dunsop Bridge, Clitheroe, Lancashire.**

**ARBORICULTURAL IMPACT ASSESSMENT
FOR PROPOSED BARN CONVERSIONS**

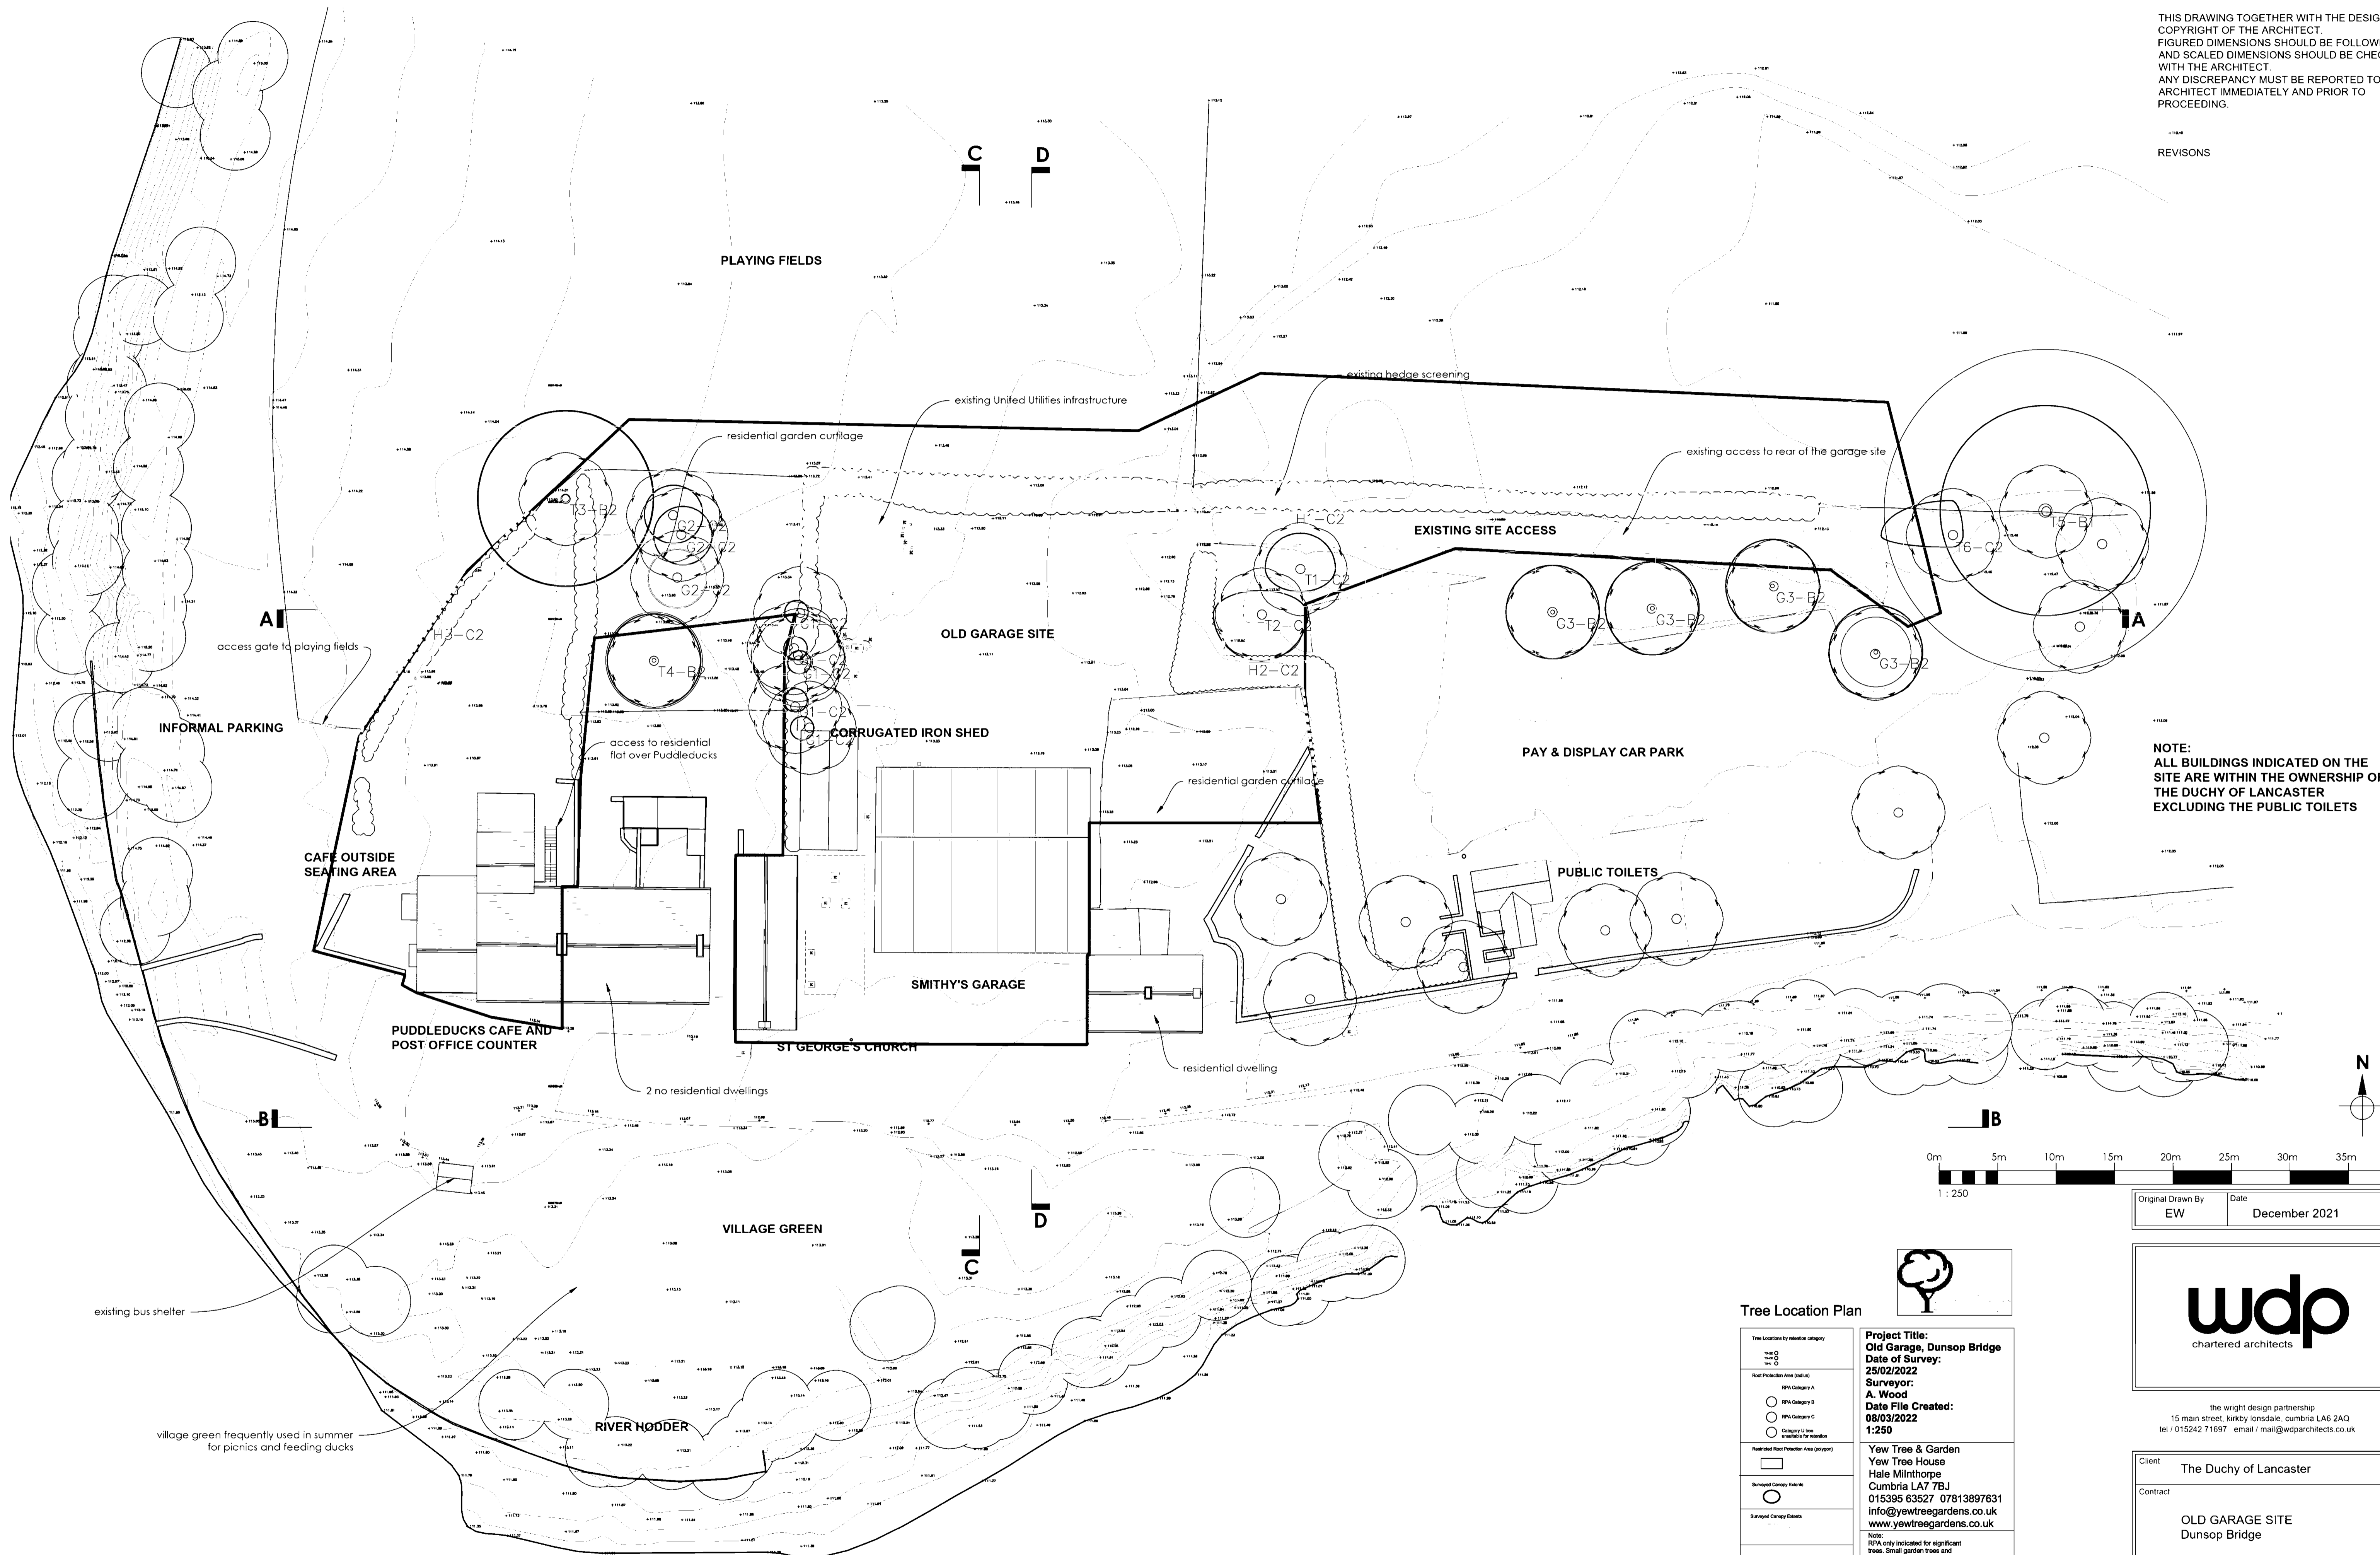
<p>Tree Location by retention category</p> <ul style="list-style-type: none"> Tree O Tree D Tree C 	<p>Project Title: Old Garage, Dunsop Bridge Date of Survey: 25/02/2022 Surveyor: A. Wood Date File Created: 08/03/2022 1:250</p>
<p>Roof Protection Area (Detail)</p> <ul style="list-style-type: none"> RPA Category A RPA Category B RPA Category C Category U (see instructions for retention) 	<p>Yew Tree & Garden Yew Tree House Hale Milnthorpe Cumbria LA7 7BJ 015395 63527 07813897631 info@yewtreegardens.co.uk www.yewtreegardens.co.uk</p> <p><small>Note: RPA only indicated for significant trees. Small garden trees and juvenile specimens may not be indicated. Retention Categories: As defined in BS5837: 2012 RPA. Plotted from individual RPA sheets. Where restricted rooting conditions are present RPA is also plotted as an area polygon.</small></p>
<p>Hatched Roof Protection Area (polygon)</p> <p>Surveyed Canopy Extents</p> <p>Unsurveyed Canopy Extents</p>

2. The development area is as indicated in Appendix 2: Tree Location Plan and tree stock is as detailed within Appendix 1: Tree Schedule and Appendix 5: Tree Constraints Plan

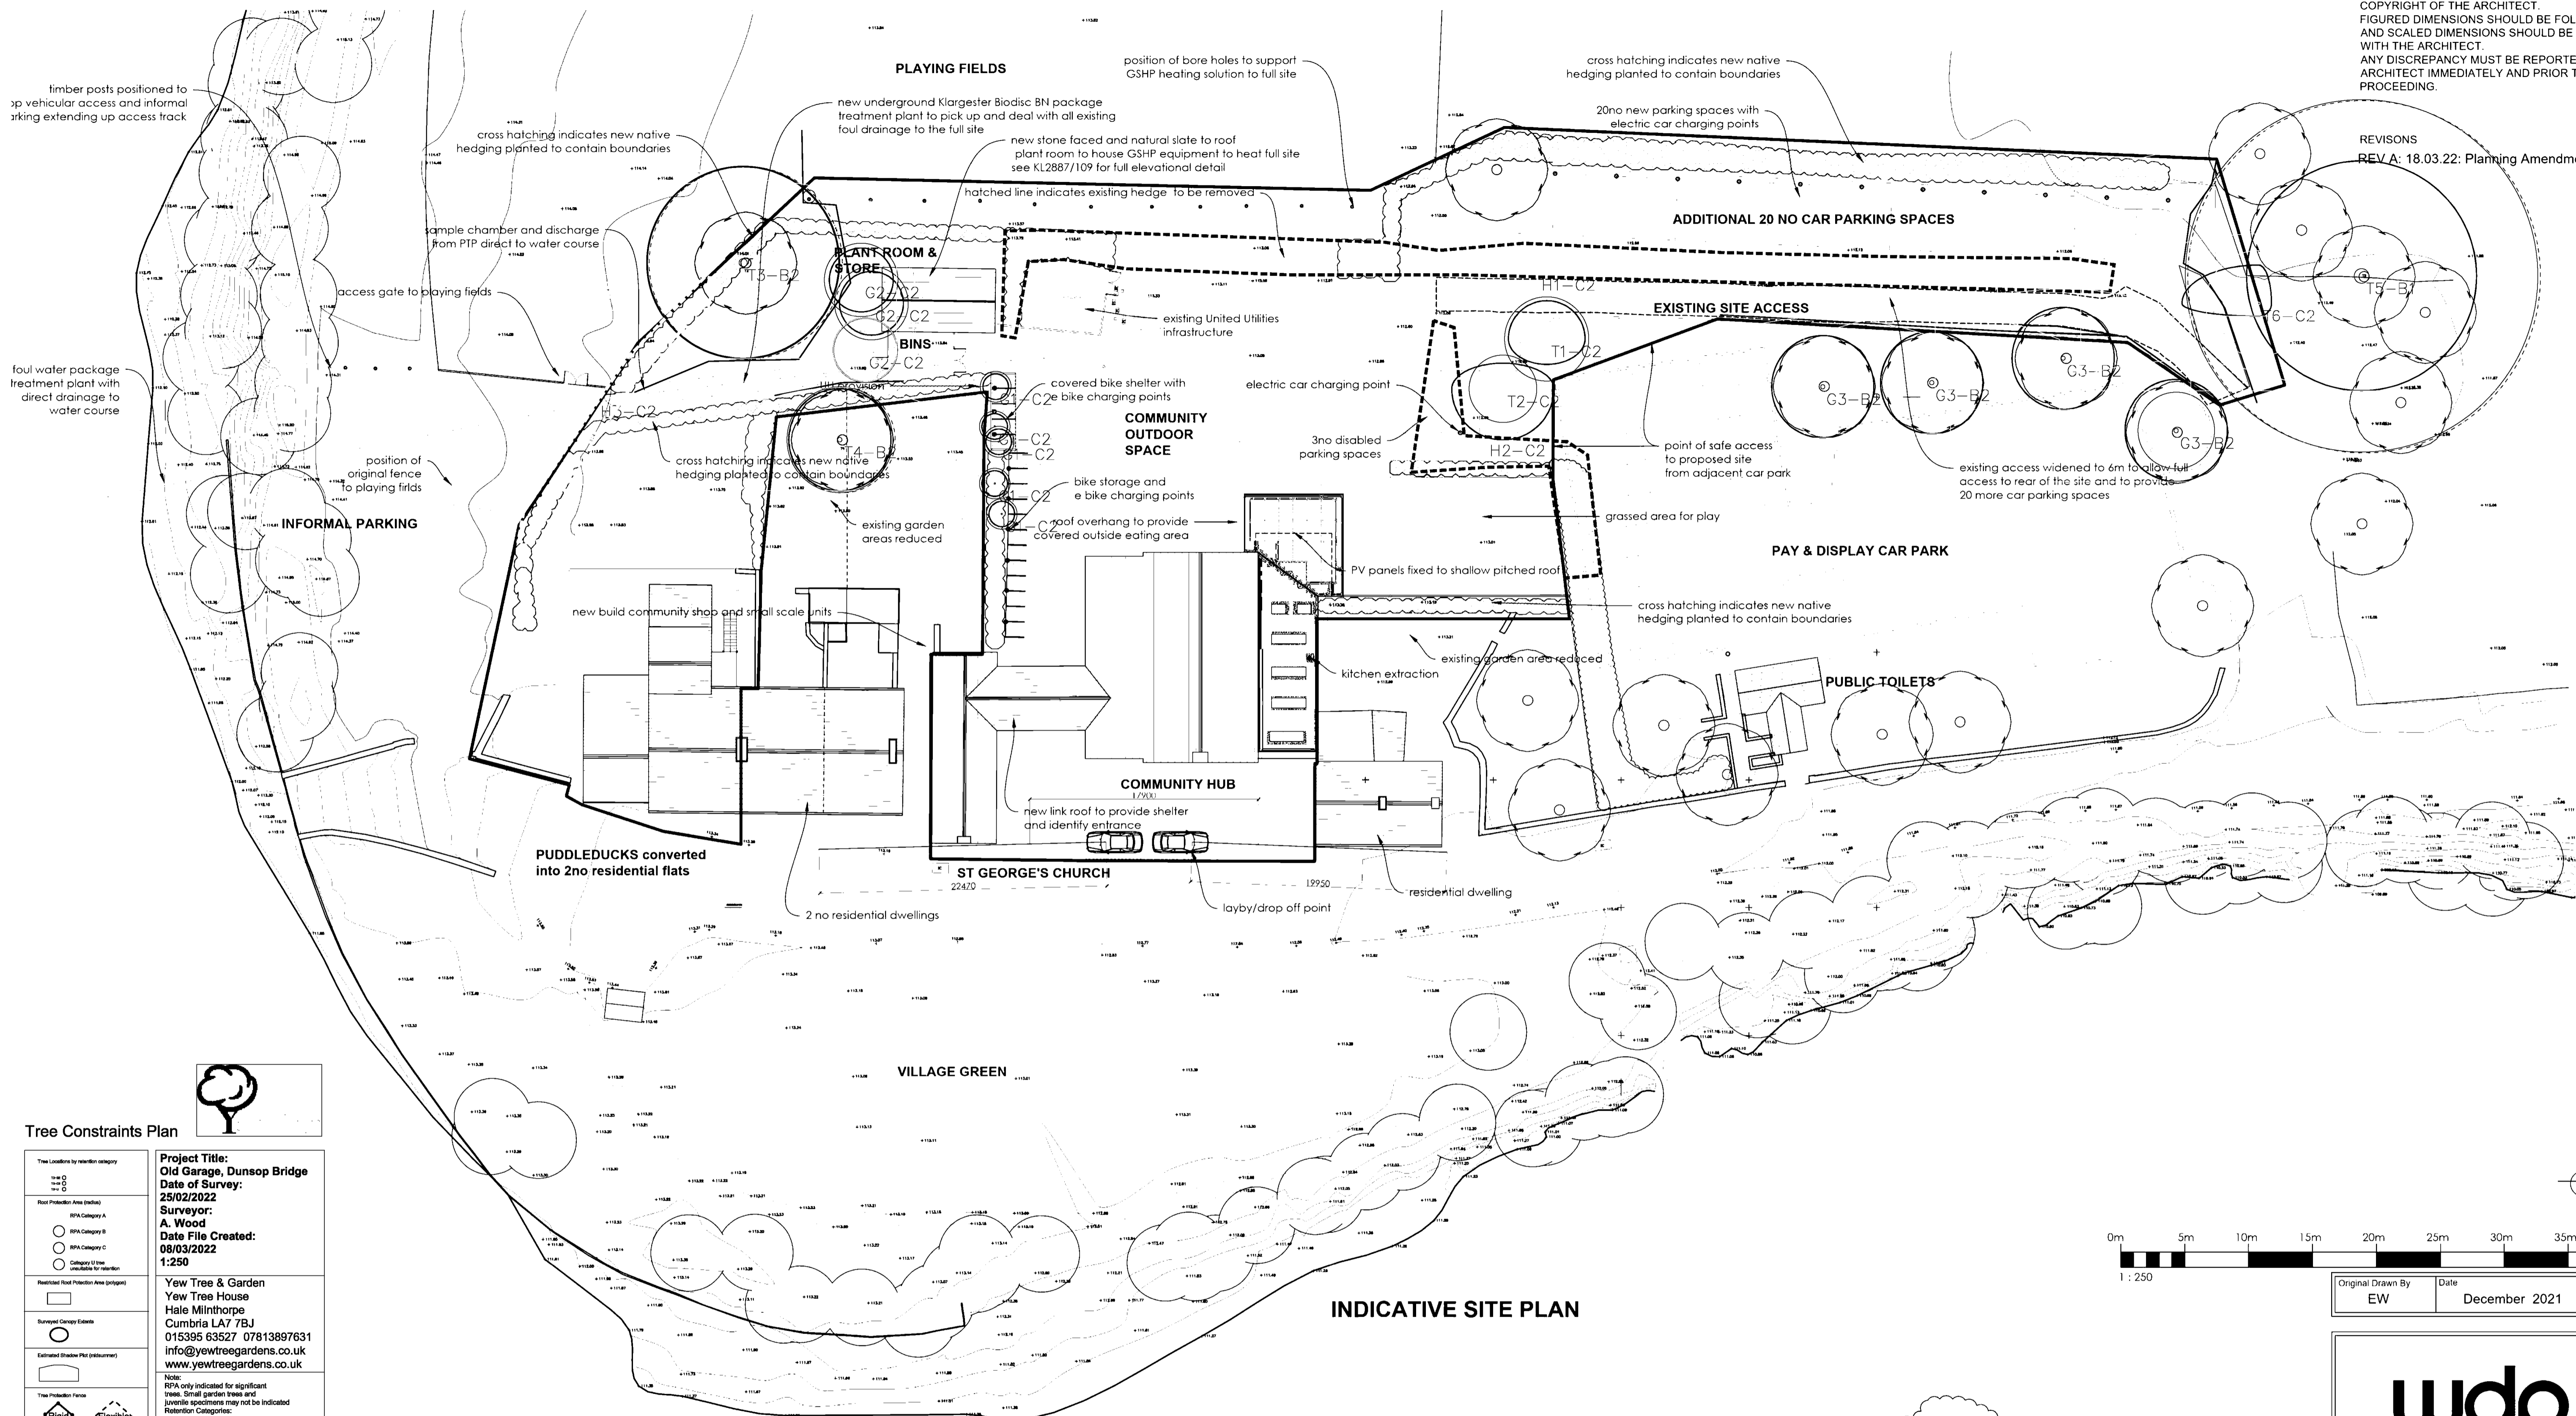
Project Title: Old Garage, Dunsop Bridge
Date of Survey: 25/02/2022
Surveyor: A. Wood
Date File Created: 08/03/2022
Scale: 1:250

6. Trees requiring removal to facilitate the proposed development or which are unsuitable for retention are annotated in red on the Tree Constraints Plan and may be further identified in the work recommendation section of the Tree Schedule.

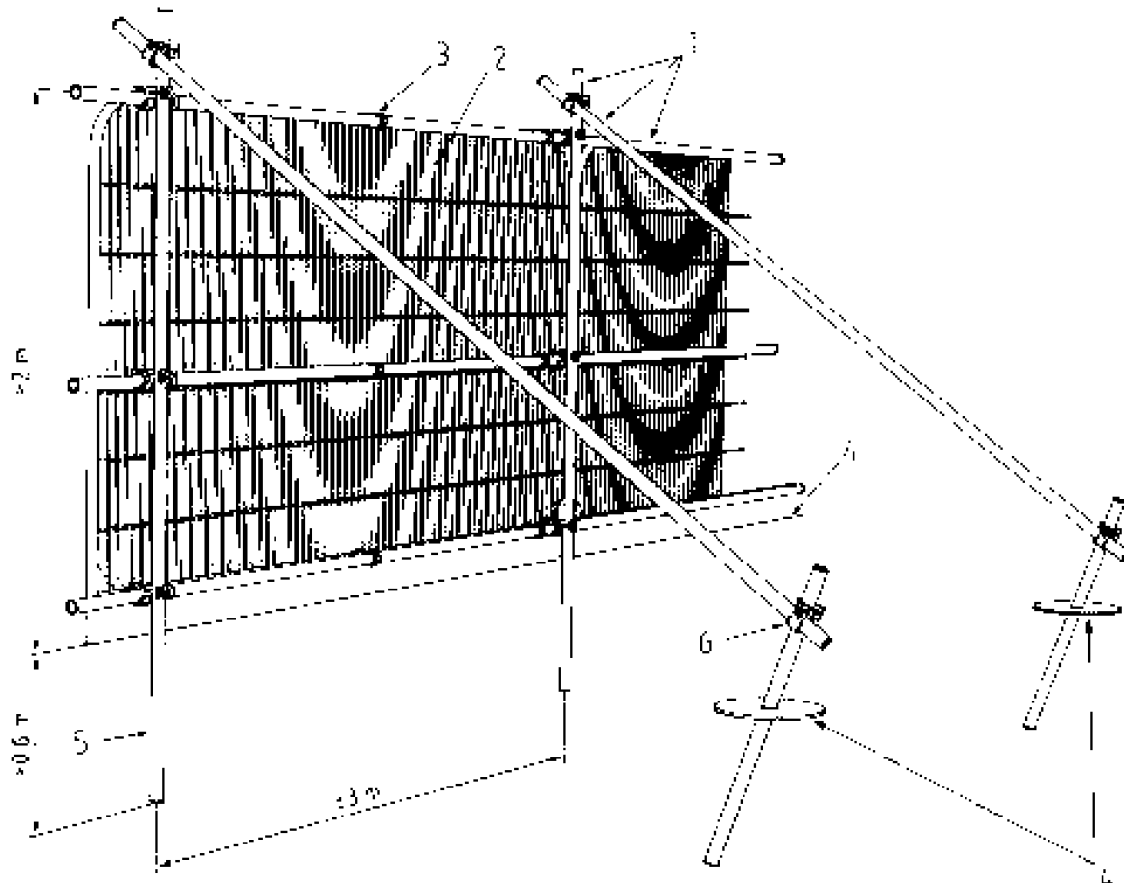
Figure 2 Default specification for protective barrier

- 1 Standard scaffold poles
 - 2 Heavy gauge 2 m tall galvanized tube and welded mesh infill panels
 - 3 Panels secured to uprights and cross members with wire ties
 - 4 Ground level
 - 5 Uprights driven into the ground until secure (minimum depth 0.6 m)
 - 6 Standard scaffold clamps
-

1. Protective fencing installed to prevent mechanical damage to trees adjacent to the development.
2. An indicative list of recommended practices during construction phase is listed below:

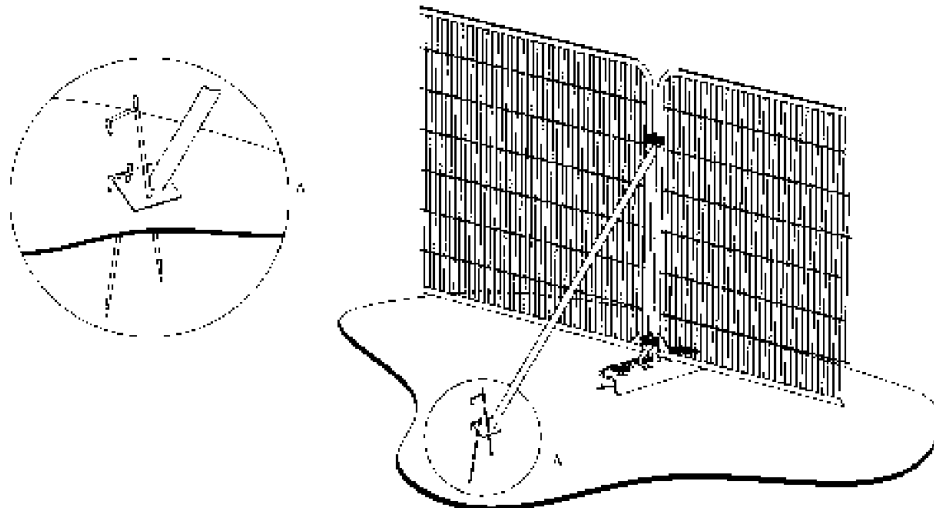
Figure 3 Examples of above-ground stabilizing systems

a) Stabilizer strut with base plate secured with ground pins

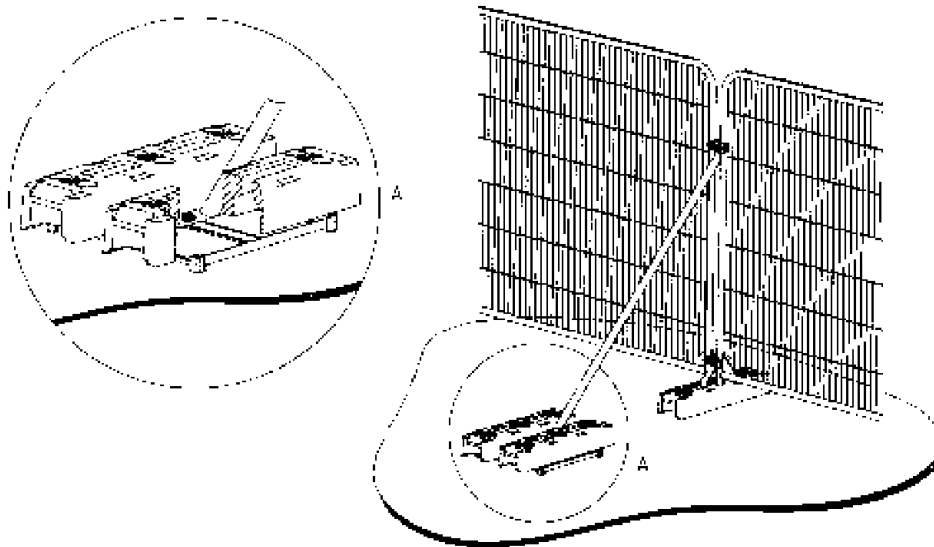
b) Stabilizer strut mounted on block tray
