Heritage Statement

Conversion of a traditional stone barn to form an annexe related to an existing listed farmhouse

Higher Lickhurst Farm

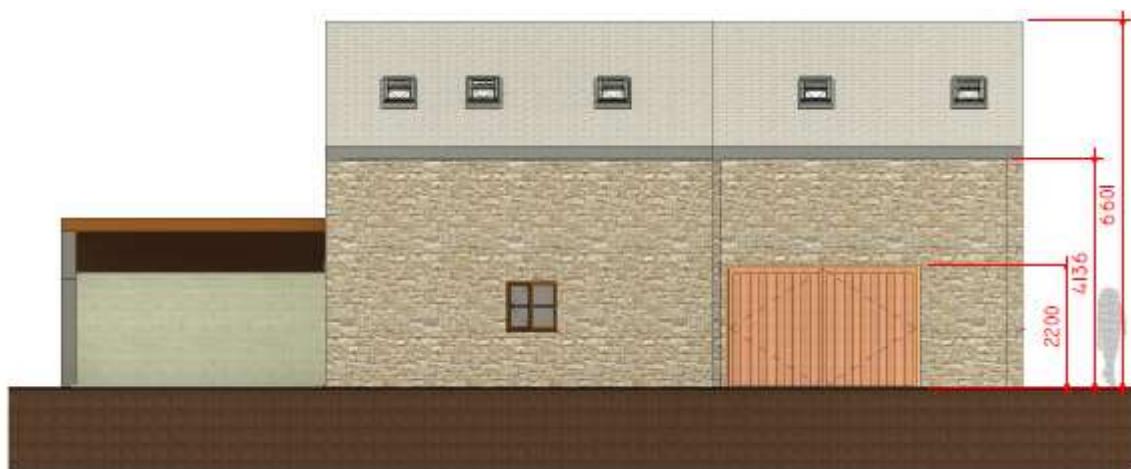
Front Elevation

- Re-use existing Doorways and openings completely with these remaining as openings or glazing un-used openings to make additional windows. The only key alteration to these is placing a traditional barn door over the existing opening in the later built portion of the barn forming a more conventional and secure Car store.

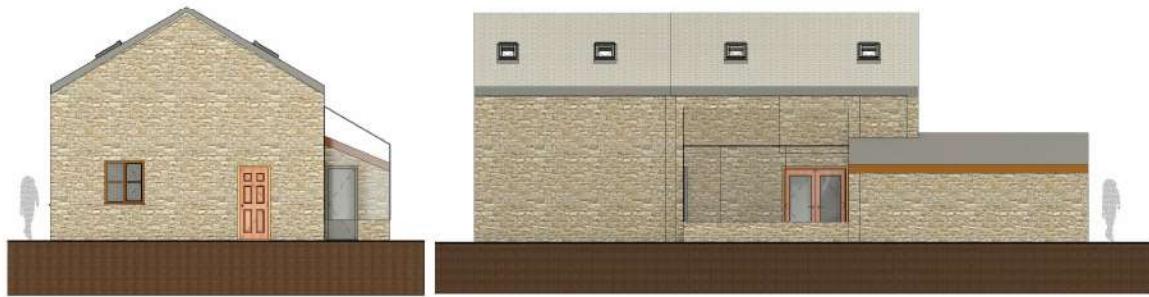
Elevation Views

- The currently unstable external lean-to section of the barn will be opened up into from the side of the barn and will be rebuilt using glazing to allow extra light into the downstairs of the barn forming a garden room. The original foundations and footprint of this lean-to will be maintained but a glazed finish rather than a stone one will be adopted. This is located to the rear of the barn so is not visible from the access.

Alterations to stone lean-to

The older part of the barn has a small lean-to structure at the side of it which is very damaged and worn, the roof has partially collapsed and the space is almost unusable.

The footprint for this will use the existing foundations from the current lean-to so the space will not be made any larger than it currently is , it will just mean the space if more accessible and better utilised.

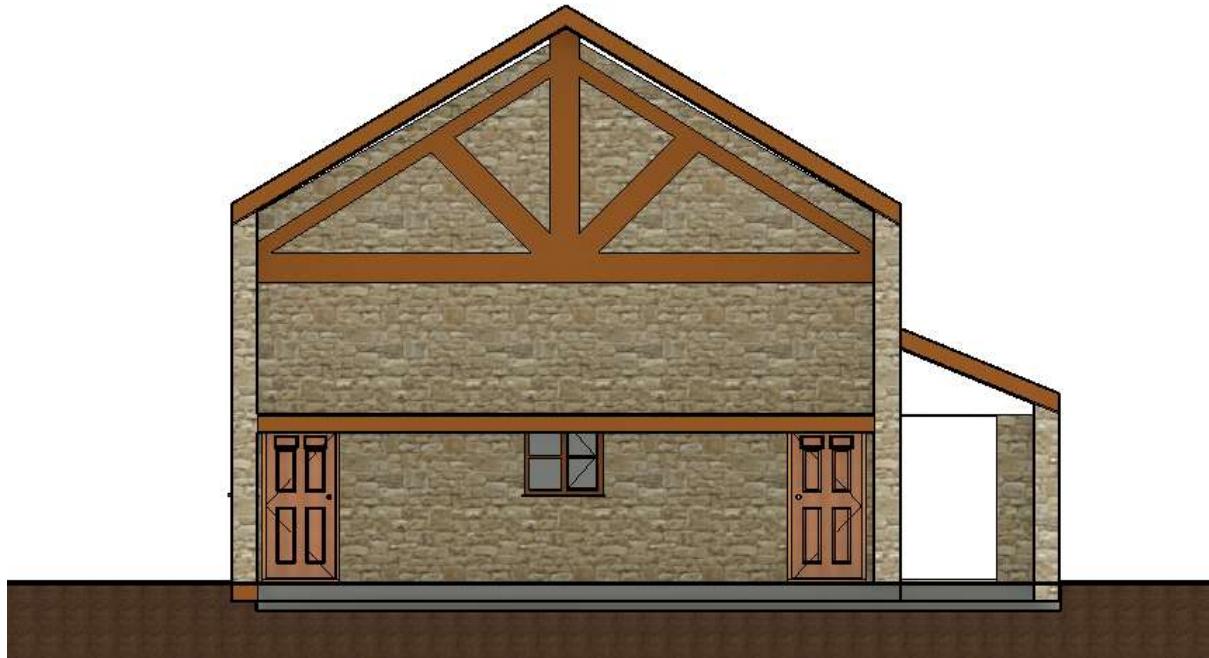
Interior section showing truss layout

- The existing King-Post trusses are to be removed and replaced with steel roof beams. The existing beams show no historical merit with one already being replaced and with these continuing to be in place, it would greatly restrict the potential of a first-floor height as these beams come down too low for the space to be useable. The roof will be refinished to match as currently there are two different roof finishes showing the two ages of the extension to the barn.

Roof Structure and Trusses

The roof is currently made up of two King post trusses, with one located in each half of the building. One side has 5 purlins installed and the other having only 3. Already these do not match up with the purlins being at different levels between the two sides.

After consulting a structural engineer, the recommended approach was to replace the trusses with Steel. This is because the beams have an underside height of (). This means there is not enough headspace to have a liveable second floor without almost entirely taking the existing trusses apart.

This shouldn't harm the character of the barn as these trusses are not original and are simply made from dimension lumber rather than a historic oak or similar.

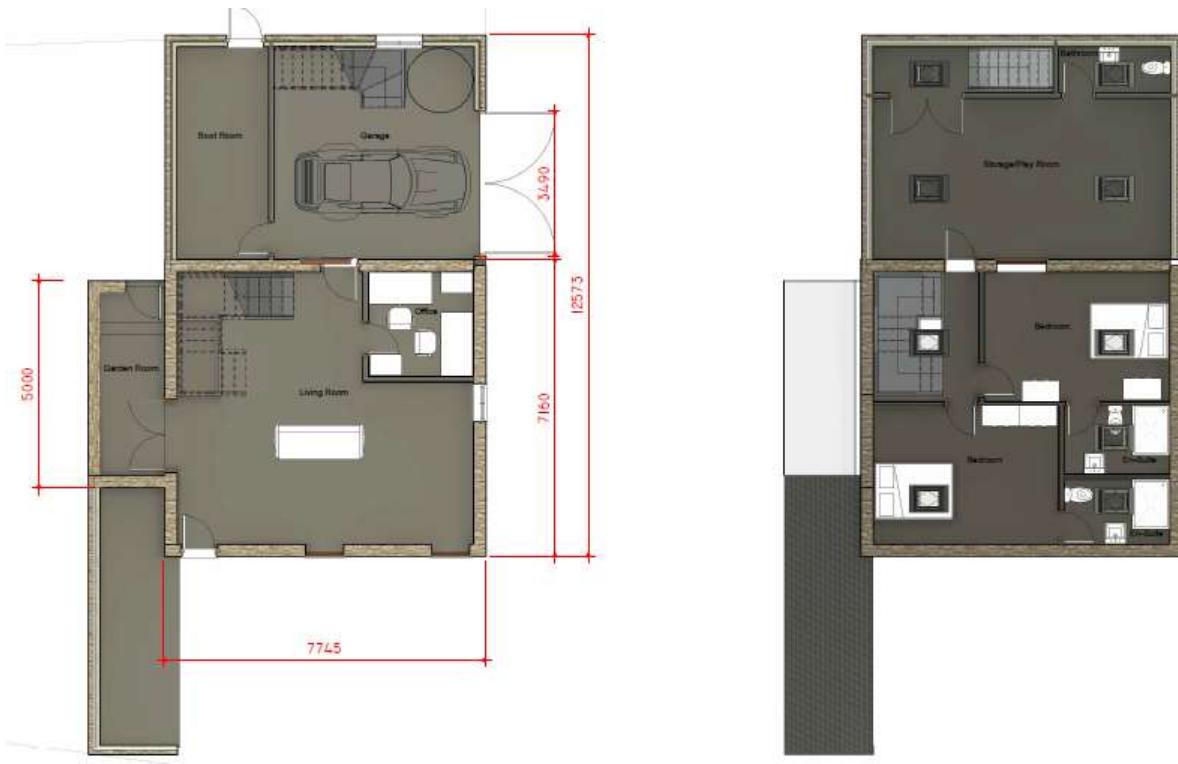
Proposed floor plans

- There will be a slight change in levels to allow for the first floor to be installed and have a useable height above it. This first floor will comprise of two bedrooms, a bathroom and a storage room above the newer addition to the barn with a staircase to access from the car-port below. The ground floor space will mostly be maintained with two minor partition walls separating an office space and a staircase to the first floor being the only additions.

This area of the barn will be utilised as a more secure car-port with a wooden barn door and a second floor installed to hold a storage area which will be accessible from a staircase proposed inside the Car-port.
