DESIGN, ACCESS AND HERITAGE STATEMENT

REPLACEMENT OF WINDOWS & GUTTERS AND OUTBUILDING CONVERSION AT:

Higher Chipping House,  
Cutler Lane,  
Chipping,  
Lancashire,  
PR3 2SY

February 2022

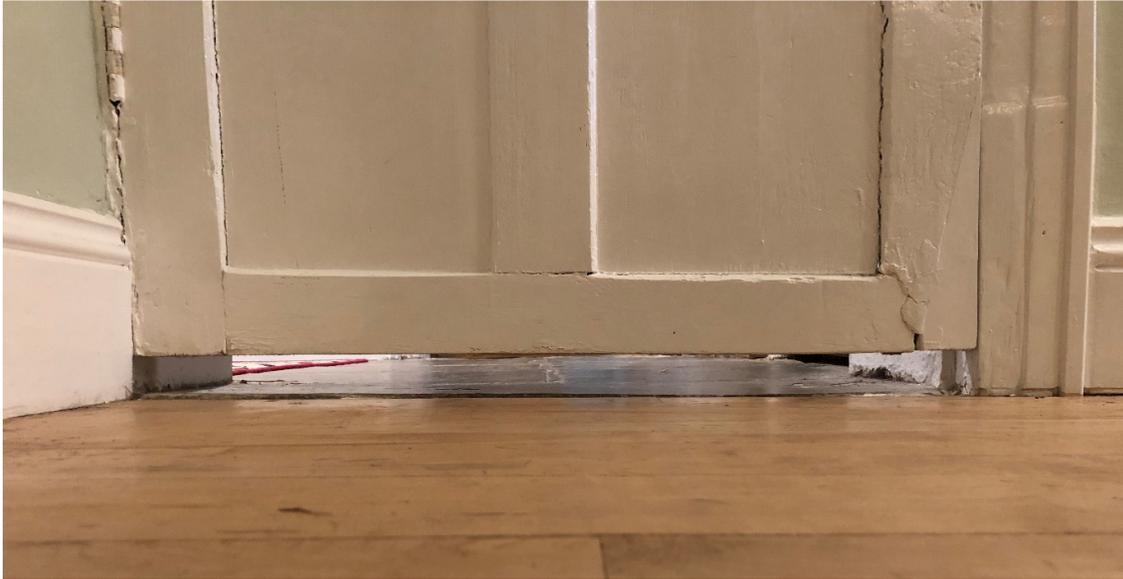
*Fig. 1 – photograph showing damage to the base on an existing door, caused by past alterations to the bottom rail.*

Repairs include the replacement of any areas of moisture or rot damaged timber with new timber sections spliced in to match the existing, with the work undertaken by a joiner with experience of heritage projects. Where appropriate, the narrow bottom rails (which show evidence of having been reduced in size in the past) will be replaced with deeper bottom rails that are less prone to damage and which reduce the size of the gap between the door and the floor finish (allowing minimum a 10mm gap to ensure ventilation and meet Building Regulations requirements).

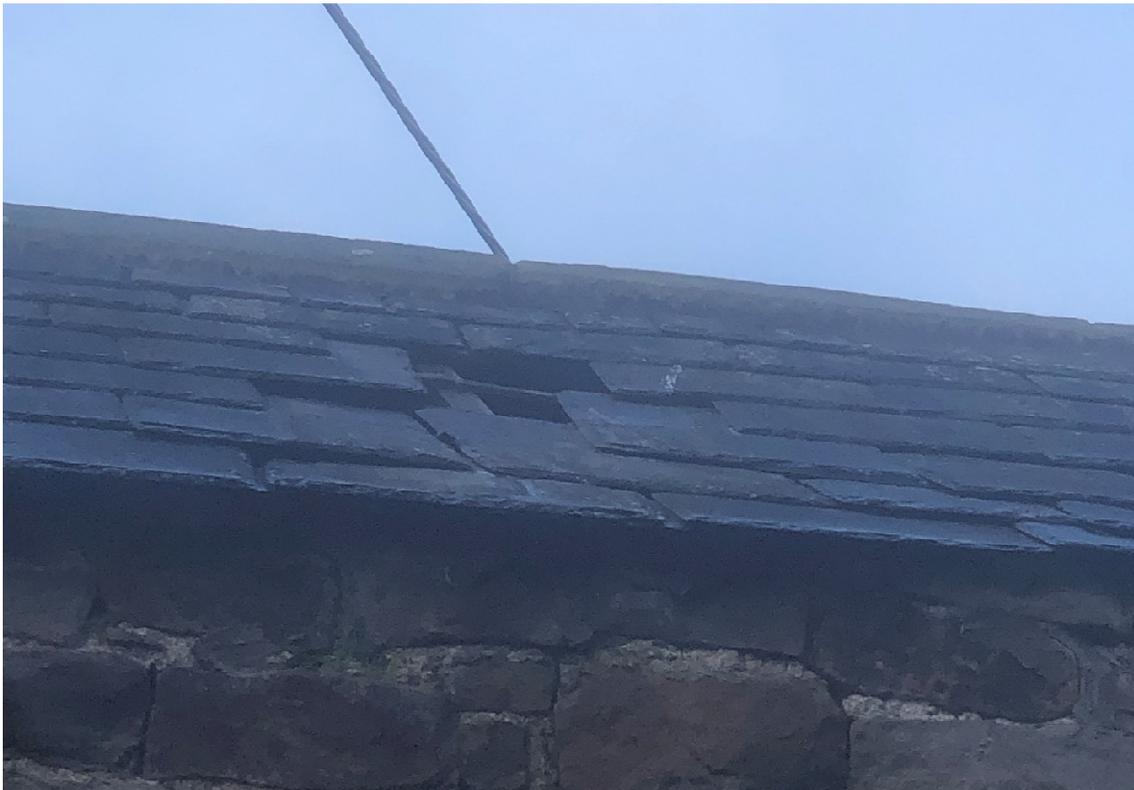
*Fig. 2 – damage to the roof of the outbuilding caused by recent storms.*

This application includes the conversion of an existing stone out-building into a new home office space. The outbuilding is in a state of significant deterioration, with concerns about the structural integrity of the external wall next to the road as well as the existing roof. Recent storms caused slates to fall from the roof on to the road, and there is concern that without urgent remedial work further (and perhaps dangerous) deterioration is likely.

It is proposed to take down and rebuild the stone external wall to the road, reusing existing stones as far as possible, and then install a new slate roof with a mix of reclaimed and new stone slates to match the existing.

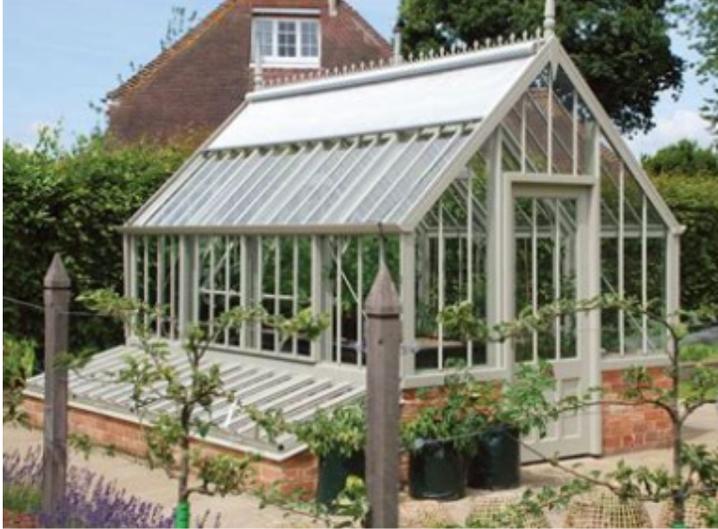
*Fig. 3 – example of proposed new greenhouse construction.*

This building will be demolished, with a new single storey greenhouse / potting shed proposed – the volume of this potting shed will be smaller than the barn it will replace. The proposed greenhouse will have brick walls up to approximately 0.8m above ground level, with a traditional style timber framed greenhouse structure above.
