DESIGN, ACCESS AND HERITAGE STATEMENT

REPLACEMENT OF WINDOWS & GUTTERS AND OUTBUILDING CONVERSION AT:

Higher Chipping House,
Cutler Lane,
Chipping,
Lancashire,
PR3 2SY

February 2022

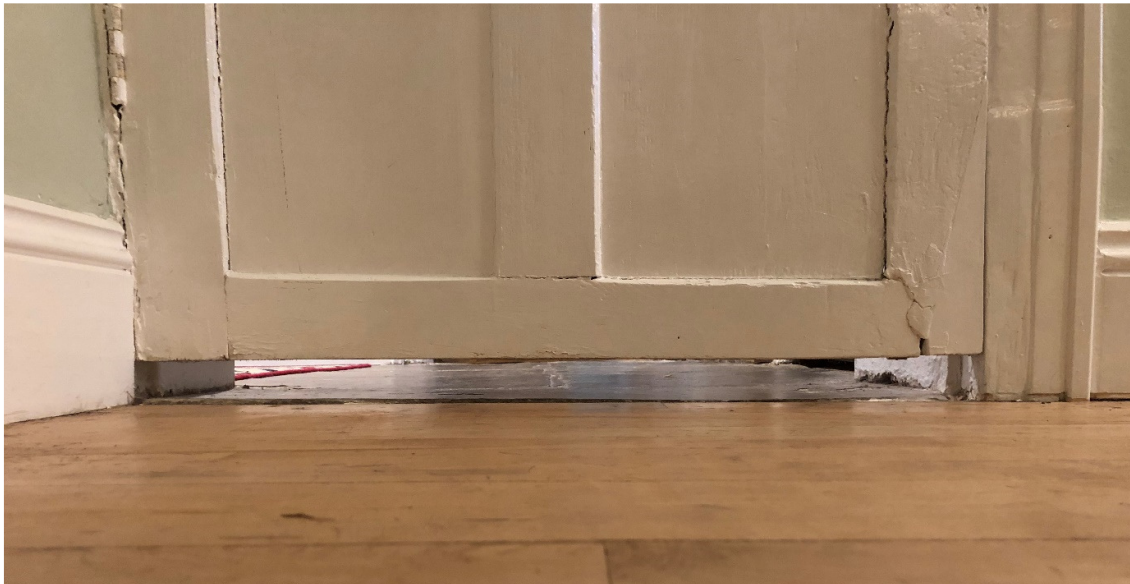
Fig. 1 – photograph showing damage to the base on an existing door, caused by past alterations to the bottom rail.

Repairs include the replacement of any areas of moisture or rot damaged timber with new timber sections spliced in to match the existing, with the work undertaken by a joiner with experience of heritage projects. Where appropriate, the narrow bottom rails (which show evidence of having been reduced in size in the past) will be replaced with deeper bottom rails that are less prone to damage and which reduce the size of the gap between the door and the floor finish (allowing minimum a 10mm gap to ensure ventilation and meet Building Regulations requirements).

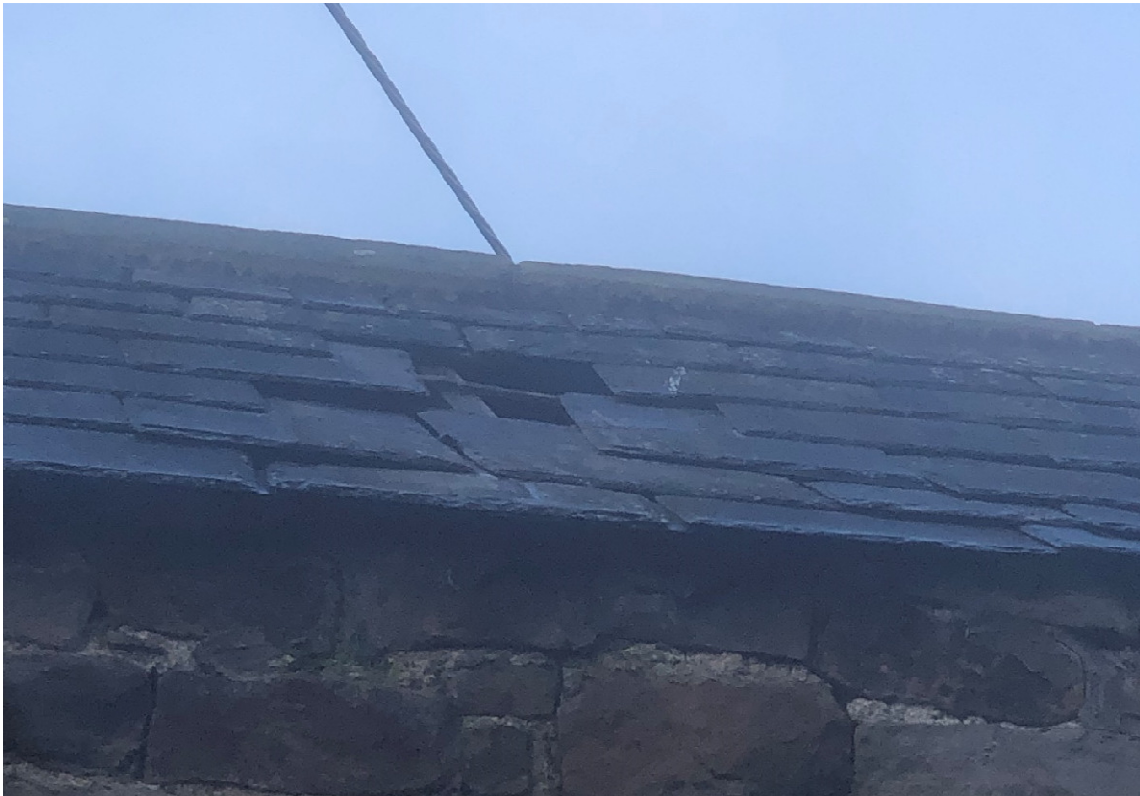
Fig. 2 – damage to the roof of the outbuilding caused by recent storms.

This application includes the conversion of an existing stone out-building into a new home office space. The outbuilding is in a state of significant deterioration, with concerns about the structural integrity of the external wall next to the road as well as the existing roof. Recent storms caused slates to fall from the roof on to the road, and there is concern that without urgent remedial work further (and perhaps dangerous) deterioration is likely.

It is proposed to take down and rebuild the stone external wall to the road, reusing existing stones as far as possible, and then install a new slate roof with a mix of reclaimed and new stone slates to match the existing.

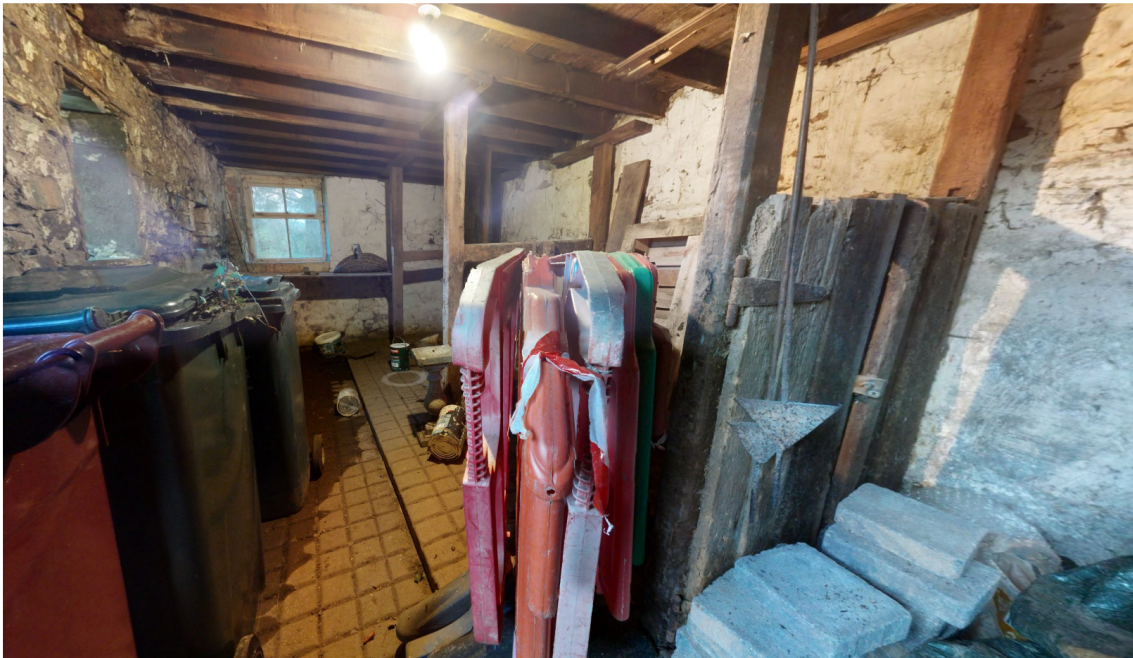
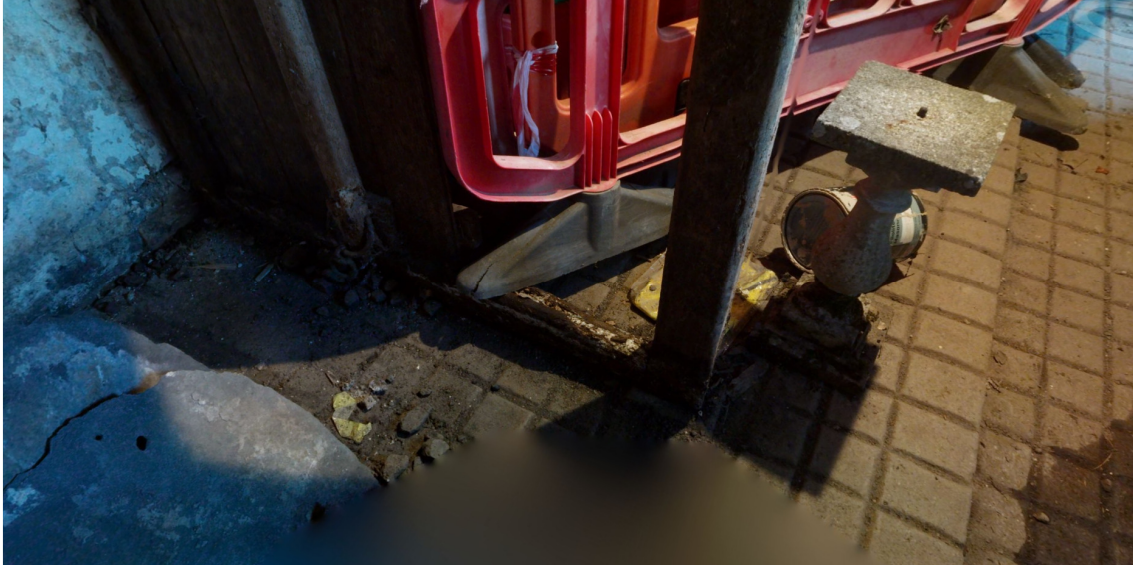
There are 4no. wooden stalls to the ground floor of the outbuilding, which will be retained and carefully protected during the construction process. The wooden stalls are likely mid-20th Century in origin and are fixed over a grooved concrete floor, so have minimal historic value or significance. The images below show the wooden stalls over the concrete floor.

One stall will be removed to allow the installation of an internal staircase. The proposed location of the staircase has been chosen to maximise the amount of usable space at first floor, as well as avoid the removal of a wooden worktop that connects to the existing stall at the northern end of the outbuilding. The existing external staircase is very steep, steps directly on to the road and can be dangerous in poor weather conditions or in the dark. As it is considered that installing a new secondary external staircase, replacing the existing with a Building Regulations compliant staircase or adding railings and other safety measures to the existing would be incongruous to the outbuilding and context of the Listed building, the new internal staircase is considered the best solution to provide safe access to the first-floor office space.
