DESIGN, ACCESS AND HERITAGE STATEMENT

REPLACEMENT OF WINDOWS & GUTTERS AND OUTBUILDING CONVERSION AT:

Higher Chipping House,  
Cutler Lane,  
Chipping,  
Lancashire,  
PR3 2SY

February 2022

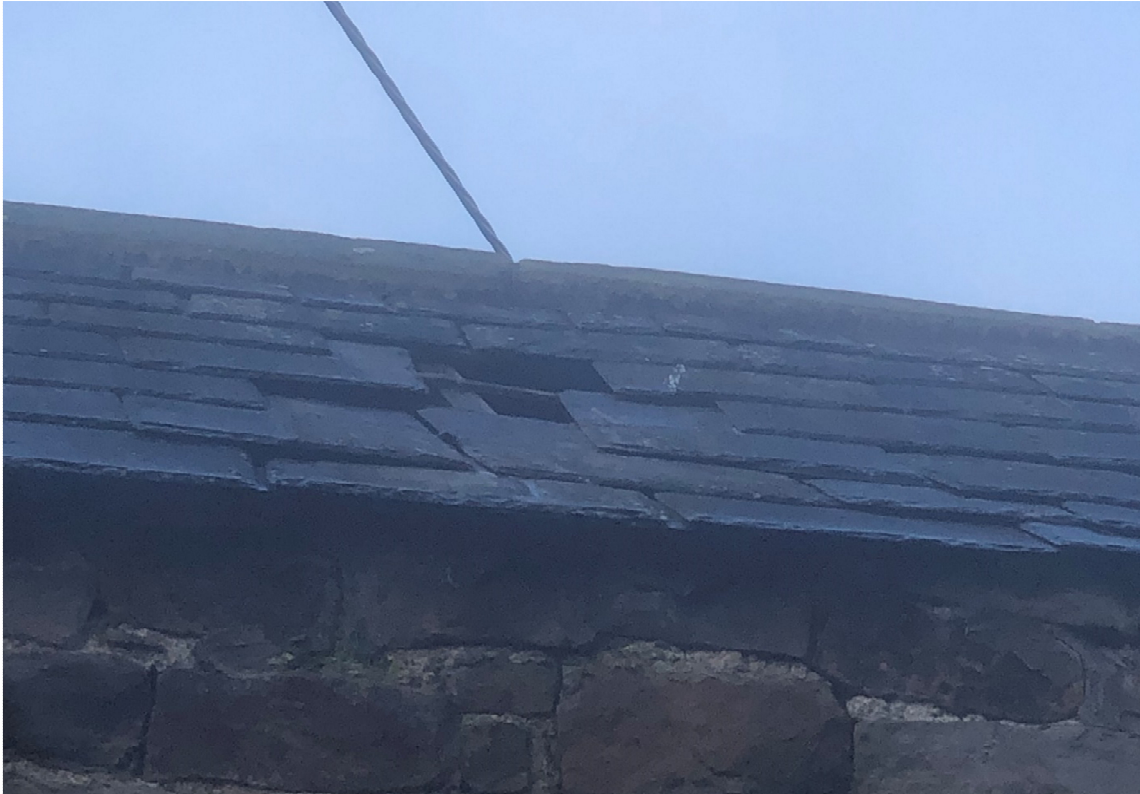
*Fig. 2 – damage to the roof of the outbuilding caused by recent storms.*

This application includes the conversion of an existing stone out-building into a new home office space. The outbuilding is in a state of significant deterioration, with concerns about the structural integrity of the external wall next to the road as well as the existing roof. Recent storms caused slates to fall from the roof on to the road, and there is concern that without urgent remedial work further (and perhaps dangerous) deterioration is likely.

It is proposed to take down and rebuild the stone external wall to the road, reusing existing stones as far as possible, and then install a new slate roof with a mix of reclaimed and new stone slates to match the existing. The outbuilding will then be insulated with a mix of natural breathable wood fibre insulation and lime plasters, to bring the building into habitable use without causing unintended damage to the historic fabric of the building.

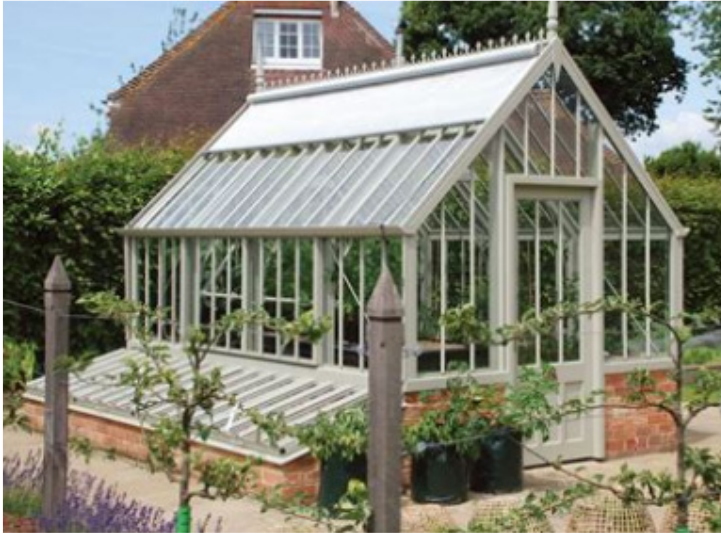
*Fig. 3 – example of proposed new greenhouse construction.*

This building will be demolished, with a new single storey greenhouse / potting shed proposed – the volume to match the barn it will replace. The proposed greenhouse will have brick walls up to approximately 0.8m above ground level, with a traditional style timber framed greenhouse structure above.
