HERITAGE STATEMENT

11 YORK STREET

CLITHEROE

Job Reference Number: BS 1197

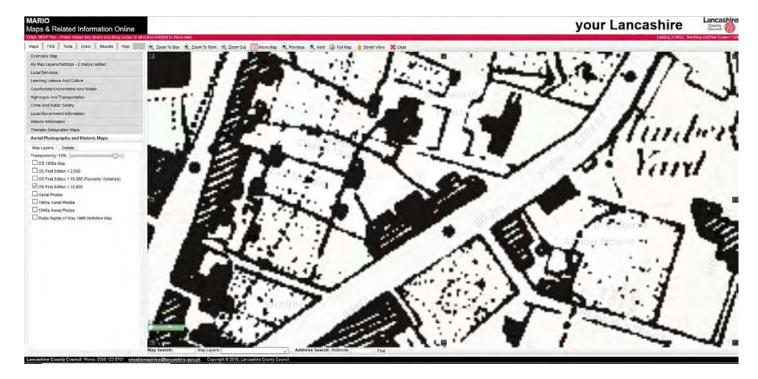
FIGURE 1. - OS First Epoch First State Map 1:10,560 c. mid 1840's [taken from Mario Lancashire website] http://mario.lancashire.gov.uk/agsmario/default.aspx

- 4.2 The earliest historical map available dates from c.1840 where 11 York Street is clearly indicated,
 Appendix 1, Figures 1 and 2 taken from MARIO Lancashire's website are extracts from this map.
 Reference to the transparency overlay to the modern OS plan tends to indicate that the main structure was originally built with a smaller rear addition.
- 4.3 Within Appendix 1, Figures 3 & 4 are also taken from MARIO Lancashire's website is at a smaller scale and understood to be a later map, dating from 1890. Which clearly shows that the rear outrigger was originally smaller and in a different position than existing.
