HERITAGE STATEMENT

Oxenhurst Farm
 Back Lane
 Newton in Bowland
 Clitheroe
 BB7 3EE

Project Number: 101560 - LBC

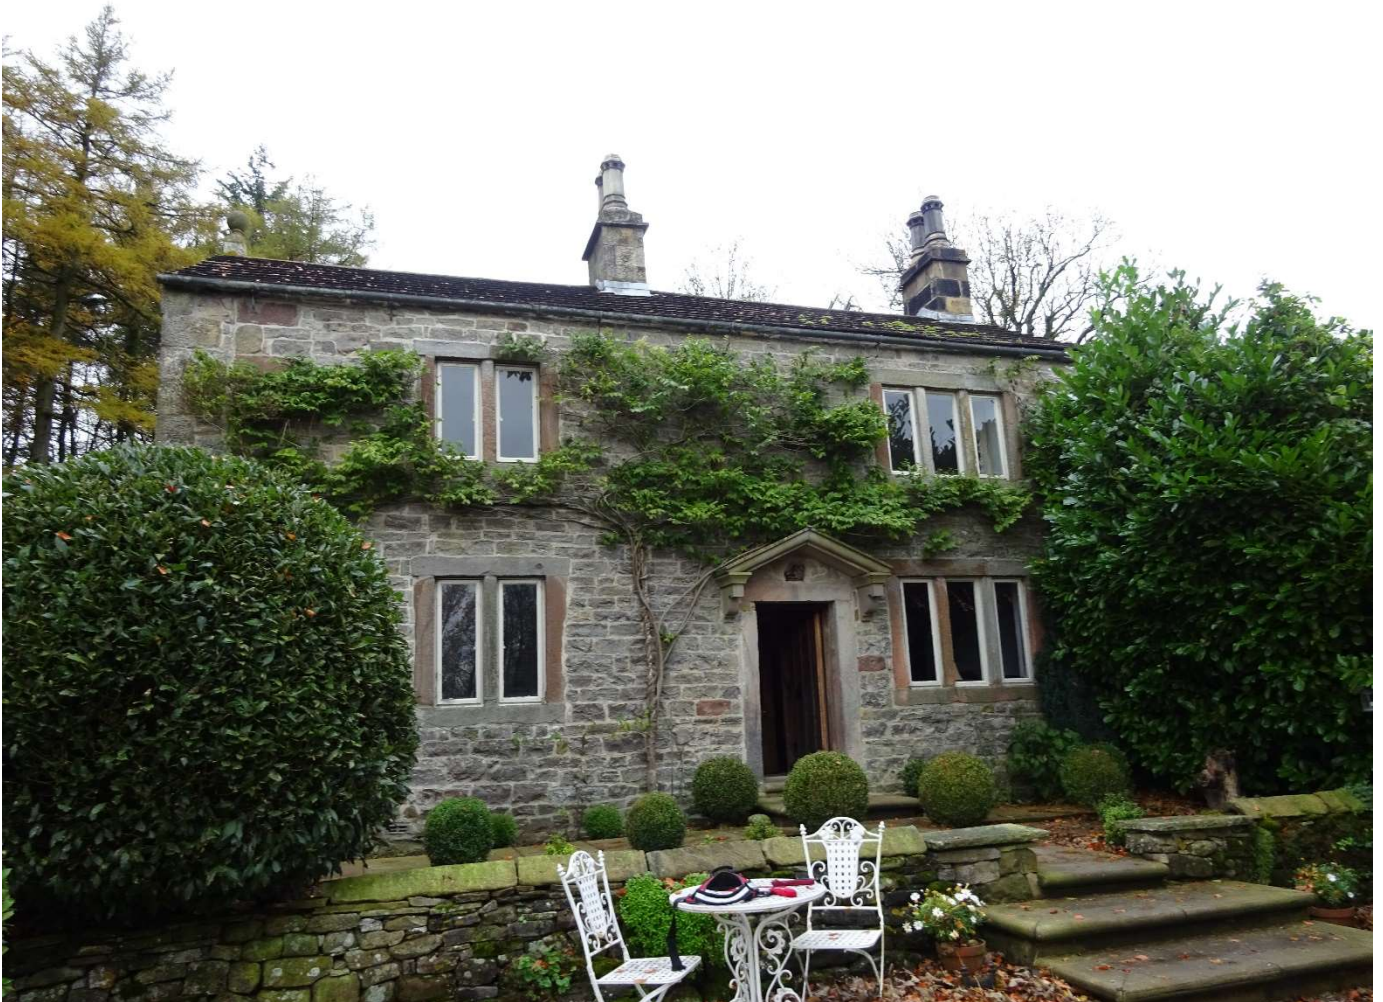
Figure 2 - Front elevation of Oxenhurst Farmhouse

2.1 Oxenhurst Farm is dated C18th with two storeys, sandstone rubble walls and concrete tiled roof over traditional cut timbers. The property is a double-pile plan with central entry and two chimney stacks. Windows have plain stone surrounds and square mullions. To the rear is a rear off shoot containing the kitchen, the bathroom has been incorporated to the rear roof pitch with two Velux style windows providing natural light.
