# HERITAGE STATEMENT

AMELIORATION OF UNAUTHORISED WORKS AND  
PROPOSED INTERNAL AND EXTERNAL ALTERATIONS / WORKS

THE PRIORY

GISBURN

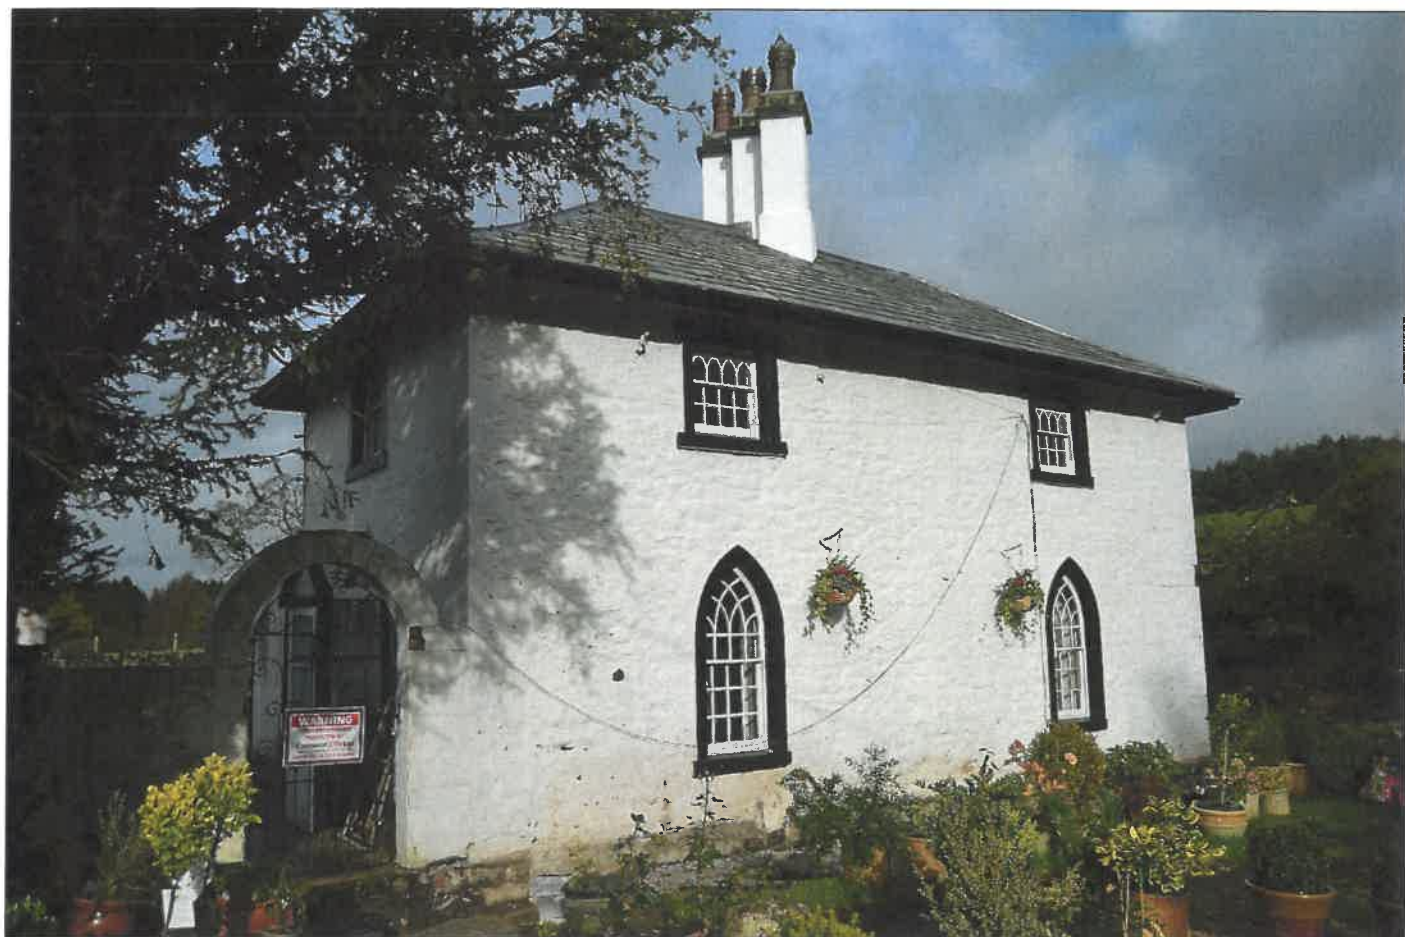
*PL01: View of The Priory from the south west.*

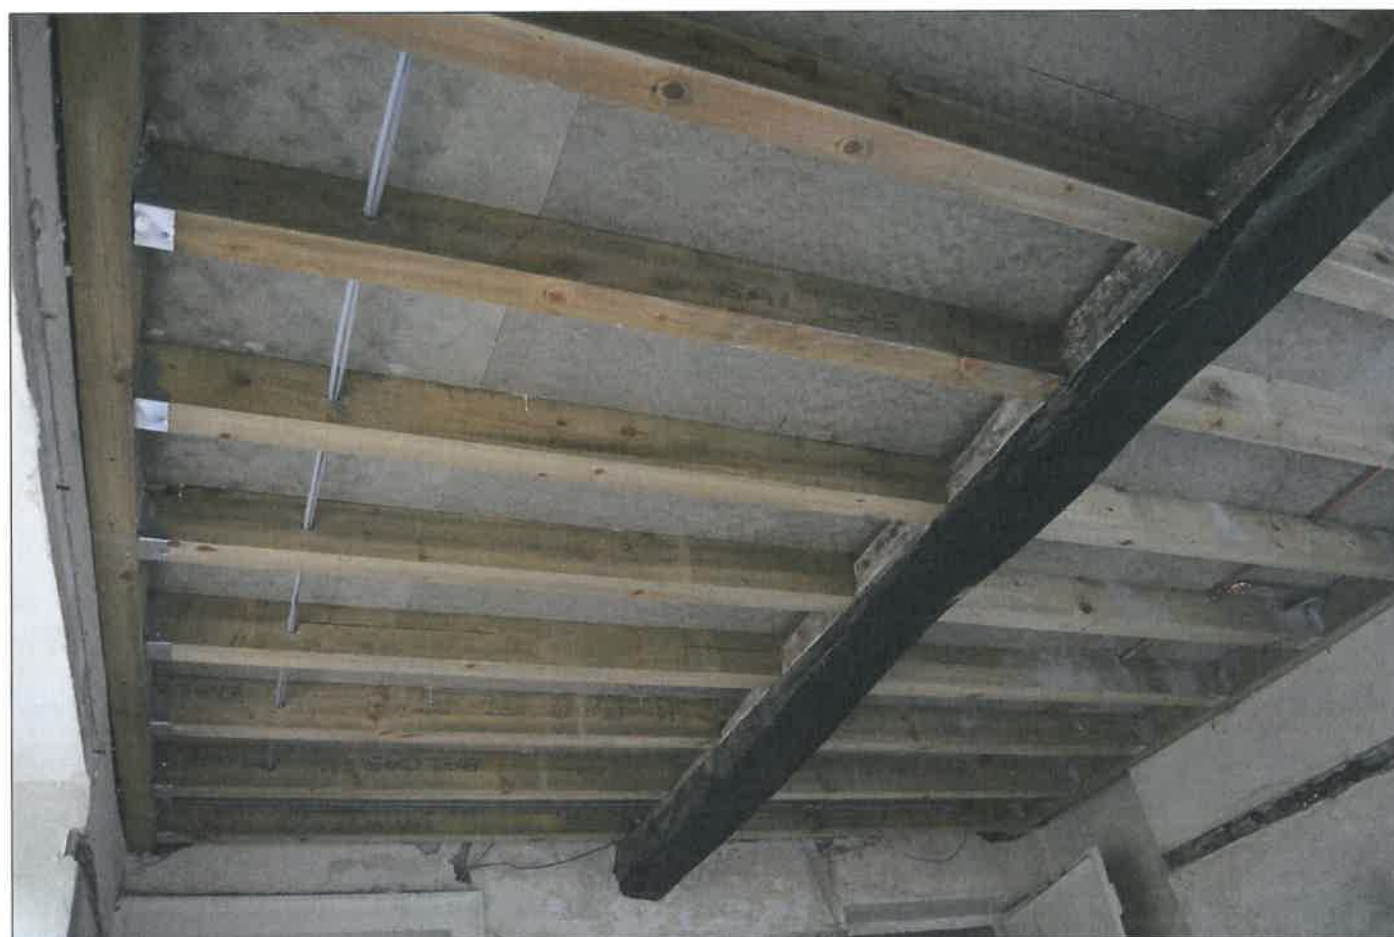
*PL12: View of modern floor structure installed over the first-floor north unit.*

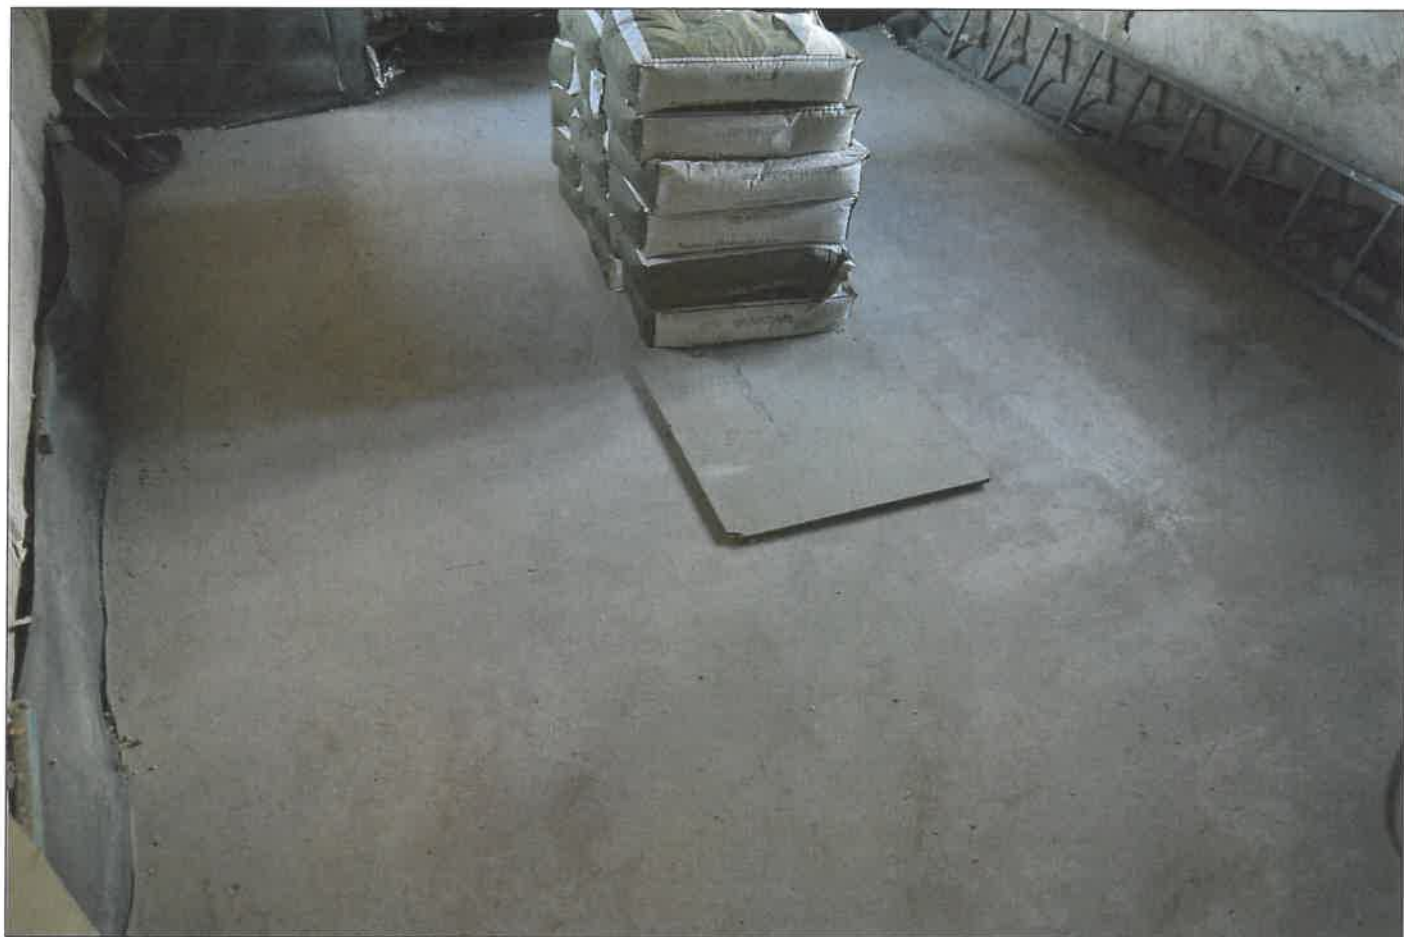
*PL13: View of concrete floor to the ground floor north unit.*

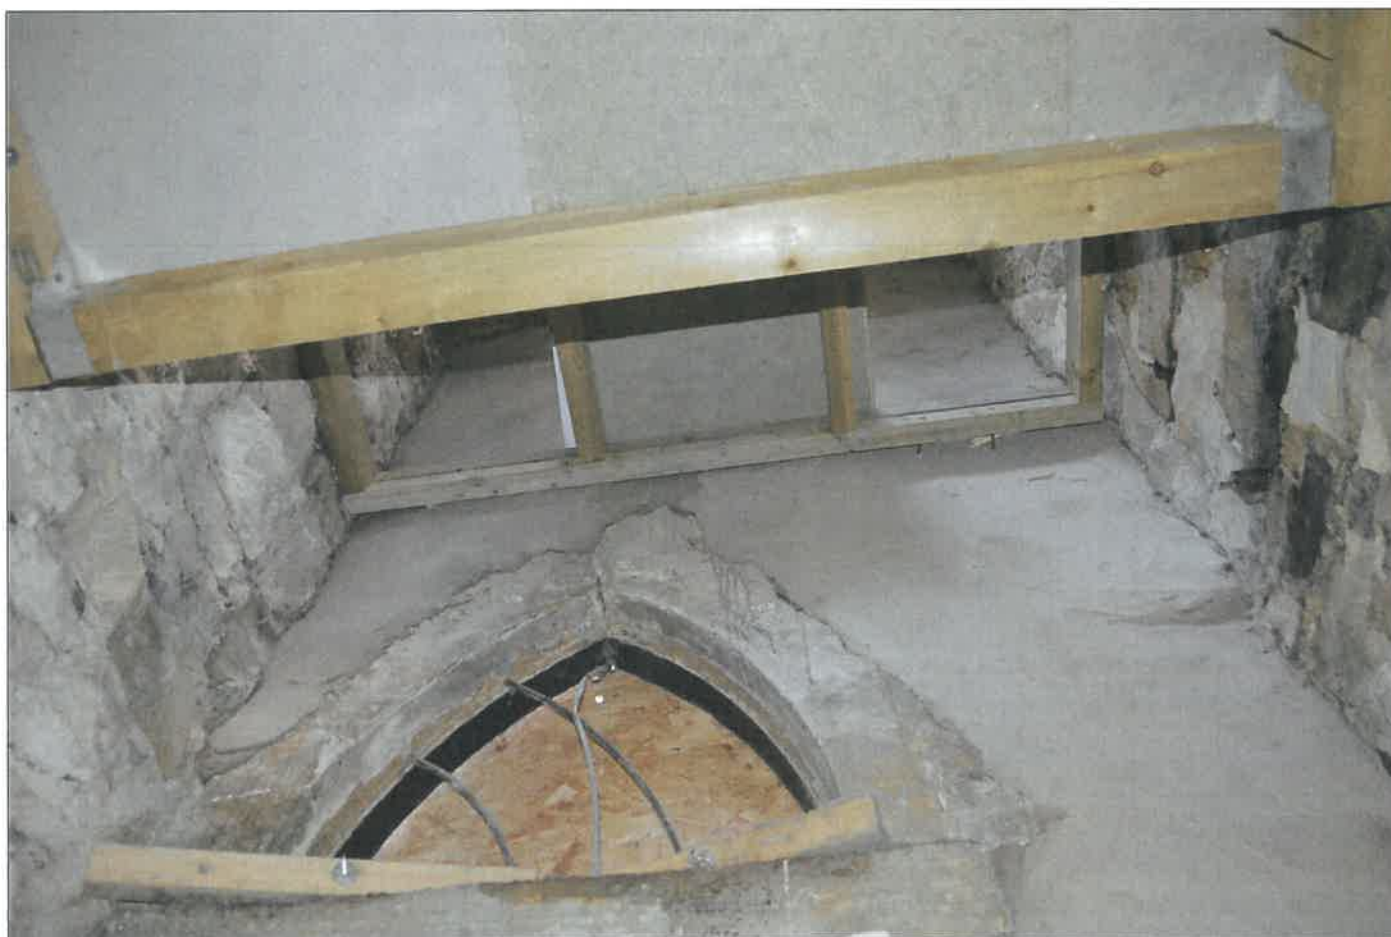
PL16: View of void formed to first floor structure adjacent external door to ground floor inner hallway.

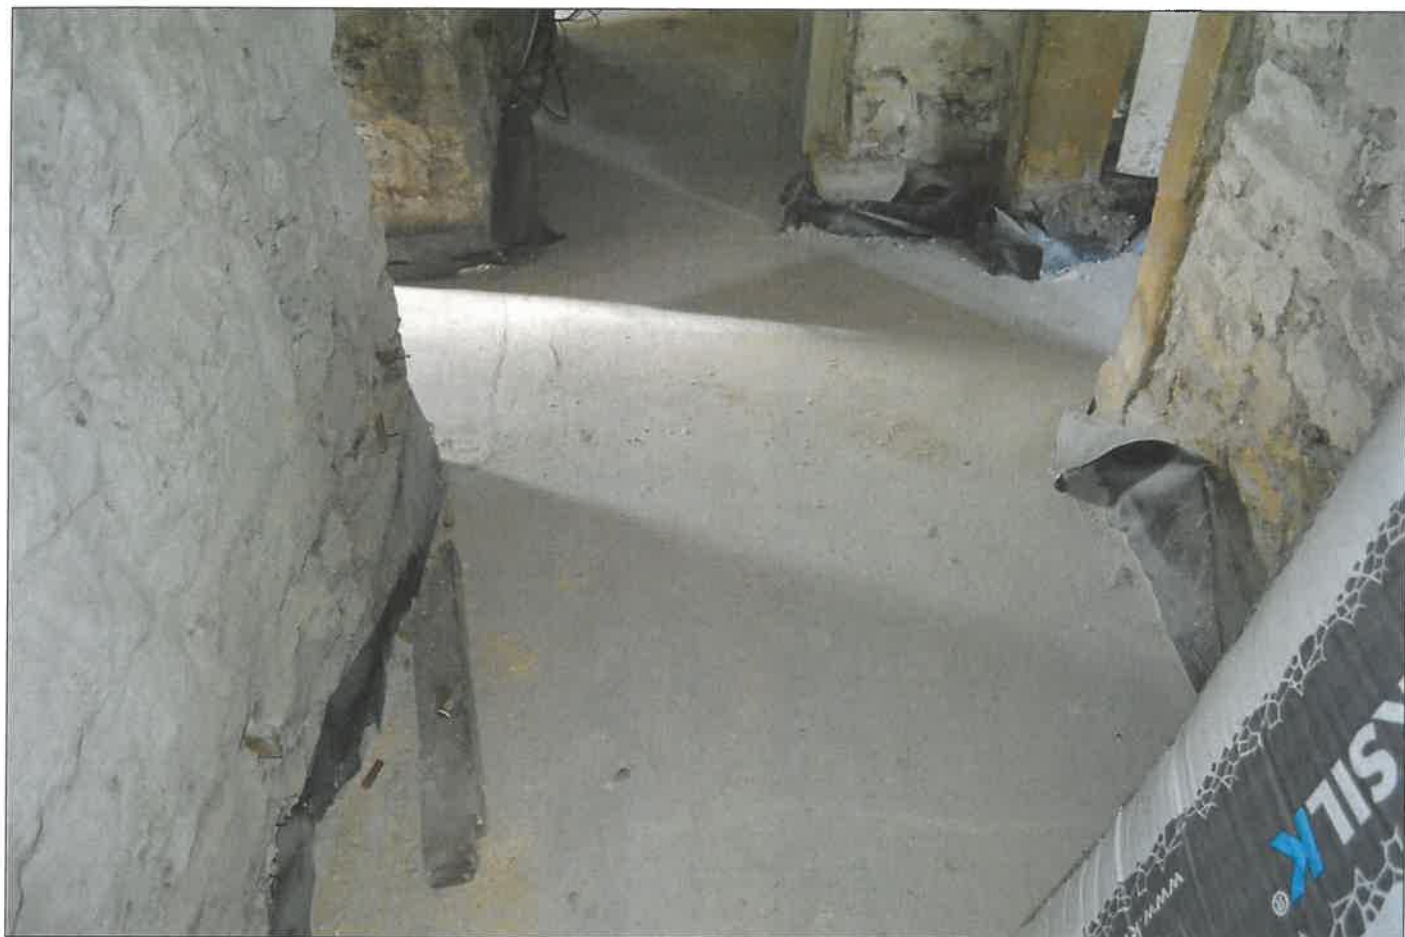
*PL17: View of concrete floor to ground floor inner hallway.*

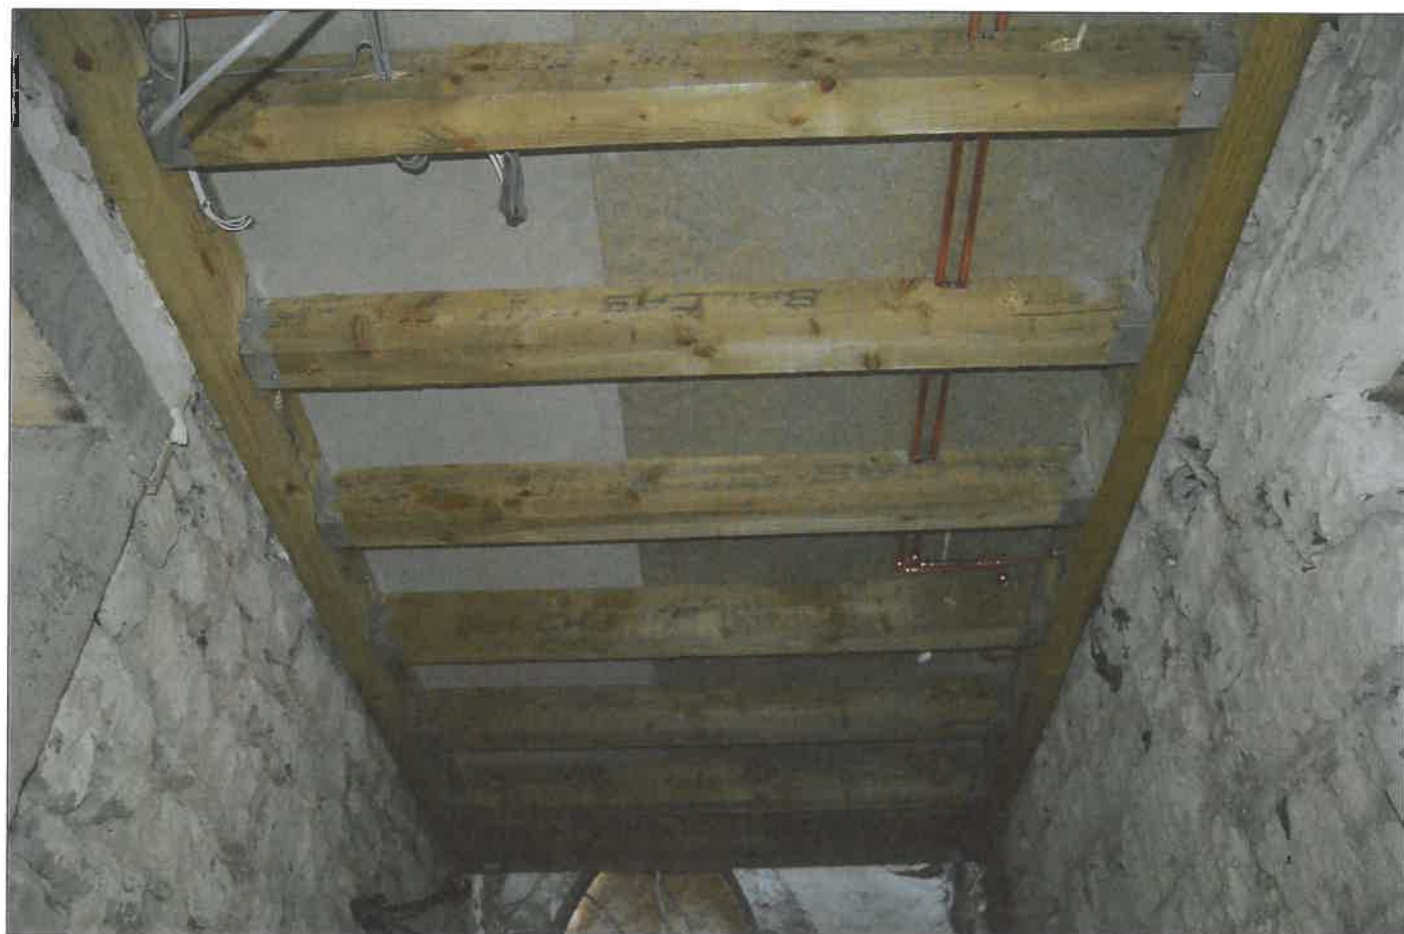
*PL18: View of modern floor structure installed over the ground floor inner hallway.*

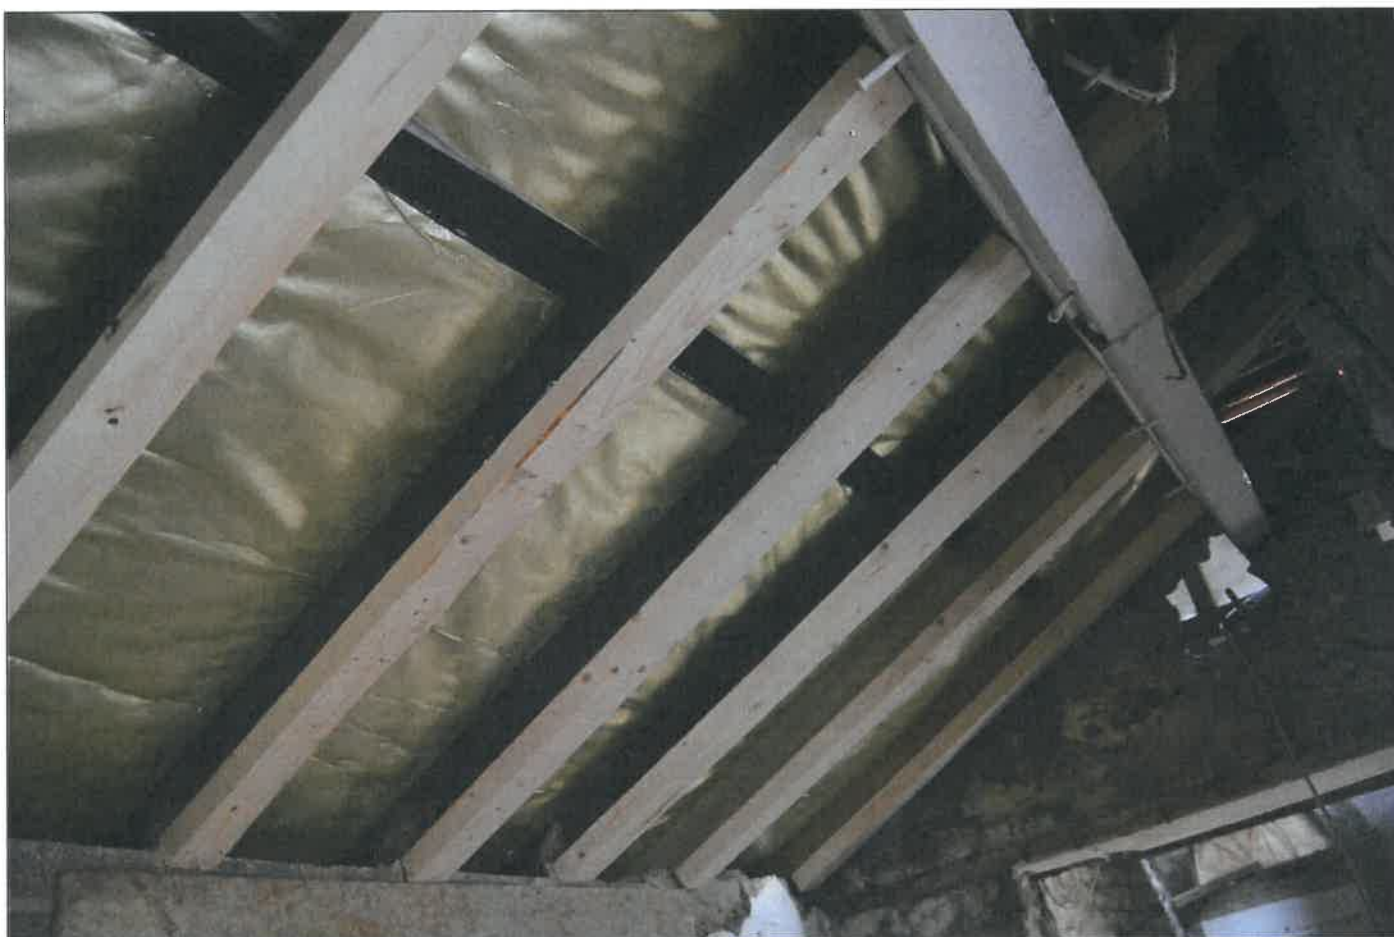
PL21: View of roof structure to former ground floor boiler room.

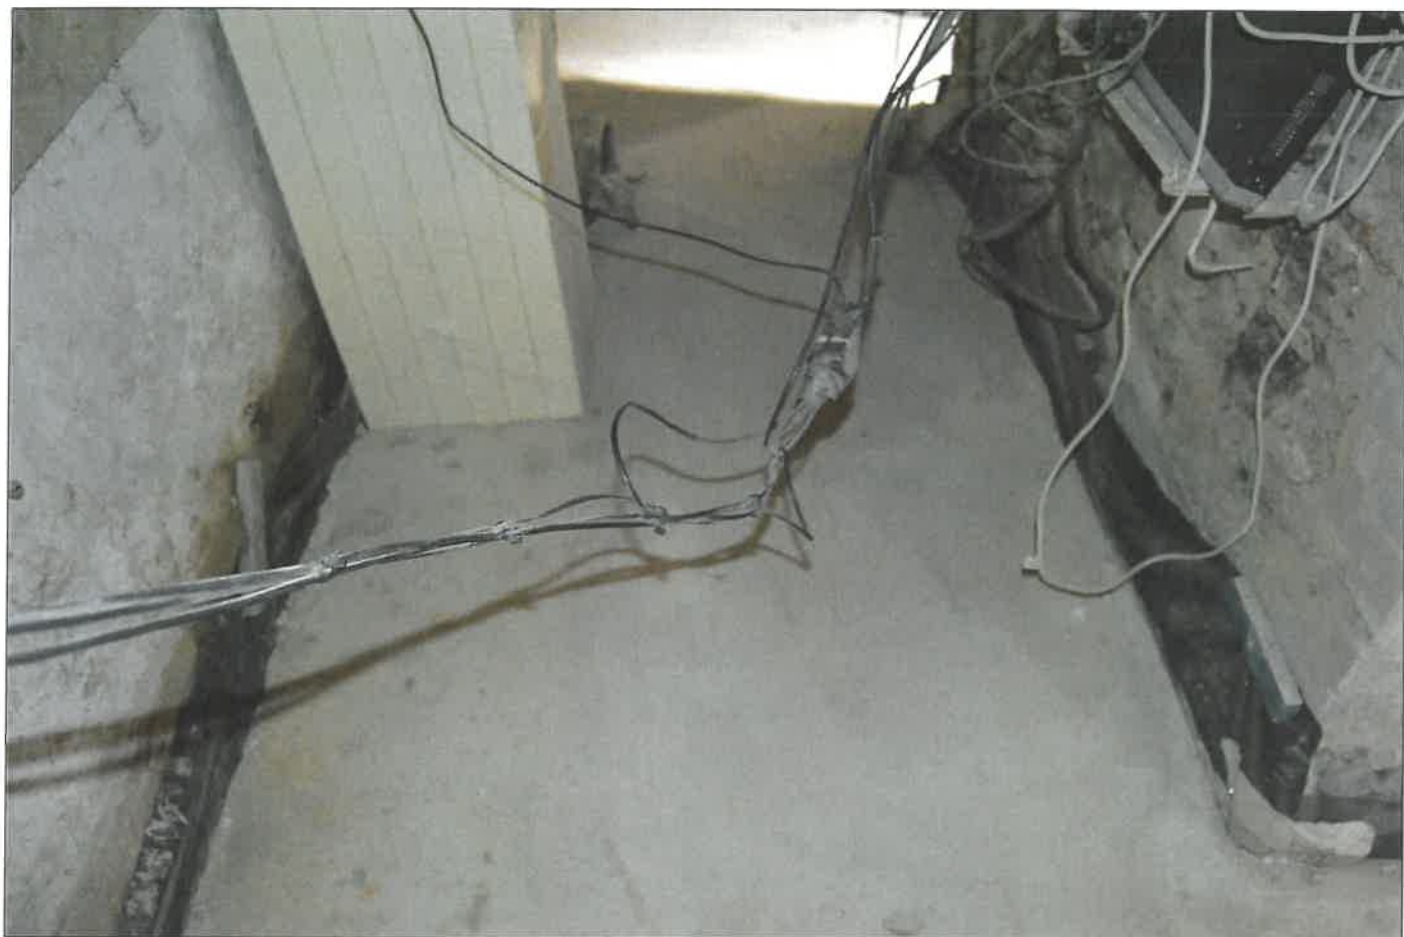
PL22: View of concrete floor to former ground floor boiler room.

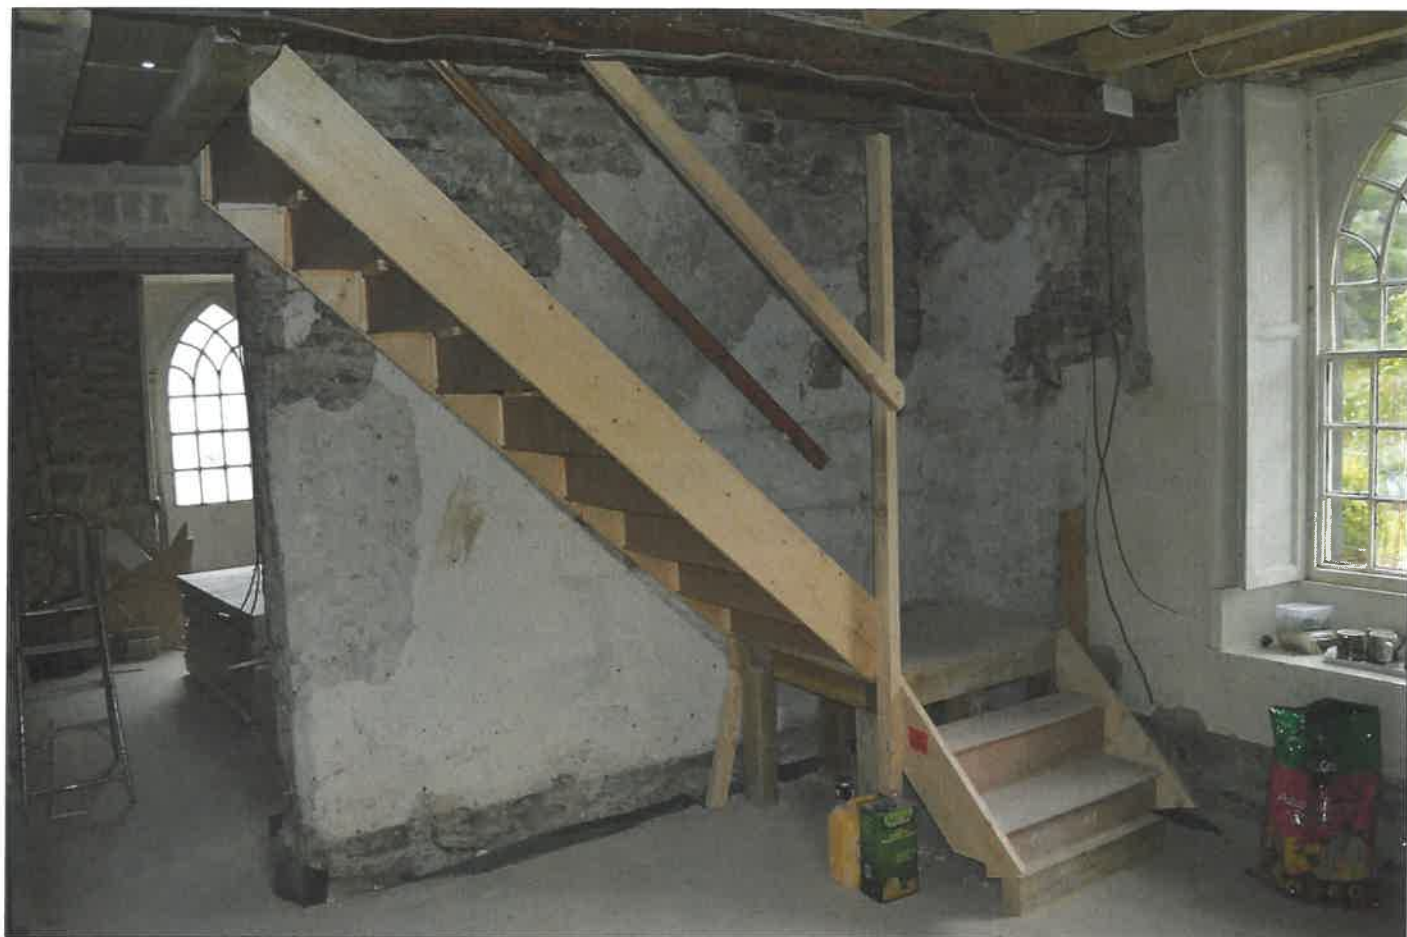
PL26: View east within former ground floor kitchen showing temporary staircase following the removal of the former staircase.

The plans show the plan form layout and a number of fixtures and fittings. Interestingly, the original staircase was entered from the north at ground floor level, as opposed to south as existing suggesting this has been altered and the former staircase which has now been removed is a later replacement. At this time, the north and south 'wings' of the building were not originally connected at first floor level. This suggests that their adjoining is a later alteration and it is likely that the staircase was altered in order to suit this as well as the doors into the first floor south east and south west rooms, both of which have been repositioned to suit the internal changes. It is thought that these changes occurred in the first half of the 20<sup>th</sup> century, probably around the 1930's.

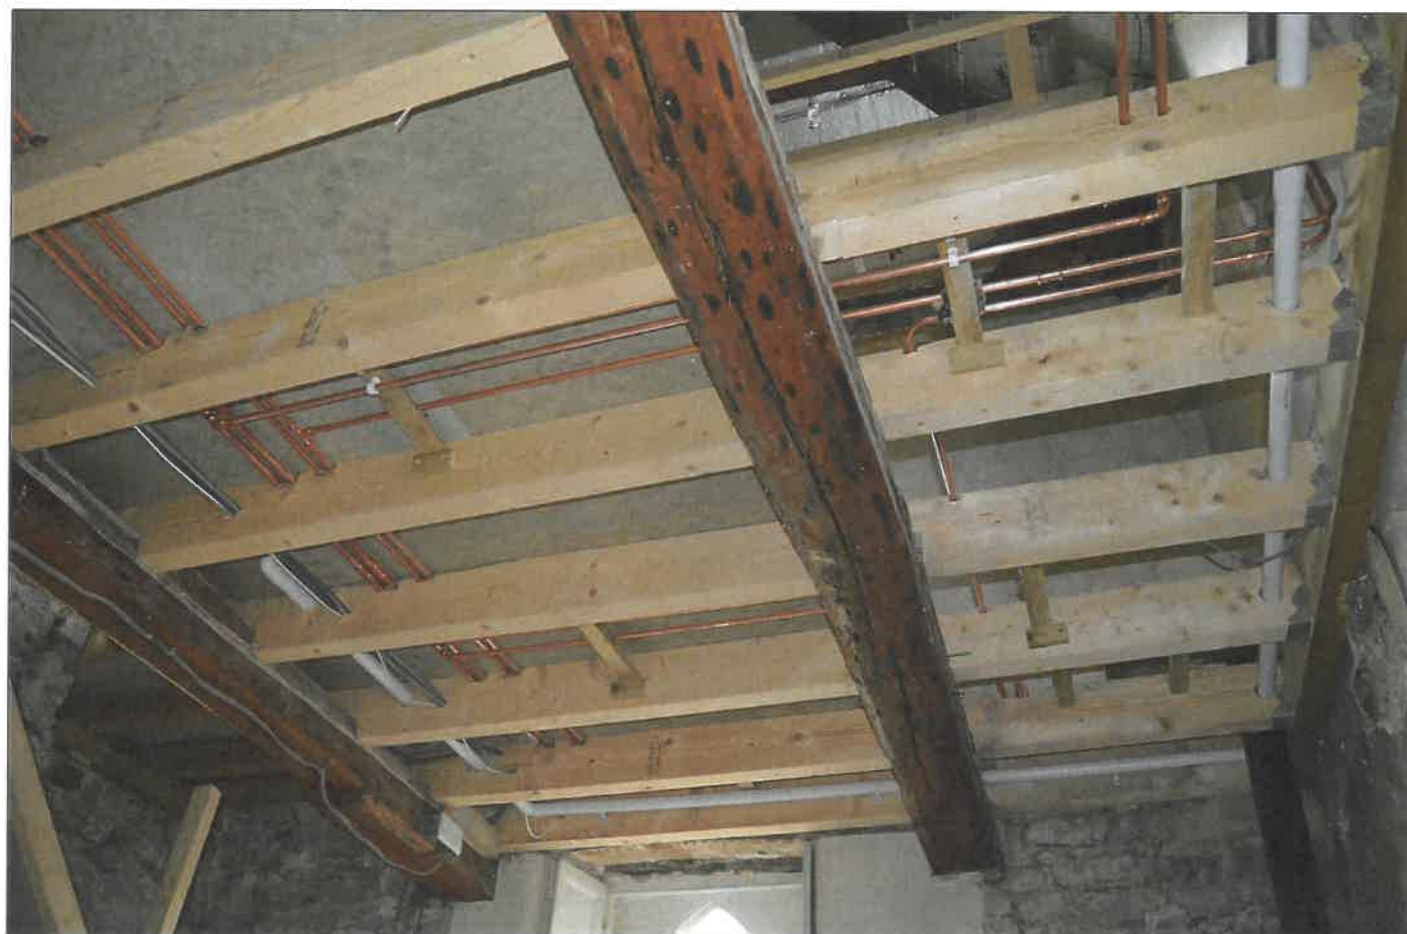
PL27: View of modern floor structure installed over former ground floor kitchen.

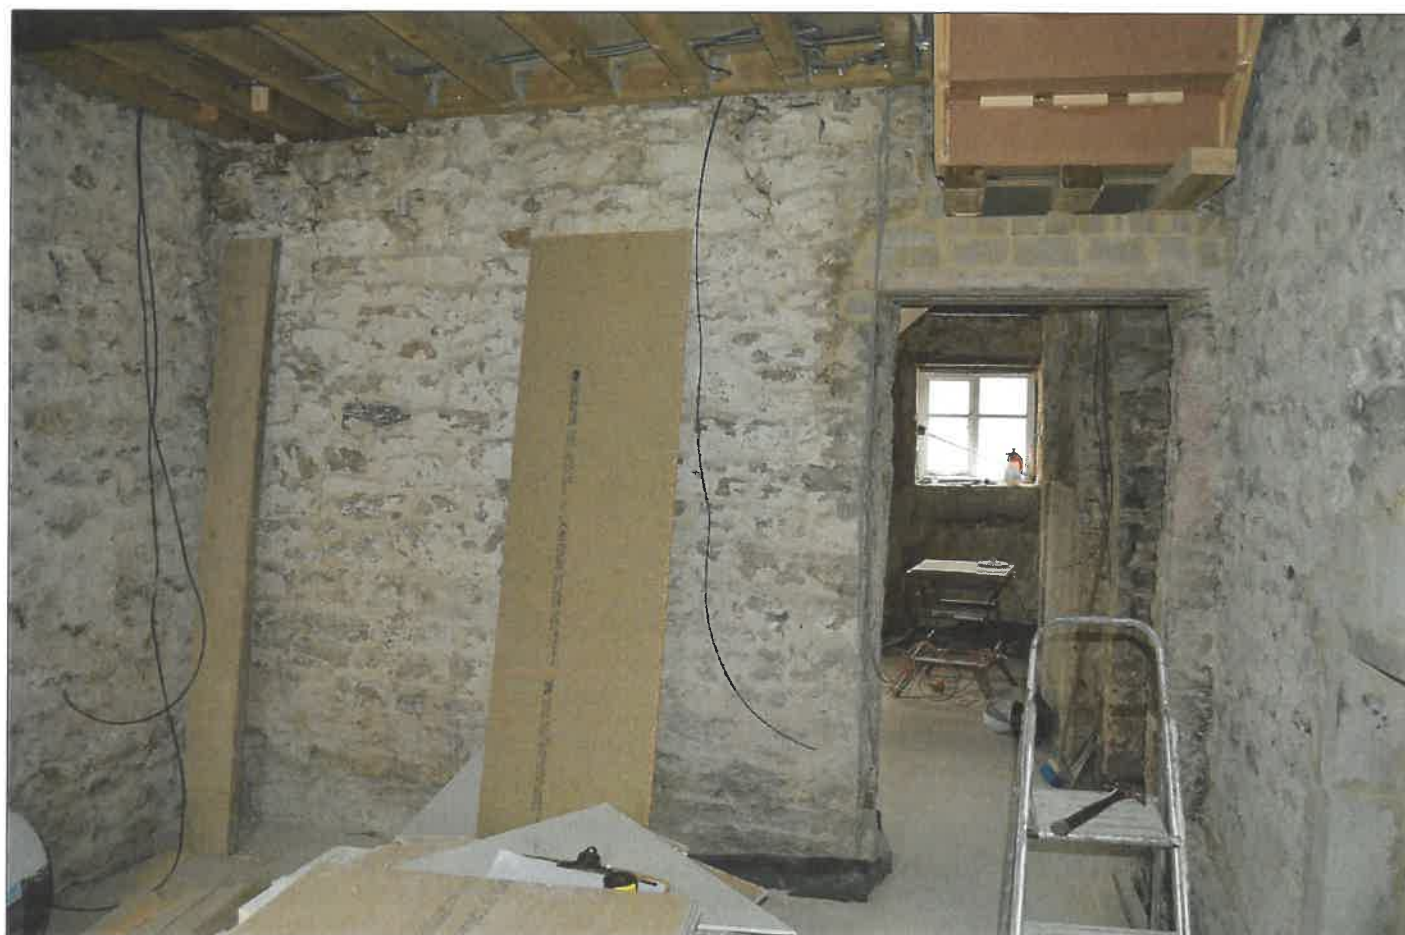
*PL31: View west within the ground floor south east unit. This appears to have once been an external wall.*

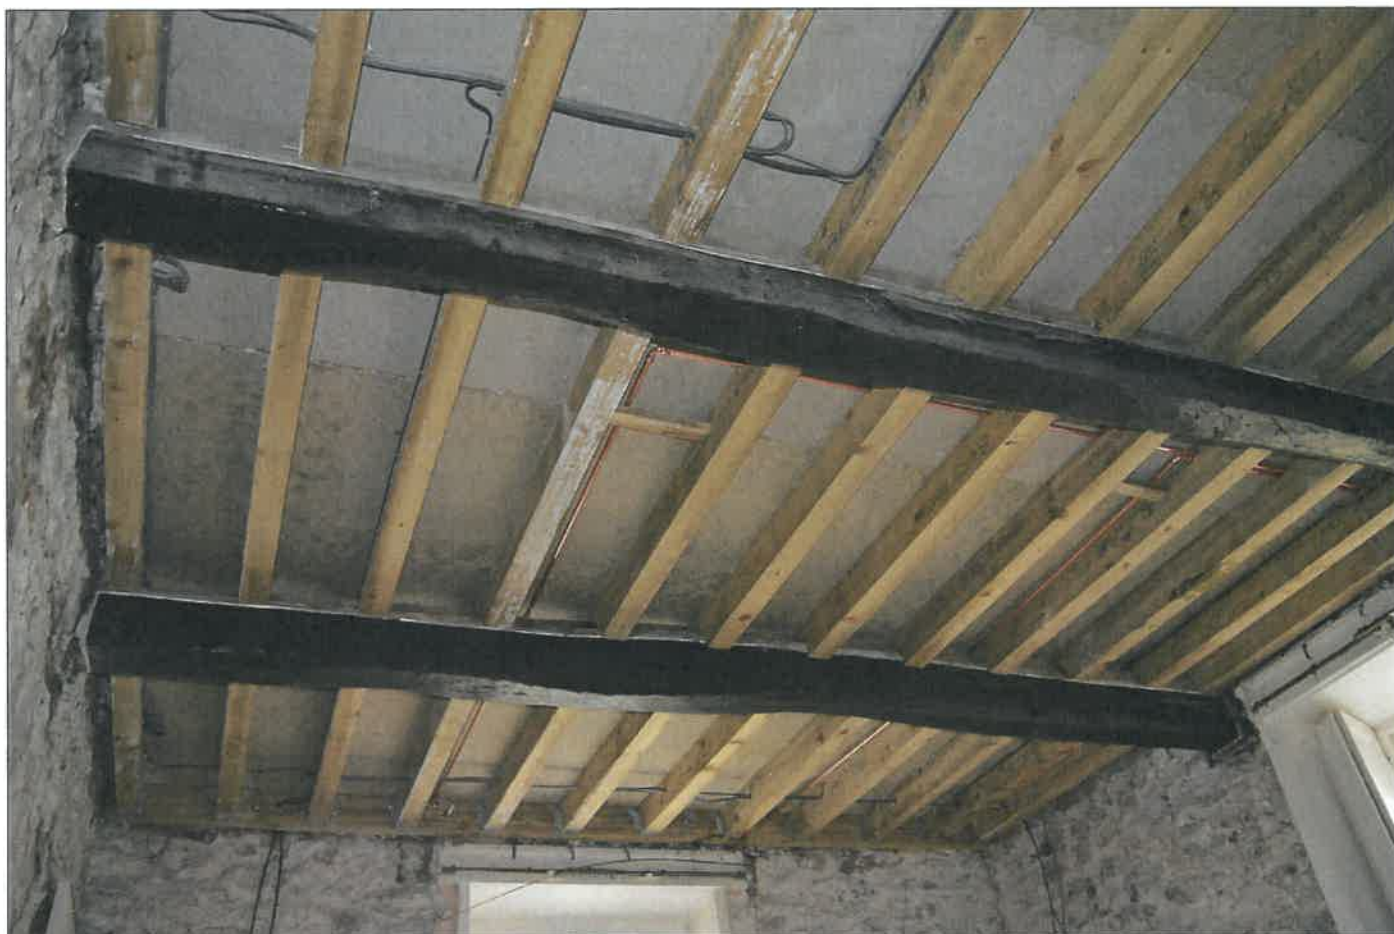
PL32: View of the modern floor structure installed over the ground floor south east unit.

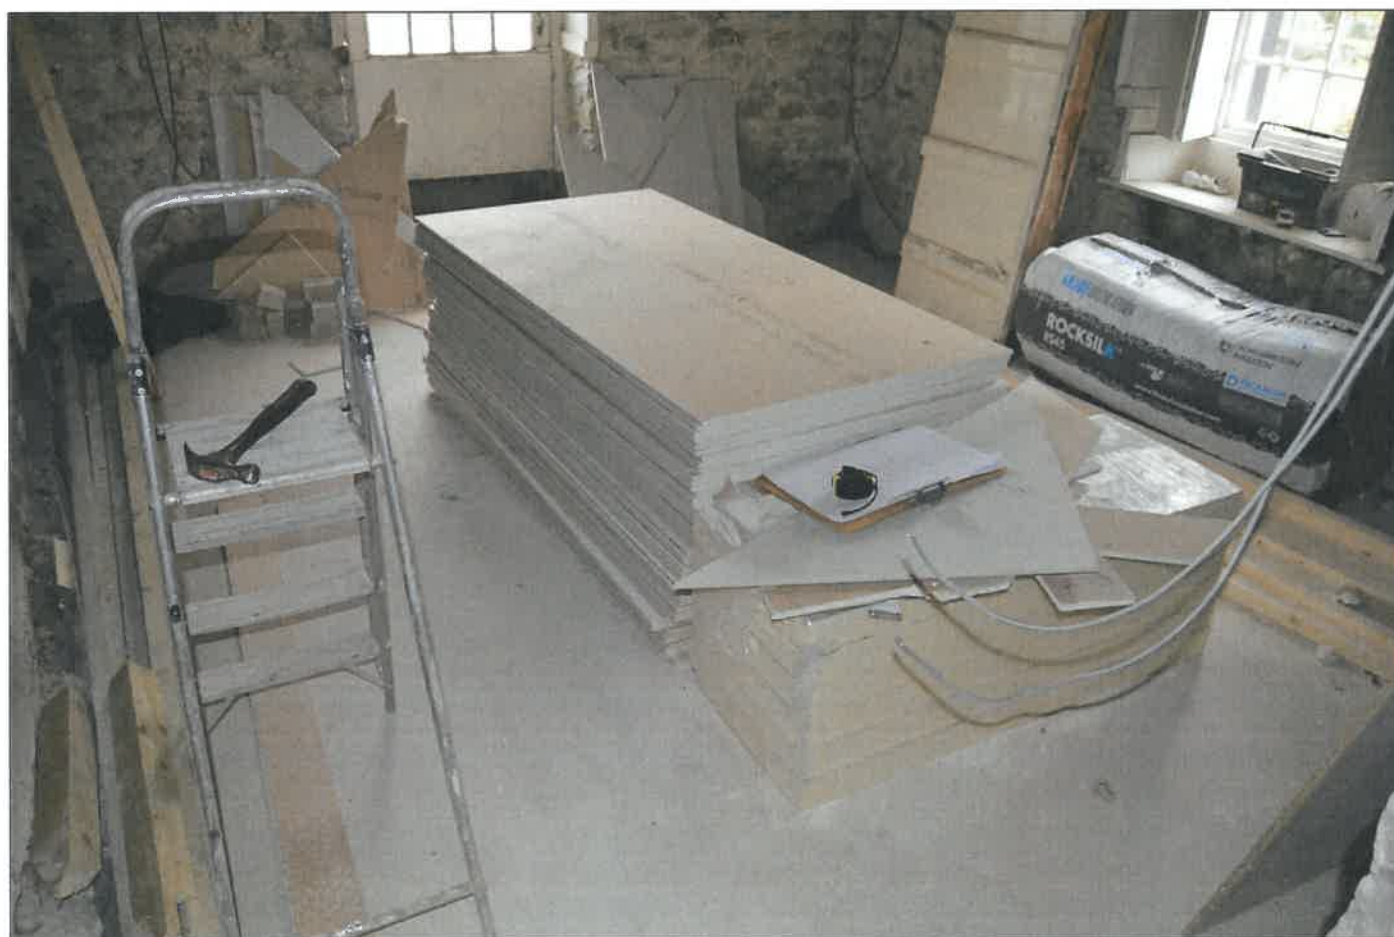
PL33: View of concrete floor to the ground floor south east unit.

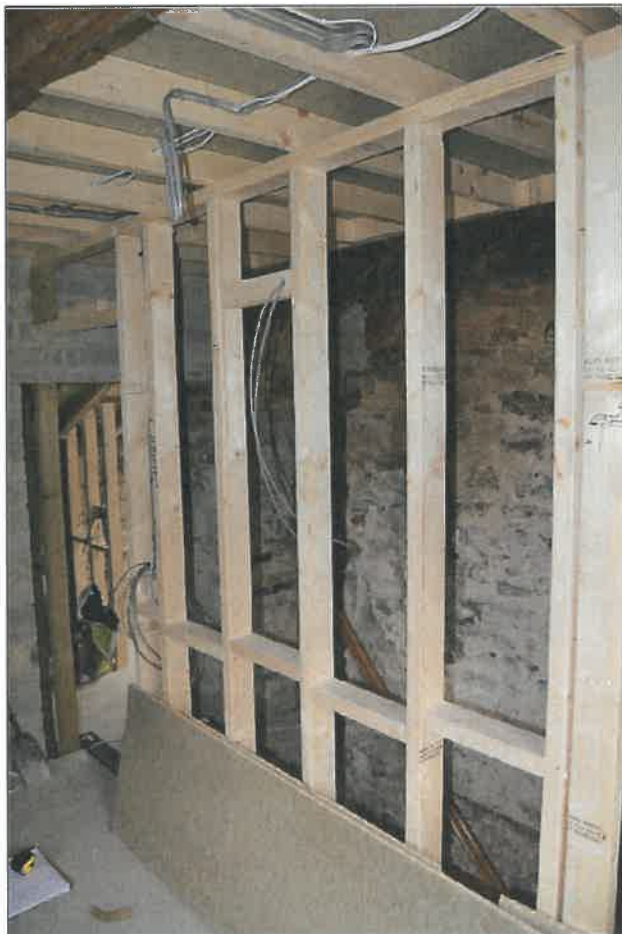
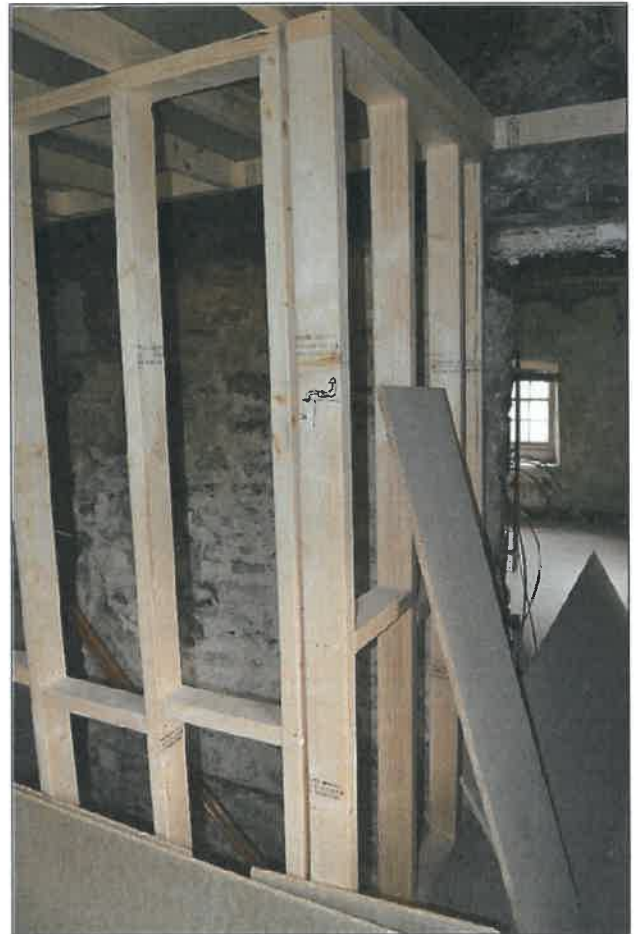
*PL37 (left) View of timber partition to the west side of the first floor south west unit. PL38 (right) View of partition to the rear of the staircase in the first floor south west unit.*

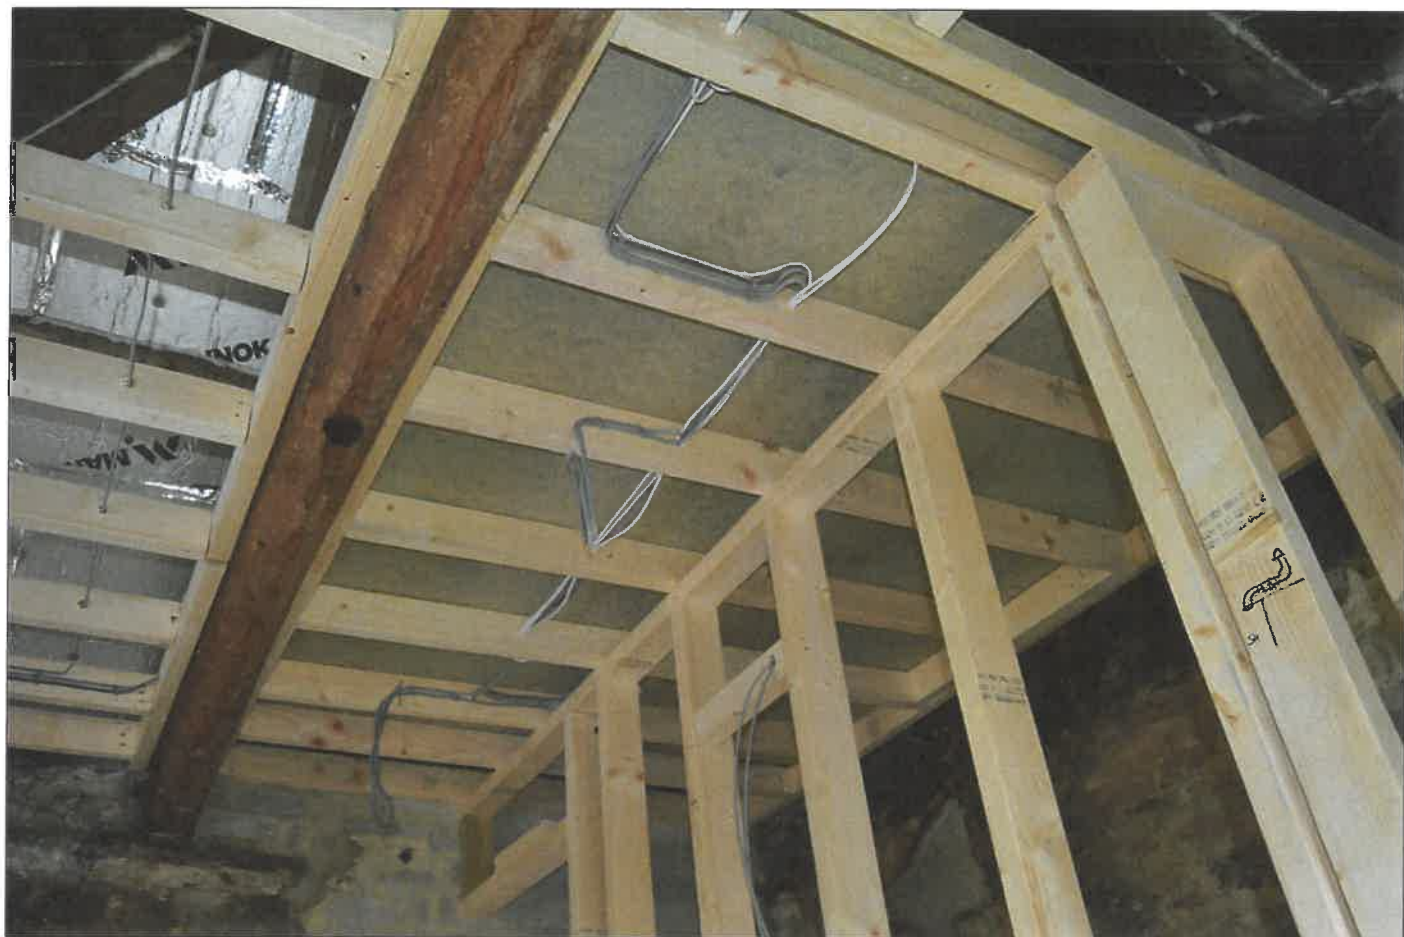
PL39 View of modern ceiling structure over first floor south west unit and staircase.

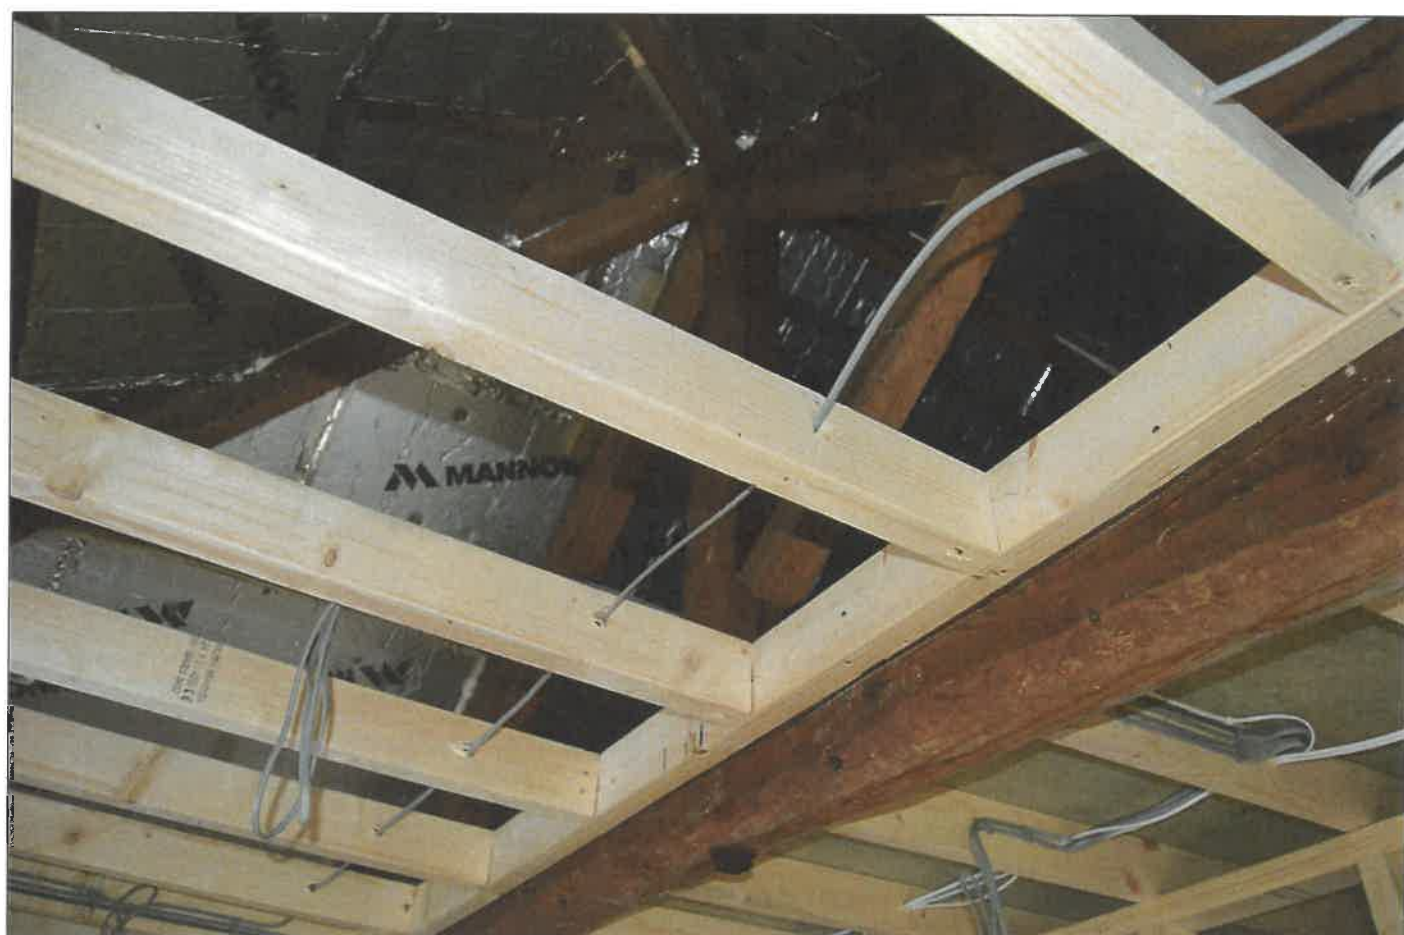
PL40: View of timber king post roof truss over the first floor south west unit.

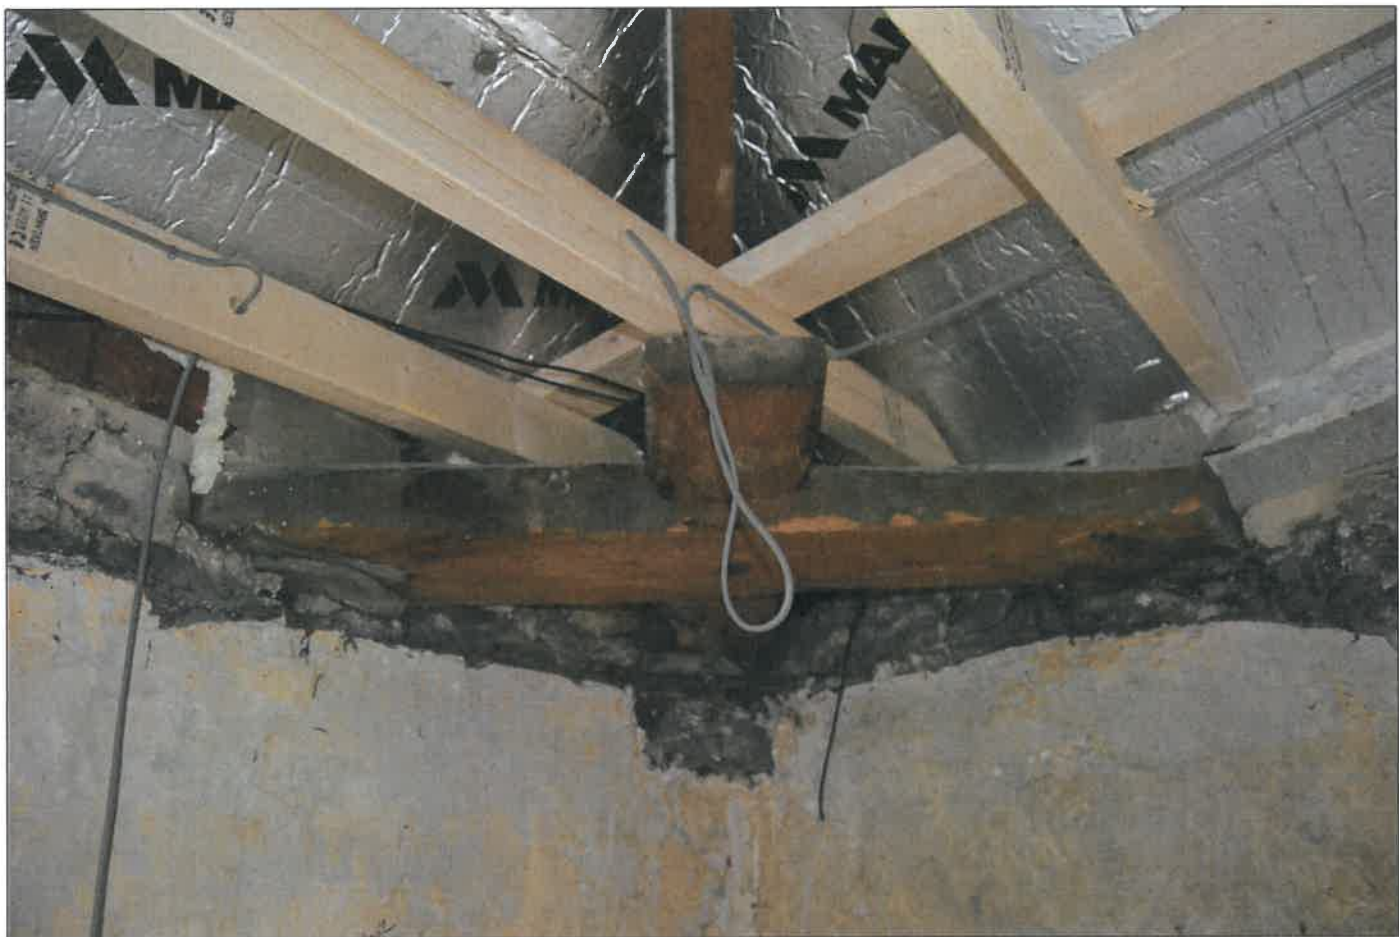
PL41: View of exposed timber dragon tie to the south west corner of the first floor south west unit.
