# HERITAGE STATEMENT

AMELIORATION OF UNAUTHORISED WORKS AND  
PROPOSED INTERNAL AND EXTERNAL ALTERATIONS / WORKS

THE PRIORY

GISBURN

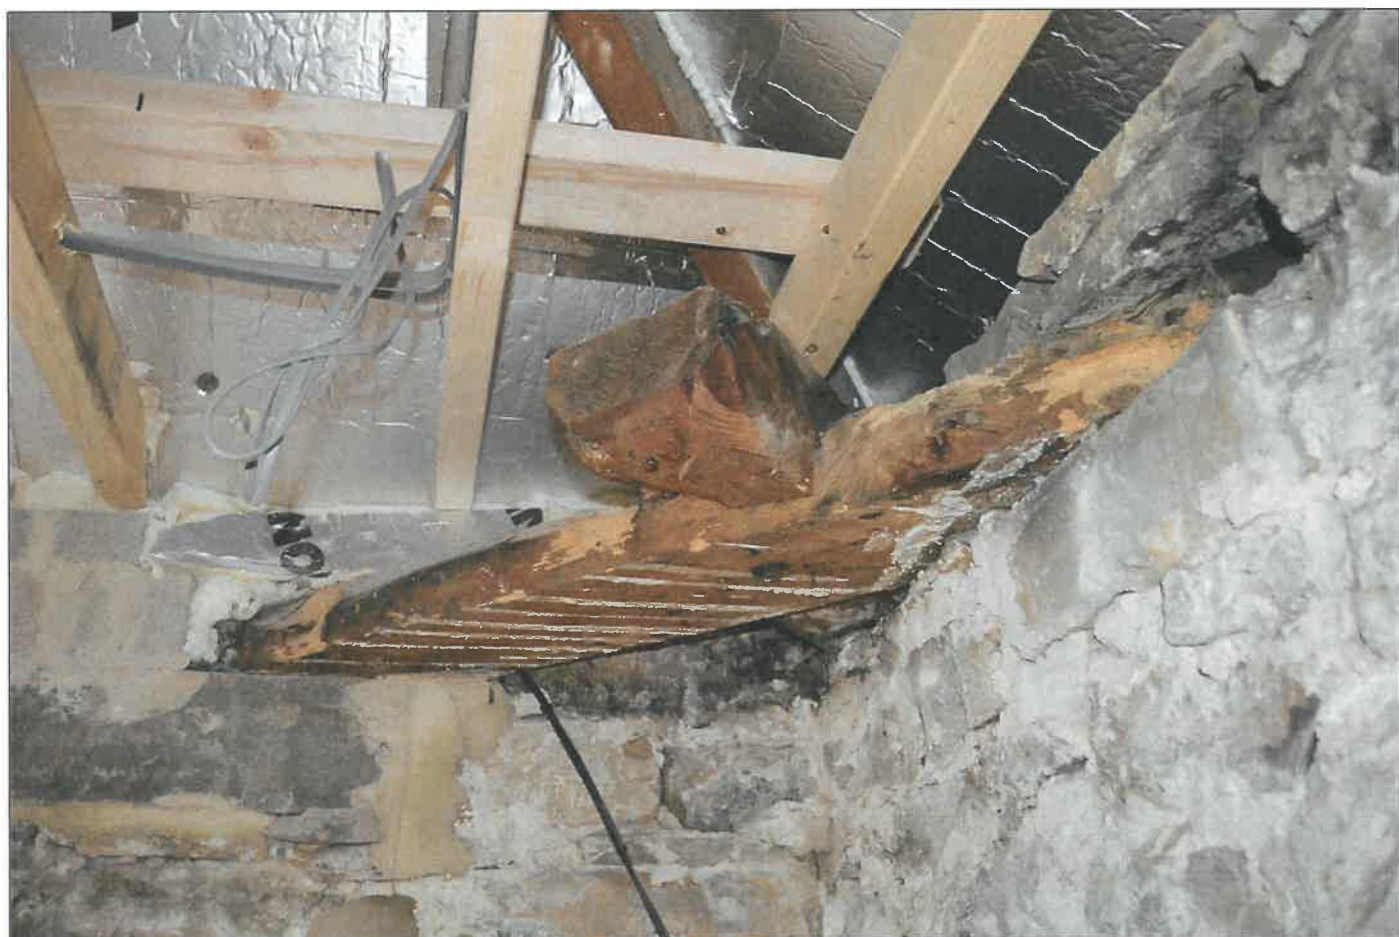
PL42: View of exposed dragon tie to the south east corner of the first floor south west unit.

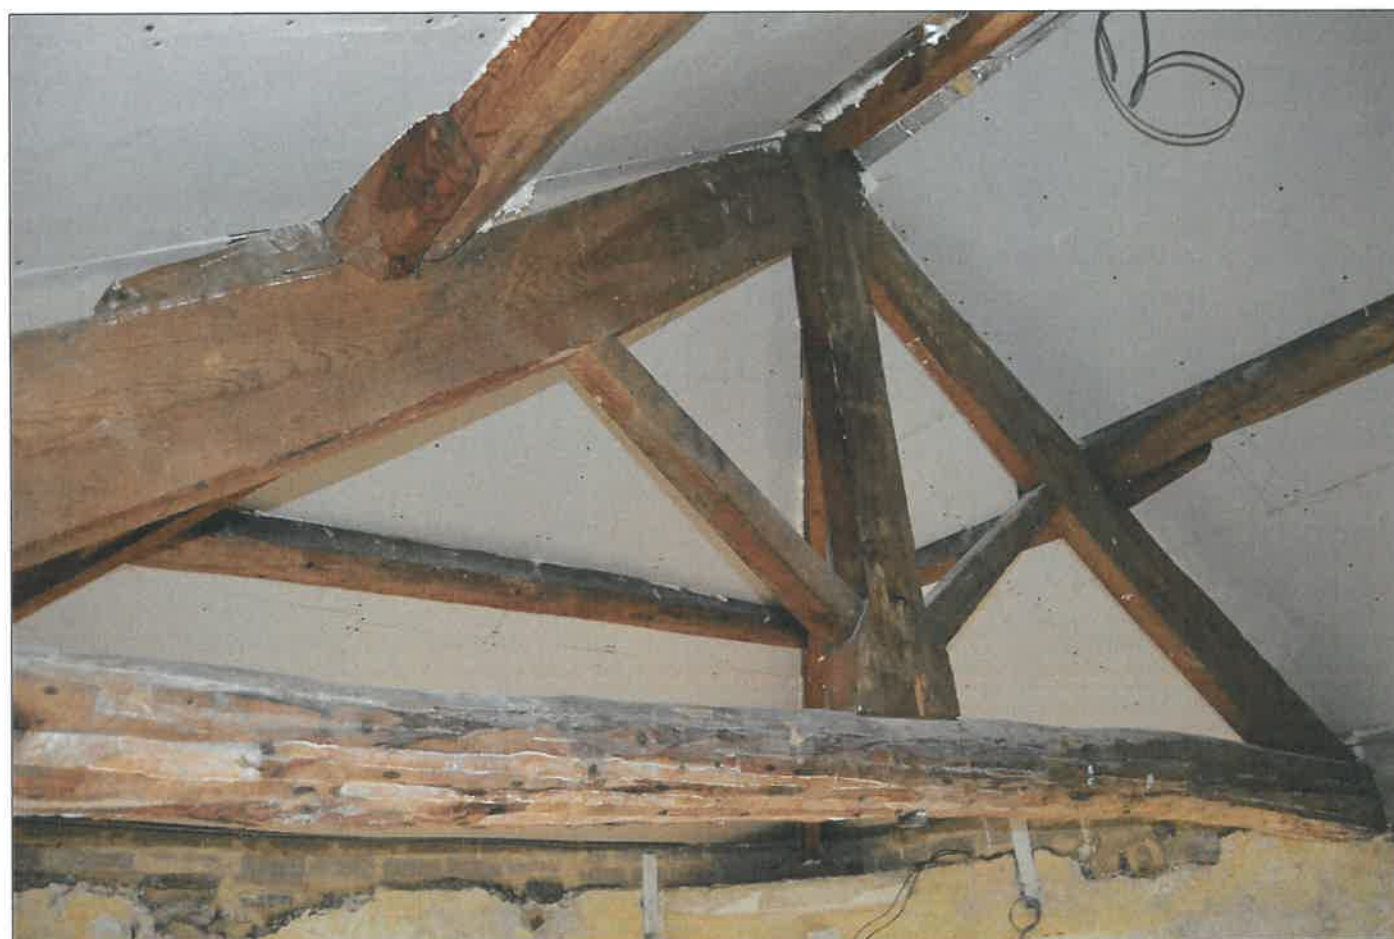
*PL46: View of timber king post roof truss to the first floor south east unit.*

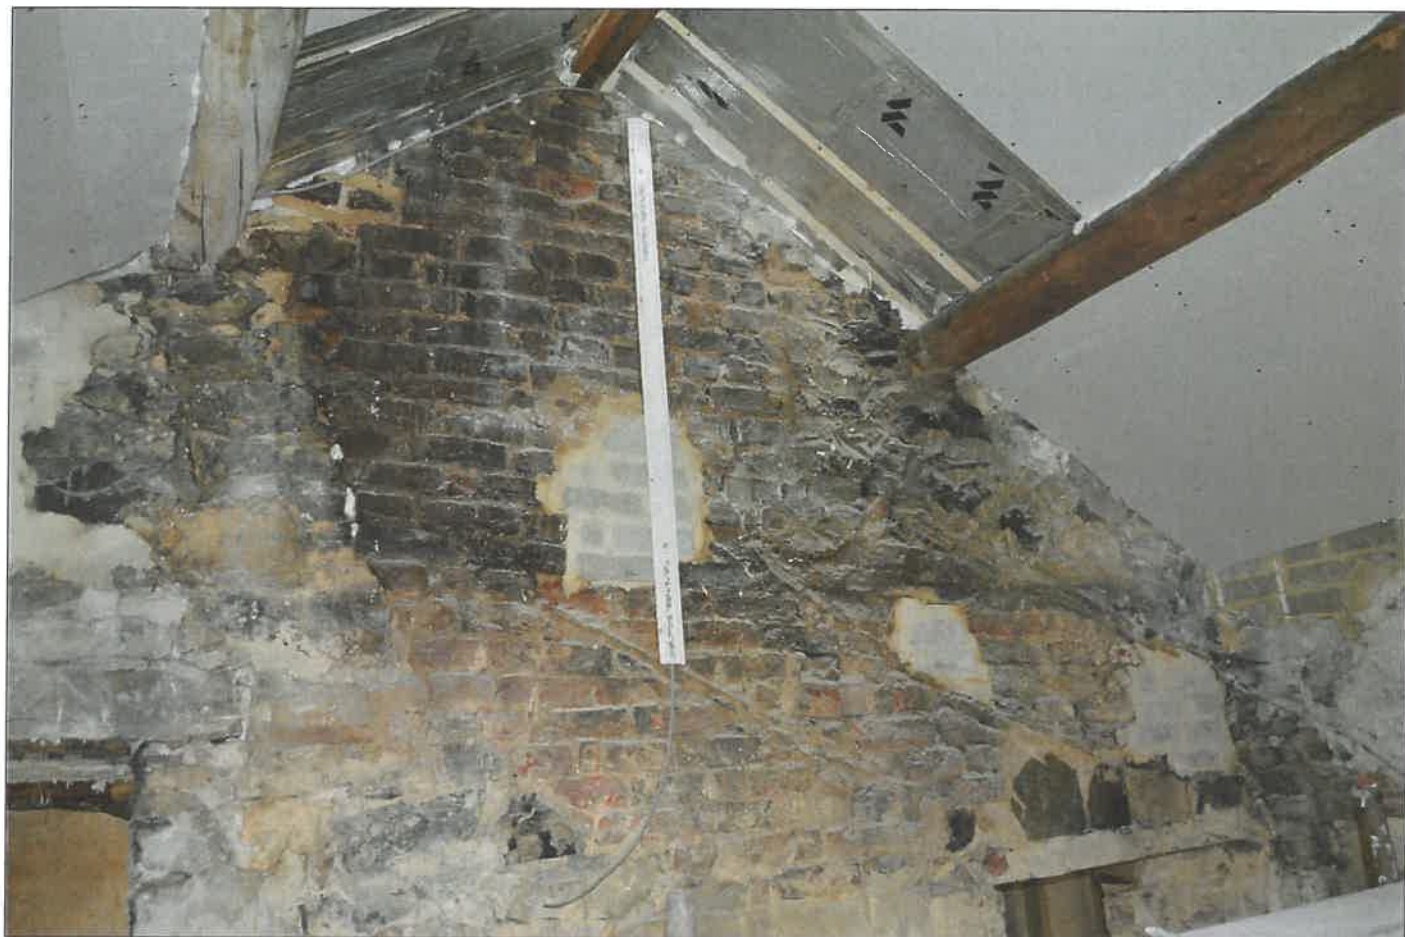
*PL48: View of brickwork flues to the west wall of the first floor south east unit.*

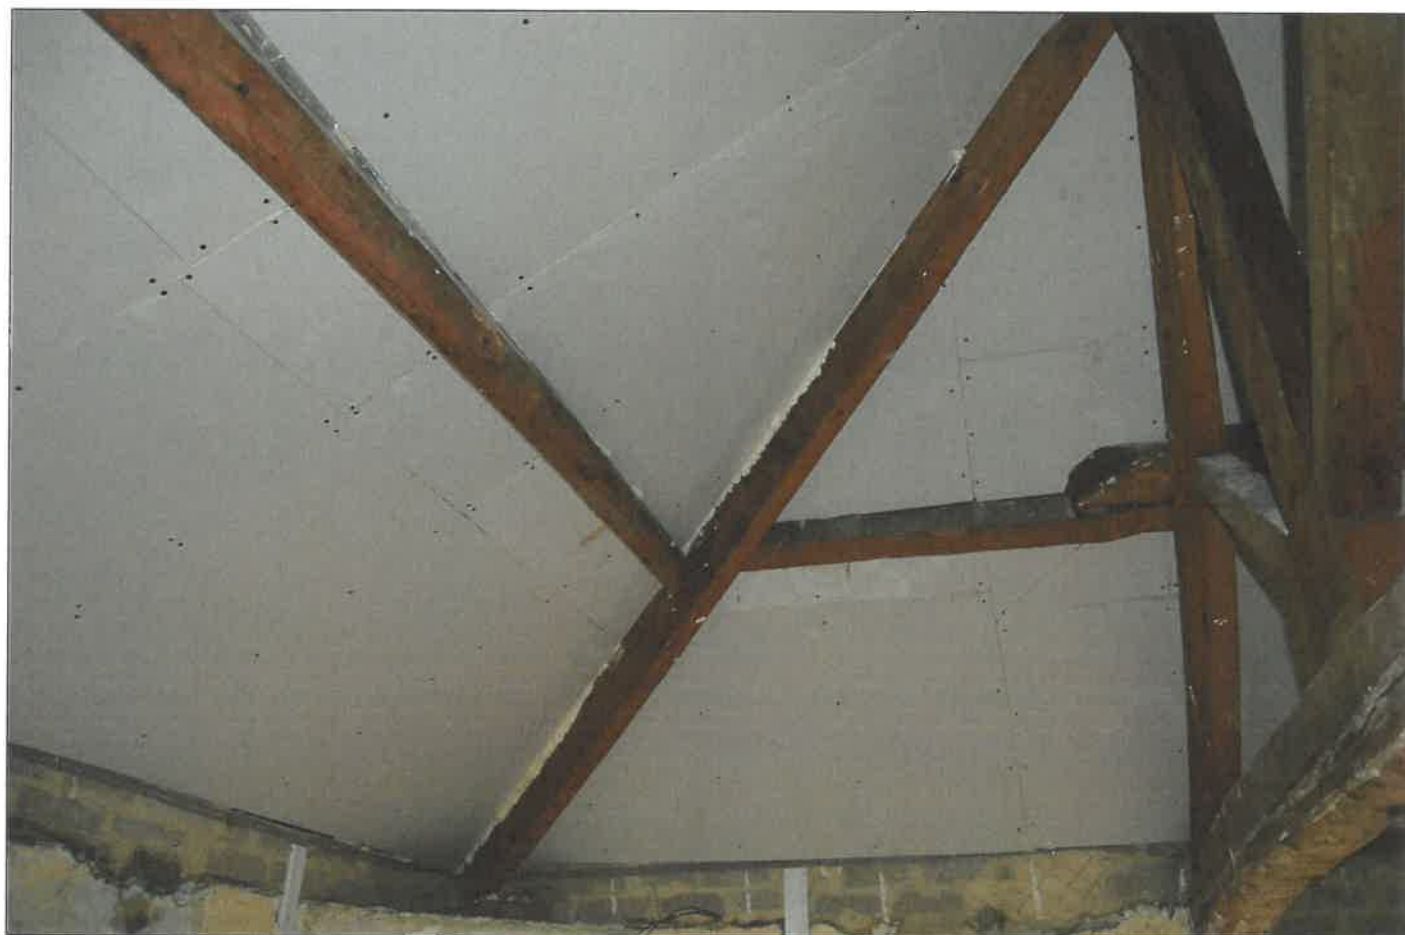
*PL49: View of plasterboard ceiling linings to the first floor south east unit.*

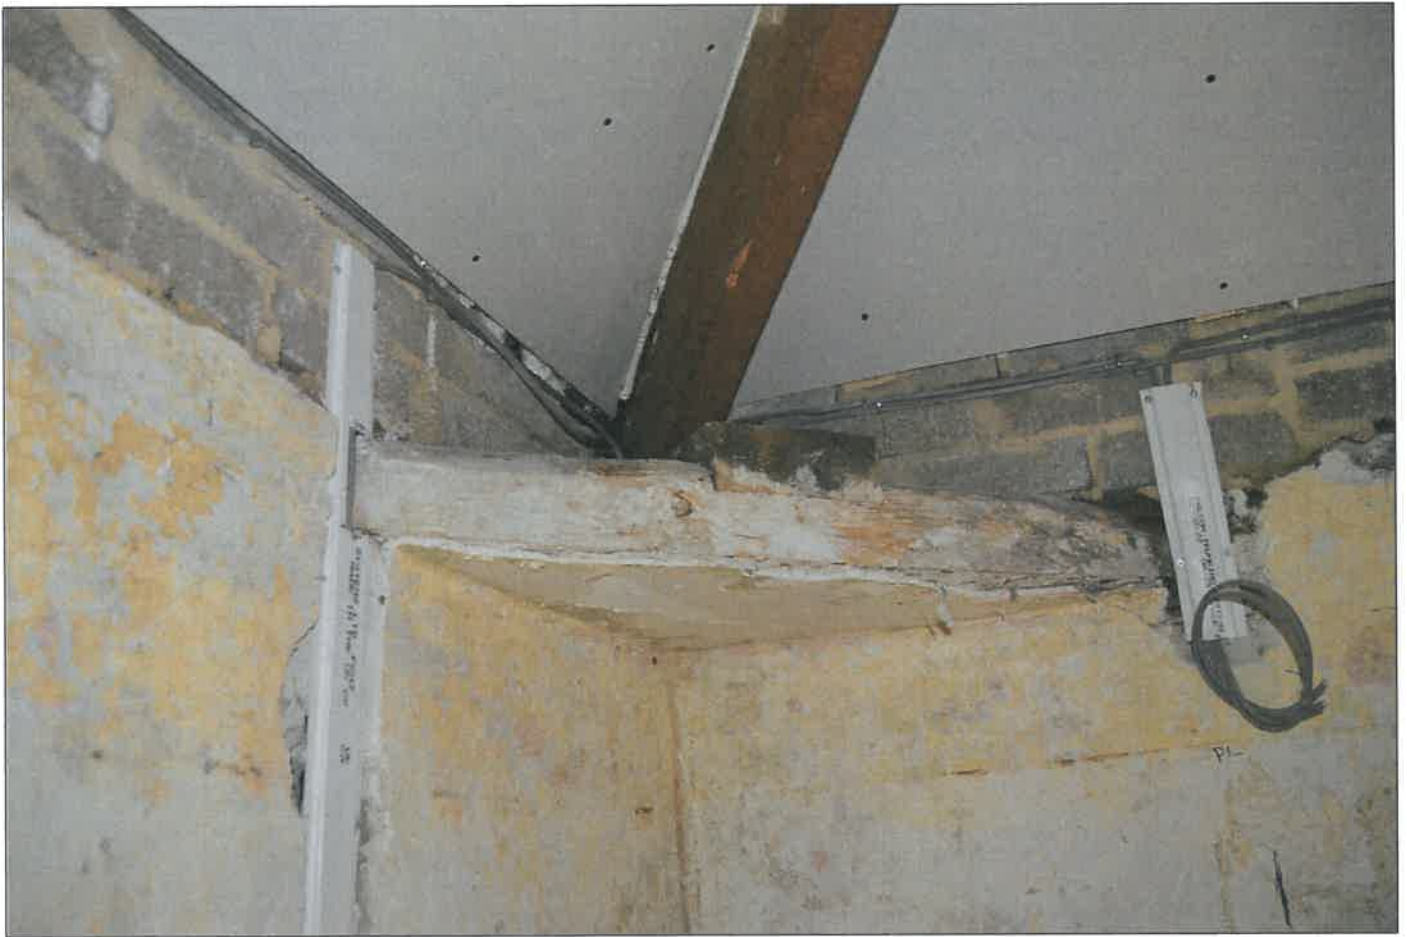
*PL50: View of the dragon tie to the north east corner of the first floor south east unit.*

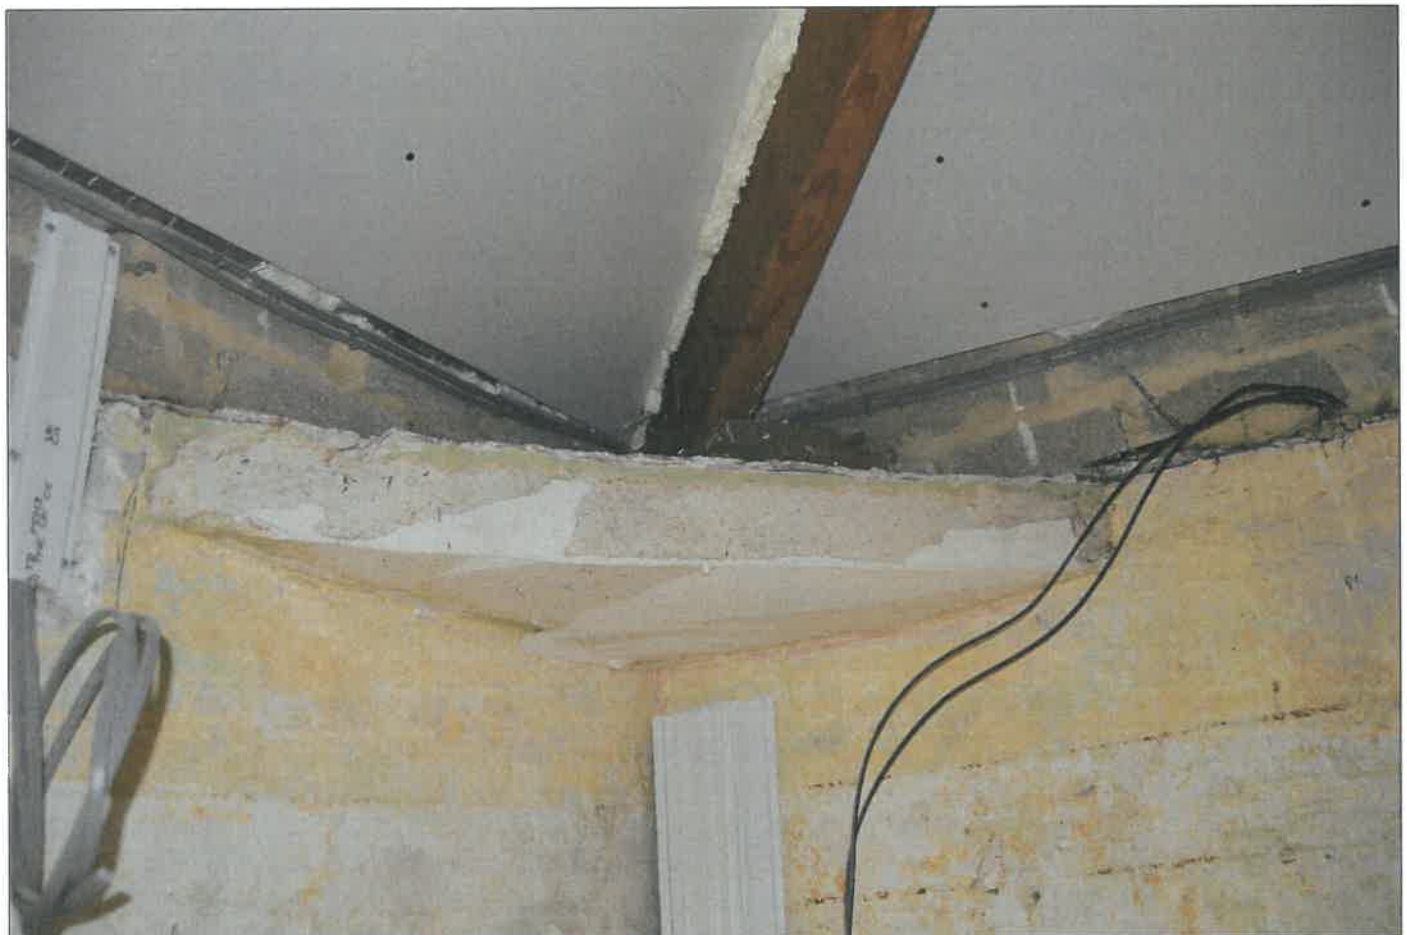
*PL51: View of the dragon ties to the south east corner of the first floor south east unit.*

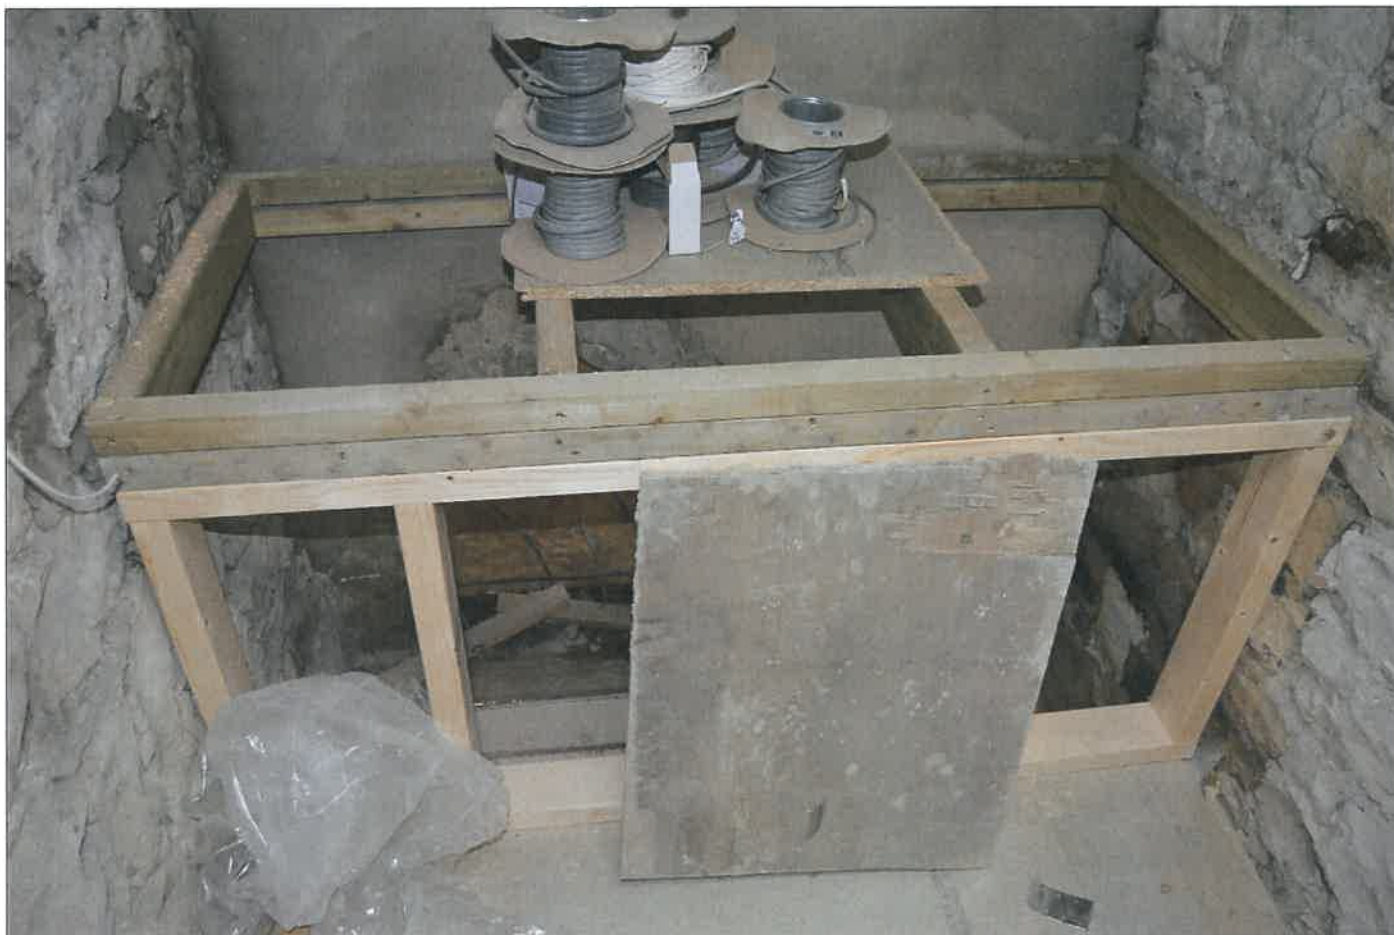
*PL54: View of timber boxing to the former first floor bathroom.*

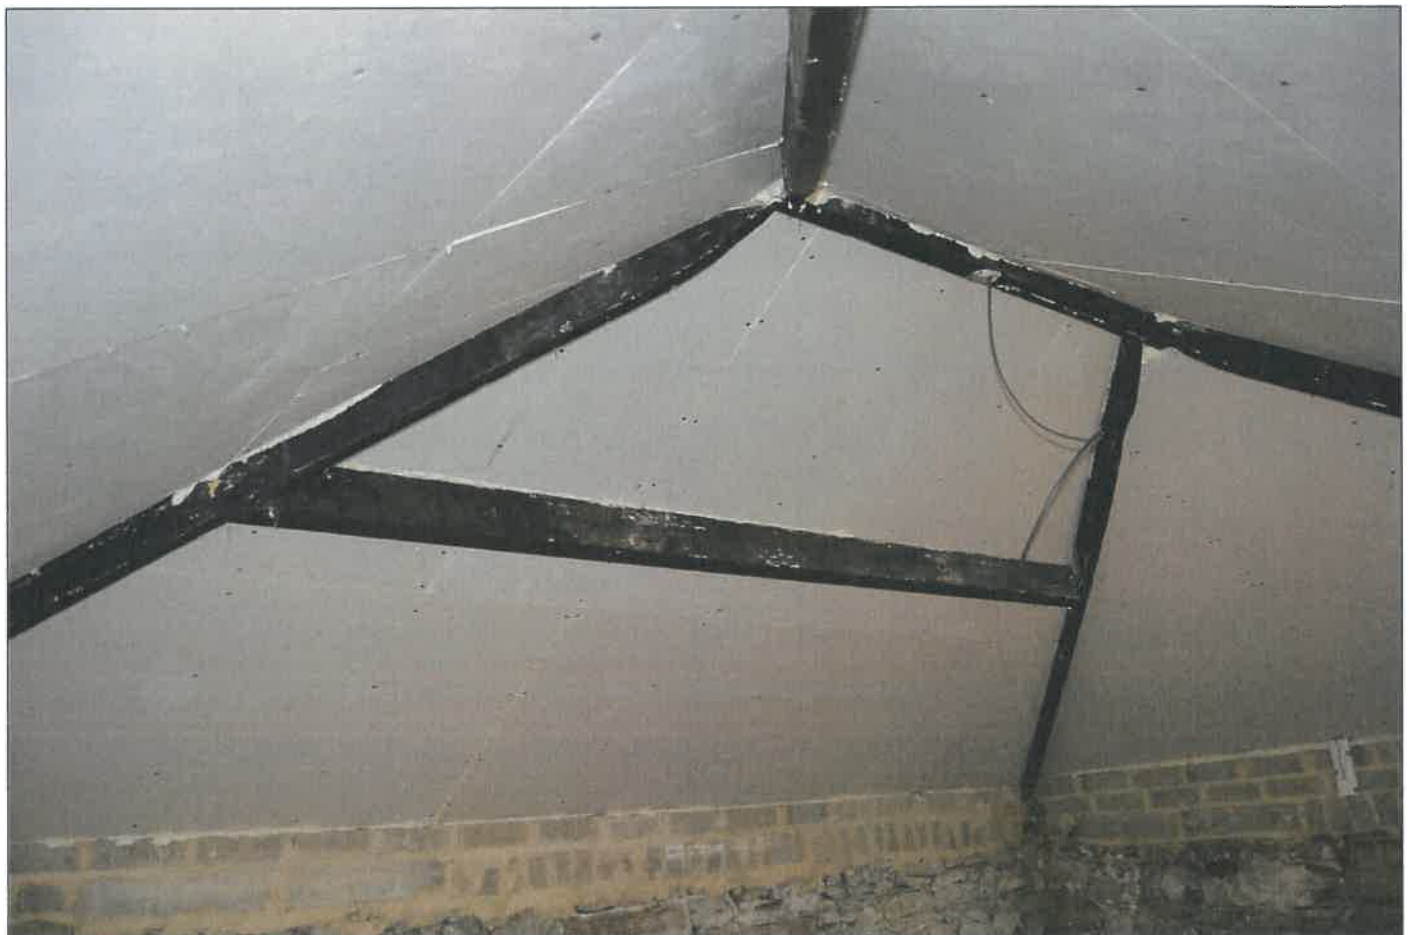
*PL59: View of the plasterboard ceiling lining to the first-floor north unit.*

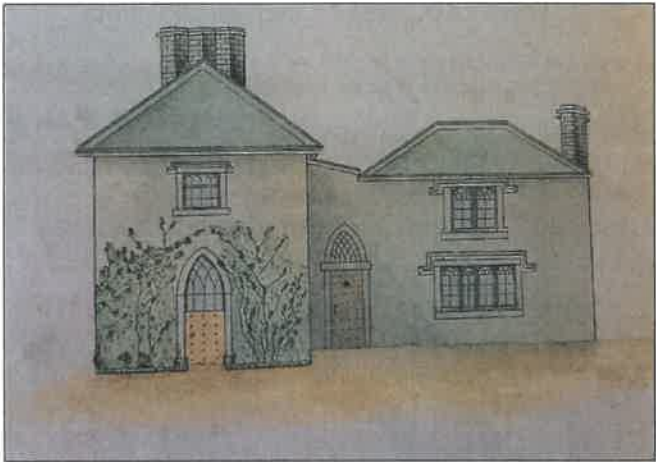
Fig 06: View of the east elevation.

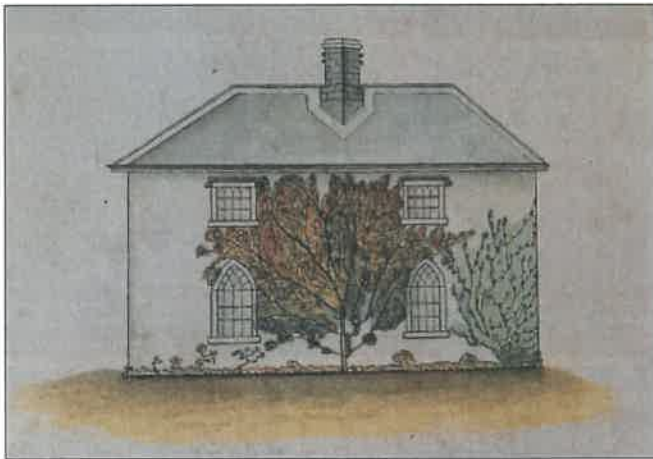
Fig 05: View of the south elevation.
