## **METHODOLOGY STATEMENT**

NW Clitheroe. York St, Clitheroe BB7 2DN

Removal of ATM and Signage from external Facade.

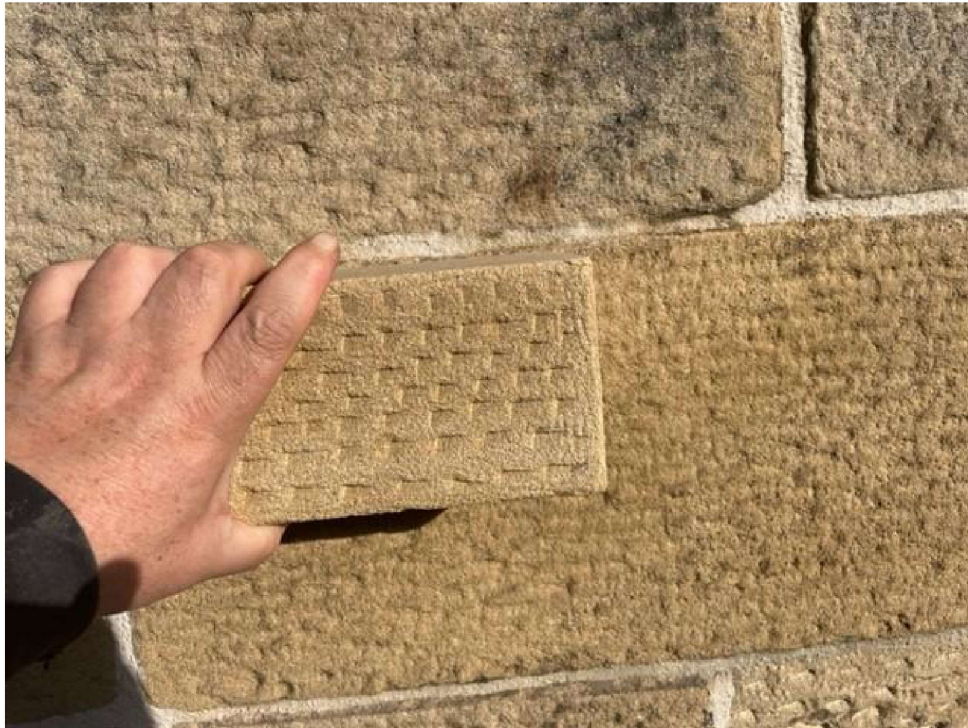
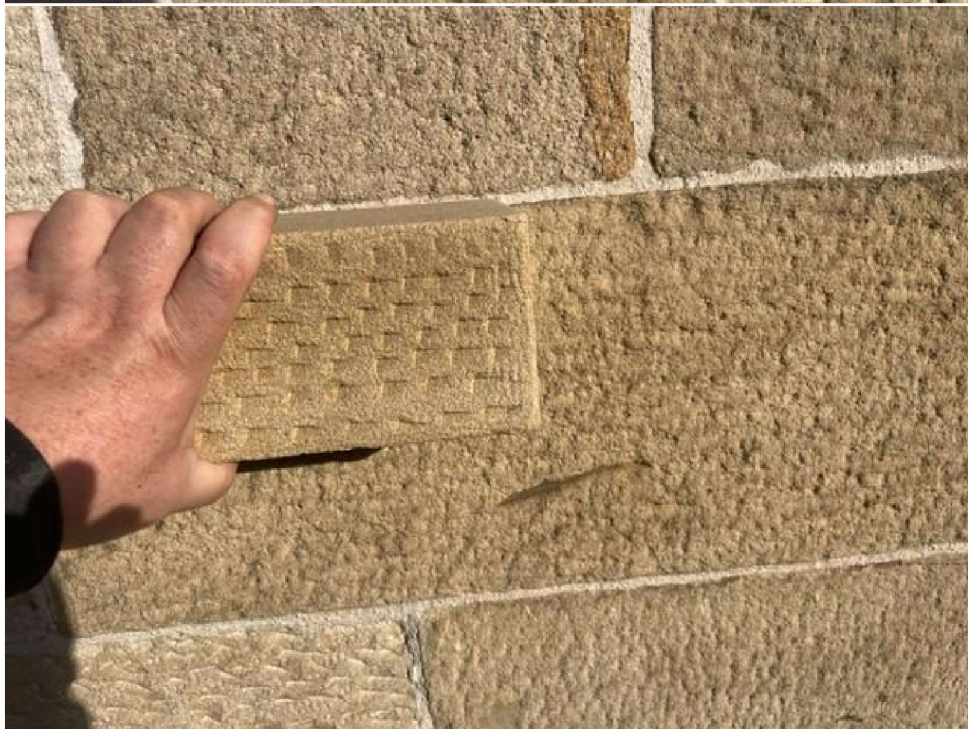
**Stone Sample:**

1.3 Externally, parts of the existing stone surrounding the ATM aperture will be removed and new sections of Matching stone fitted to match the existing finish. Mortar to use for bedding new stonework with a joint to match existing.

1.4 Stonework to be used is (See photos)
