Heritage Statement
to support planning and listed building consent applications
at Bridge End, Slaidburn

April 2023

STEPHEN HAIGH
Buildings Archaeologist

to support planning and listed building consent applications

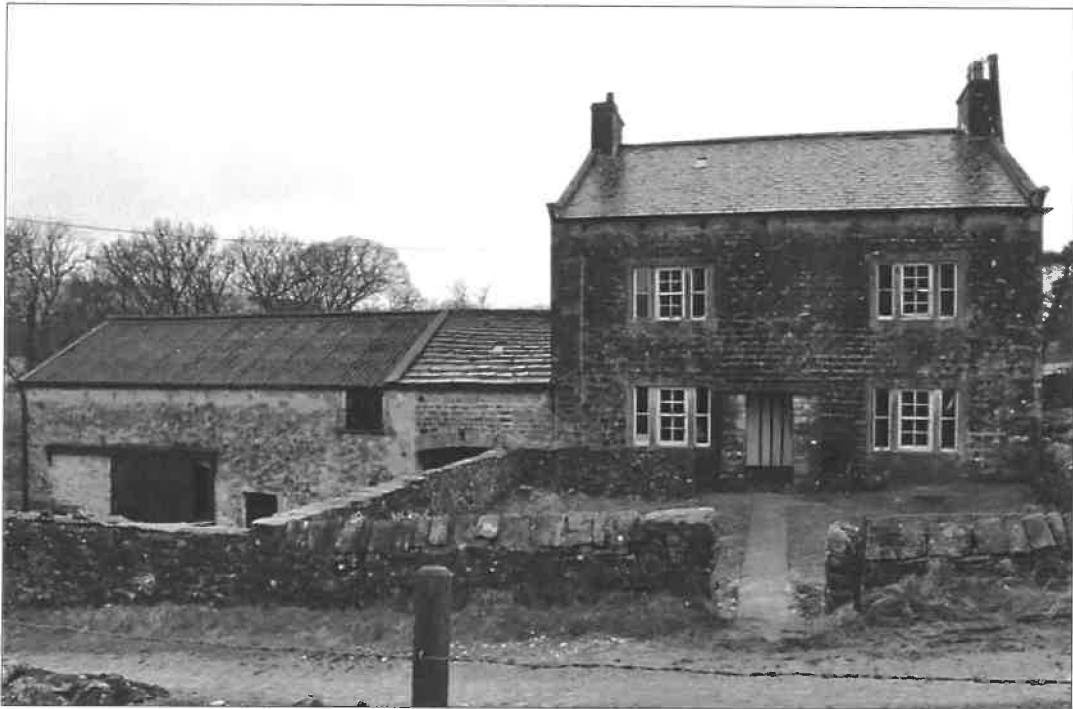
Photo 1: Front of farmhouse and adjoining buildings

- 6.1 The farmhouse stands on a natural terrace above the barn, and faces south. It is of two storeys with attic, and cellar beneath part of the rear. The front is of coursed, watershot limestone with sandstone dressings, and has blue slate to the roof (replacing the original stone slate, which survives to the rear). It has a symmetrical design, with an approximately central entrance containing the original door, flanked by windows to ground and first floor: all these openings are original. The windows have vertical sashes to the central portion, with fixed lights to the sides, but the frames are not original.

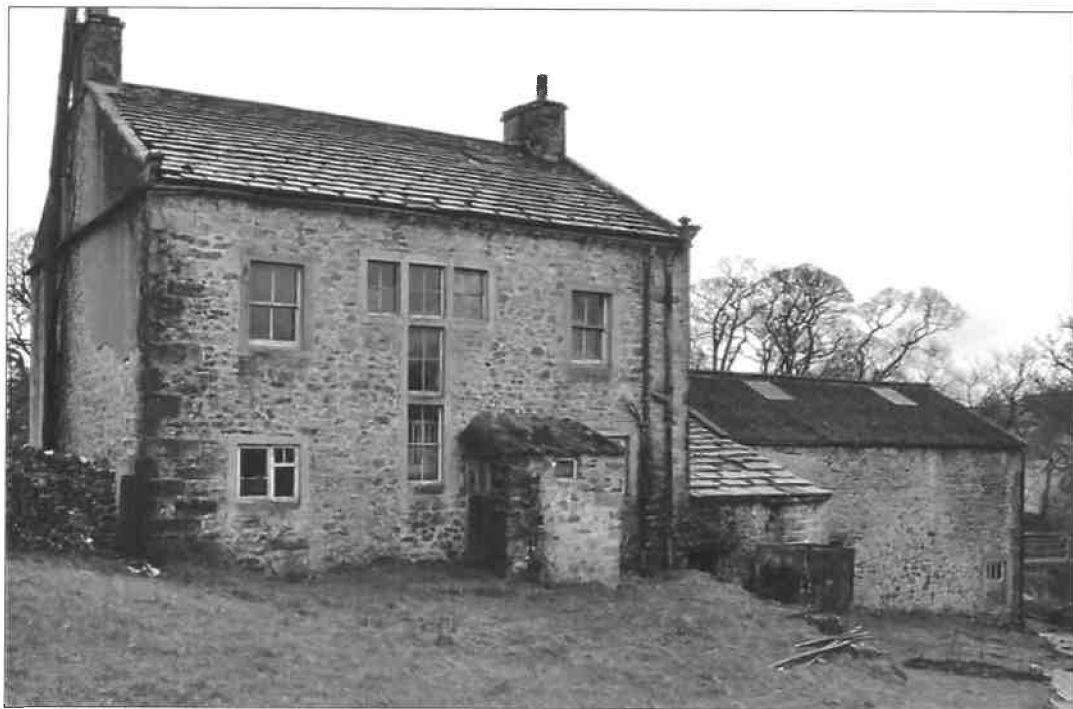
Photo 2: Rear of farmhouse

- 6.3 There is a large, T-shaped window to the rear, lighting the stairs and first floor rooms. As an opening it is unaltered, although its glazing is not original. The two first floor rear windows have been altered or inserted (late nineteenth or early twentieth century).

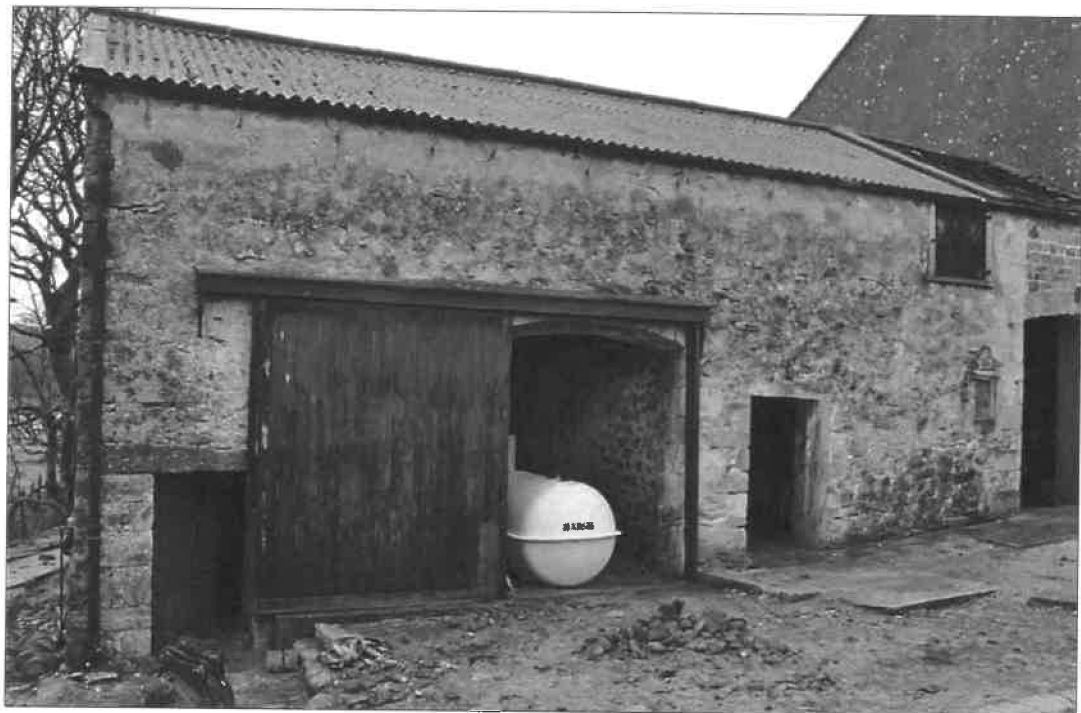
Photo 4: Front of barn

- 7.3 The barn is built from random rubble throughout, except for dressings around openings, including an arch over the central doorway (concealed by a modern sliding door). Its entire roof covering has been replaced with asbestos-cement sheets.

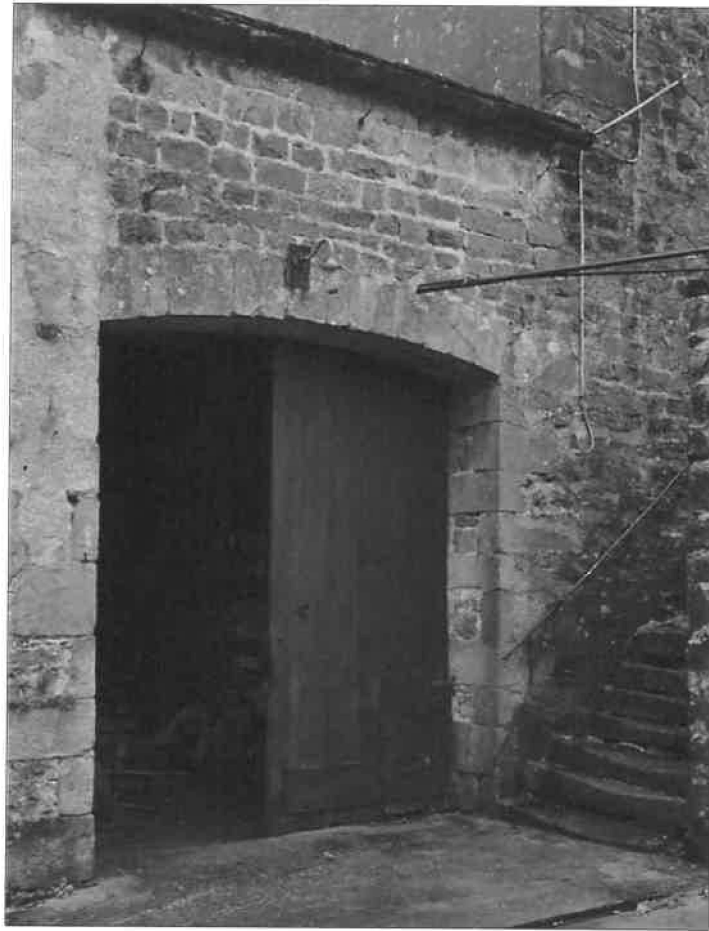
Photo 5: Trap house

trap house is in line with the farmhouse but projects beyond the barn, and is of random rubble. Inside it has a cobbled floor, and appears not to have contained any partitions. It retains stone slate to both pitches of the roof.

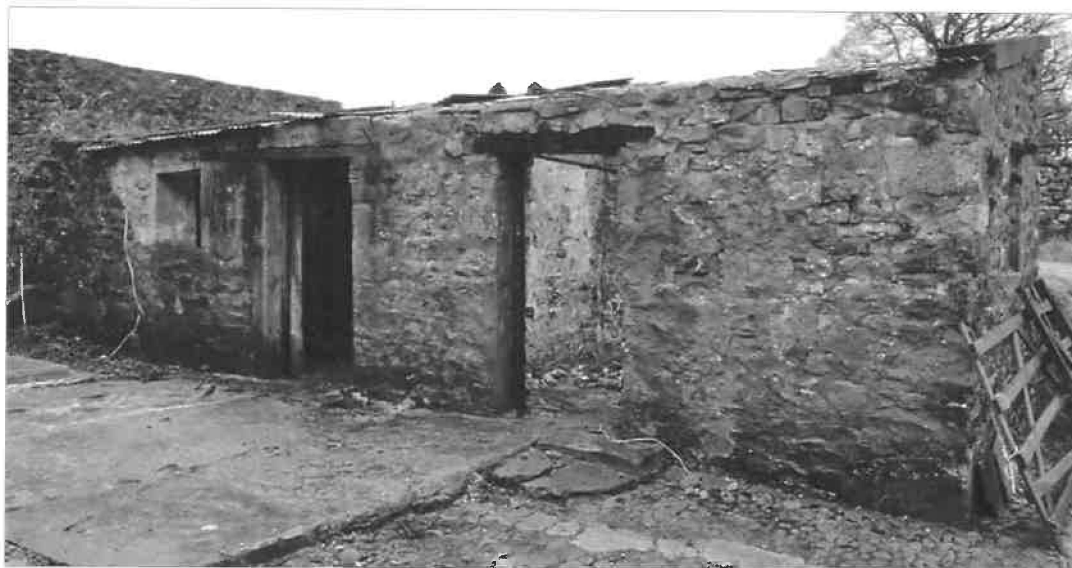
Photo 6: Outbuildings on south side of yard

- 8.1 The barn has a forecourt or yard of cobbles, overlain or replaced to a large degree by patches of concrete, and with stone steps up to the farmhouse garden. There are two adjoining outbuildings at the south side of the yard, built against the retaining wall on the east side. They are of random rubble, with corrugated iron roof of a single, shallow pitch, and of little interest as they lack distinguishing features. Although the historic maps show some structures in this area, it appears that they have undergone at least partial rebuilding.

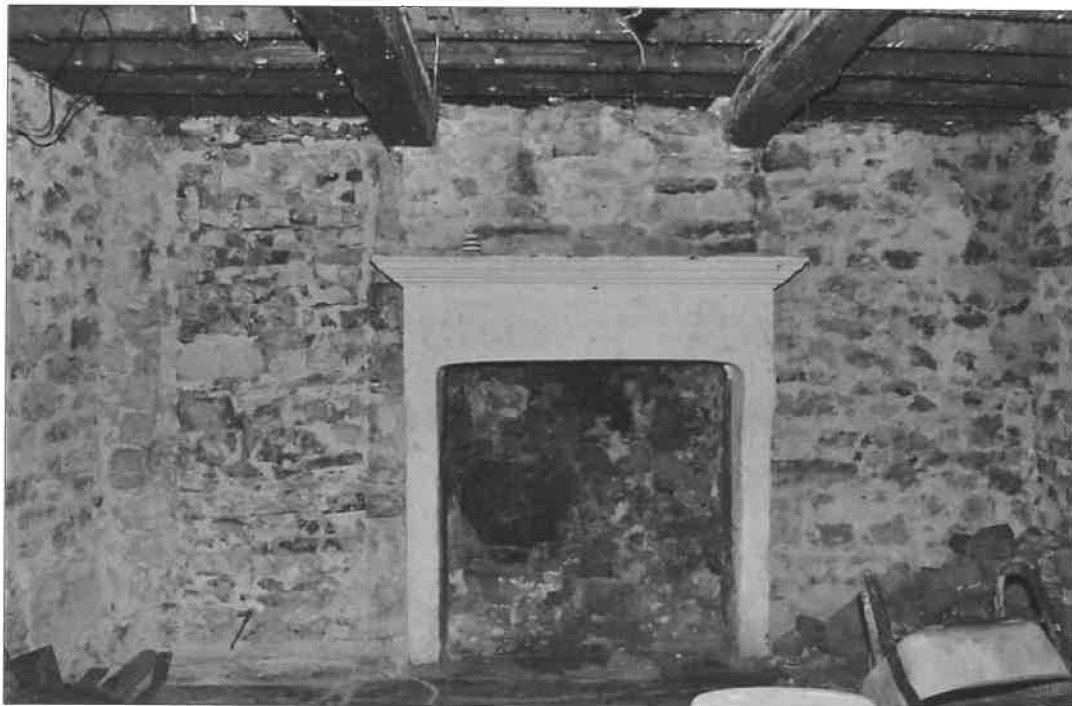
Photo 8: Living room fireplace

- 6.4 The floor plan of the farmhouse appears unaltered, and all divisions are substantial masonry walls. The front doorway leads directly into the living room, which has its original, large, stone fireplace surround in the gable wall. A doorway to the east leads into the parlour, its rather smaller fireplace opening damaged historically. A second doorway from the living room leads to the rear hall at the foot of the stairs, with kitchen off to the north-west, its large kitchen fireplace bricked up. The north-east room is a pantry, with slate shelf. All rooms have or did have lath and plaster ceilings, beneath either pine or oak beams, and pine joists and boards.

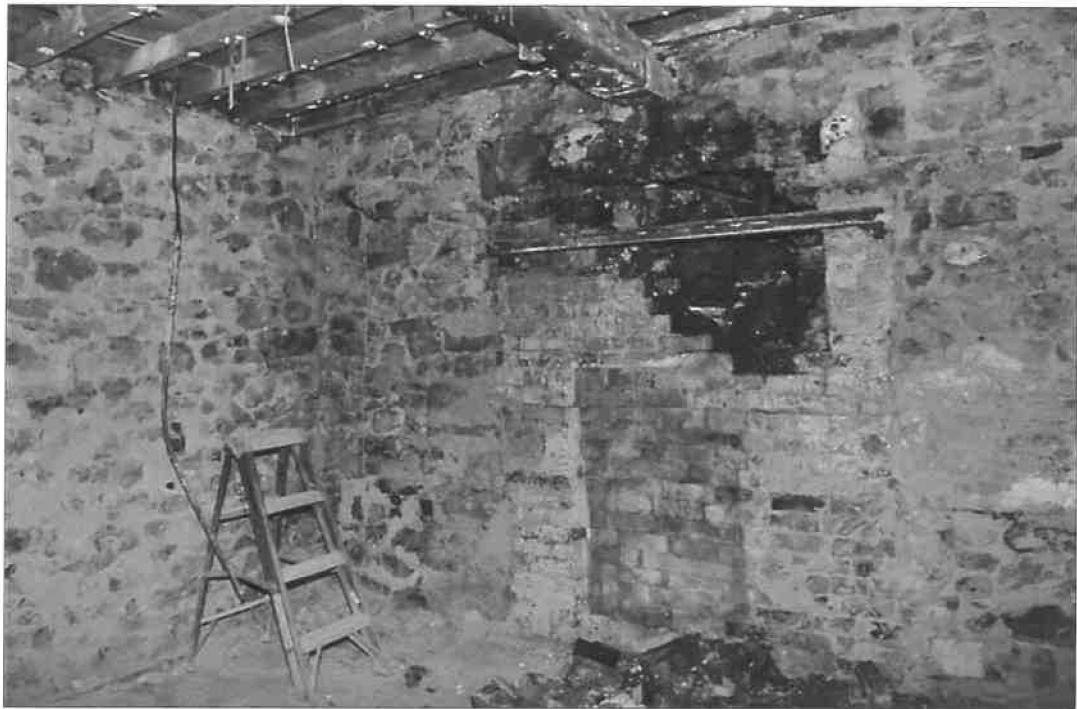
Photo 11: Kitchen (fireplace infilled historically)

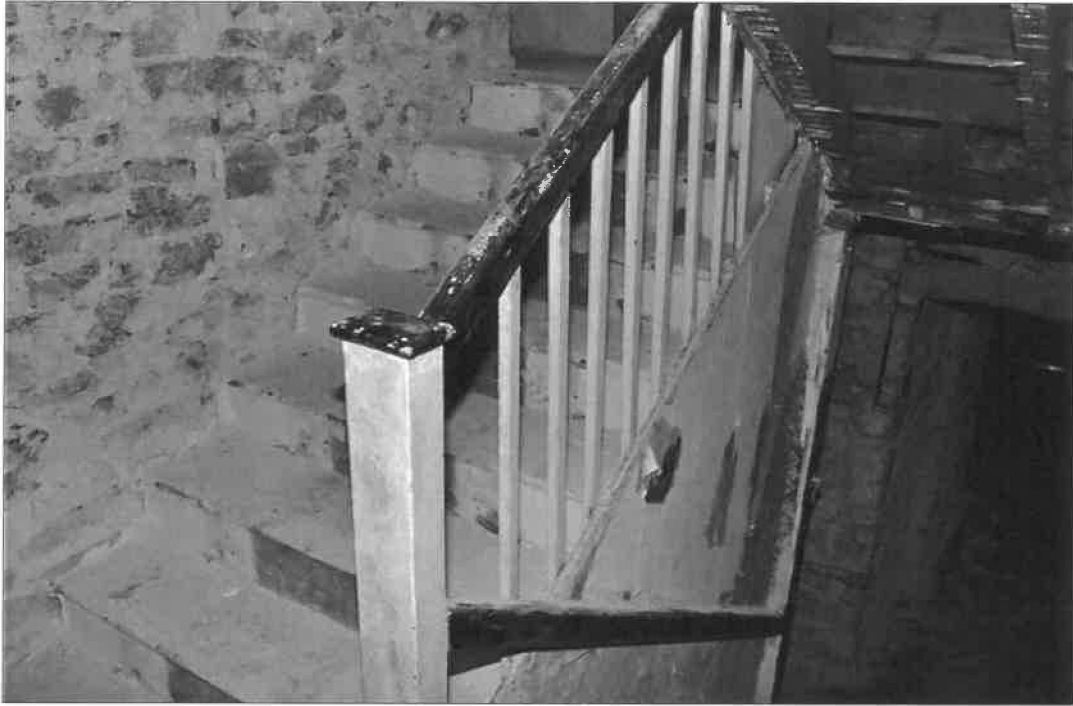
Photo 13: Staircase balustrade

- 6.5 Stone stairs lead down to the cellar, which comprises two rooms, in the north-east corner of the house.
- 6.6 The stairs to the first floor have pine treads and risers, and simple balustrade and handrail. There is a landing with four rooms off, of which only the two to the front were heated, but in neither case does the fireplace remain intact. The rear two rooms borrow light from the wide stair window, via splayed openings in the side walls, but also have the later rear windows referred to above. (It is possible these replaced original openings.)

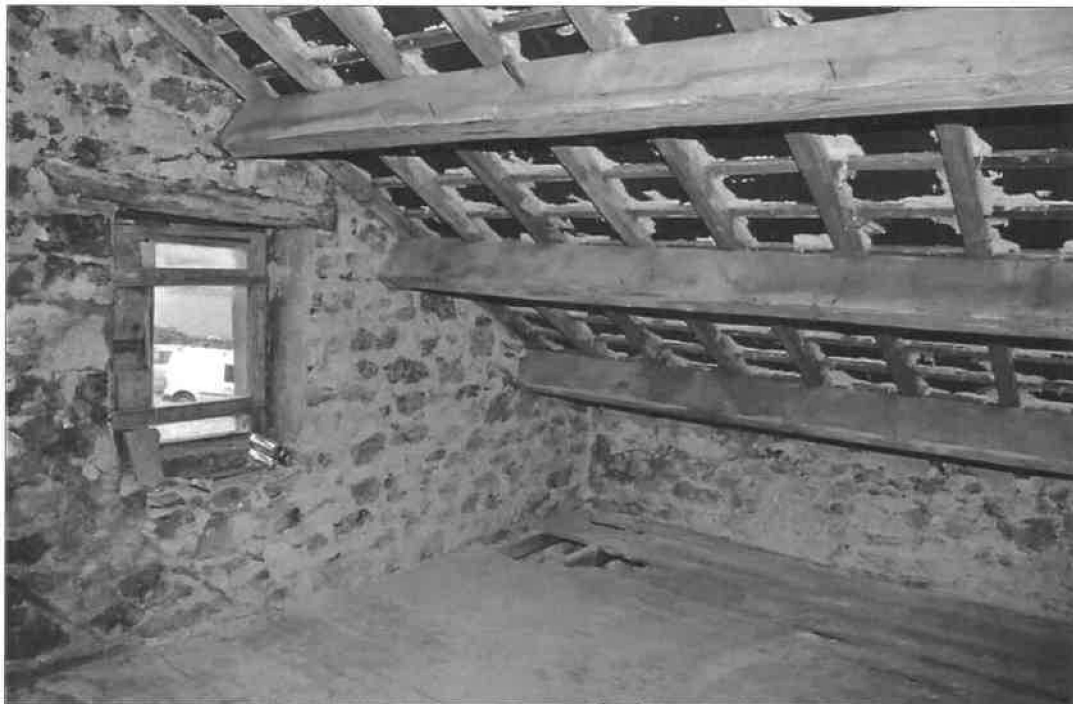
Photo 14: Attic, in south-east corner

- 6.7 The stairs continue to the attic, where there is a late nineteenth/early twentieth century plank partition at the top of the stairs. The attic comprises an east and west room, the east one with a window, which appears formerly to have been only shuttered on the interior. These two rooms are unheated and open to the roof. There are no trusses as the roof is carried on purlins spanning between masonry walls; the purlins are pine, and reported to have been replaced about 1970.

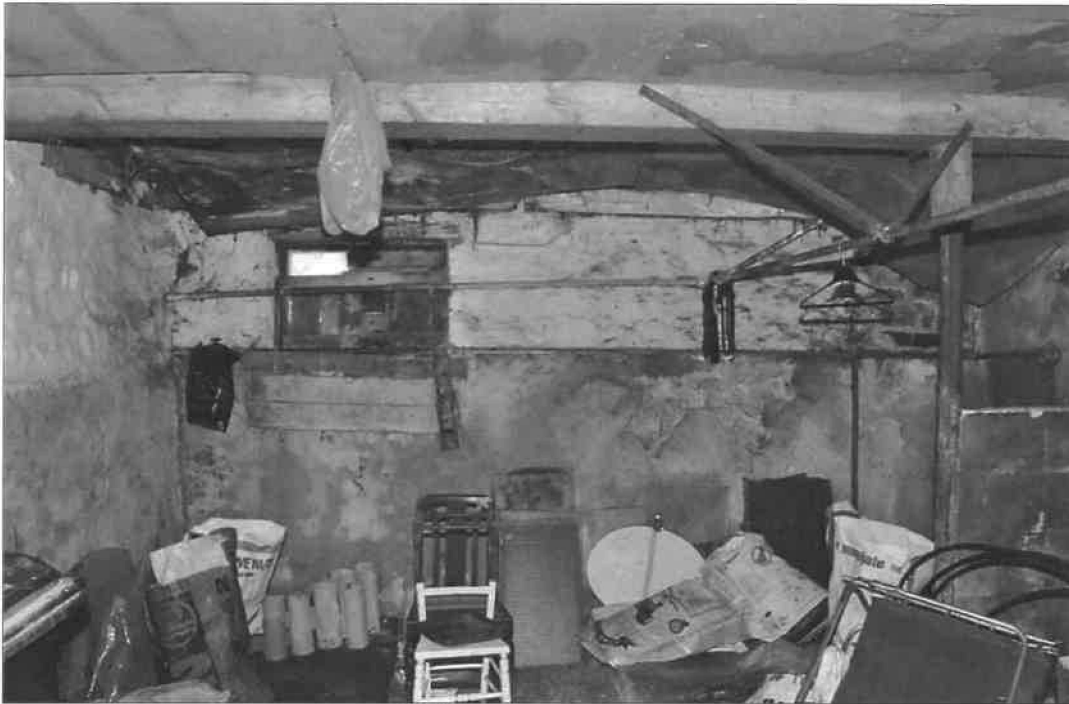
Photo 16: Former stable, now shippon

- 7.4 The barn is four bays long, and contains a former stable in its east end, with its own front doorway. The stable interior has been converted to a shippon in the twentieth century, and is entirely modern, with early vacuum milking equipment. A masonry wall, at ground floor level only, separates this room from the cart bay. The cart bay is open to the roof: lack of a rear doorway implies it was never intended as a threshing bay. The west end of the barn contains a shippon for six cows with oak-framed boskins and hayloft over, characteristic for the local area and period. The shippon has undergone some changes, including the insertion of the present windows in the west and north walls, but is essentially original in appearance.

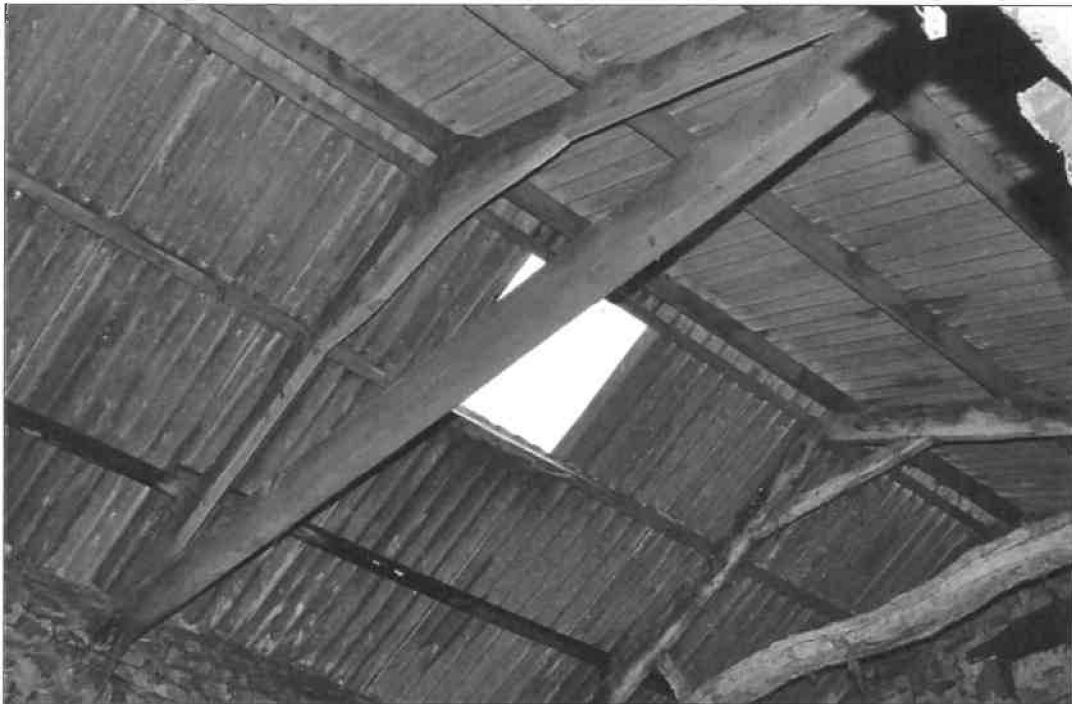
Photo 18: Barn roof
