# PROPOSED MATERIALS SCHEDULE.

Repair and Refurbishment Works  
Dinkling Green, Barn A, Whitewell, BB7 3BN

# Proposed Materials Schedule

Dinkling Green  
Barn A  
Whitewell  
BB7 3BN

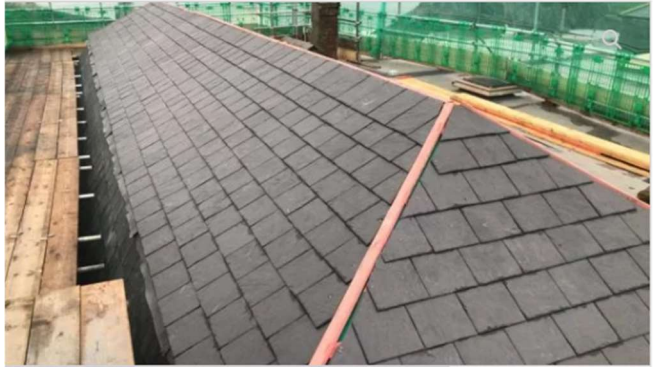
ITEM	ELEMENT	MATERIAL / PRODUCT	IMAGE
01	Roof Slate	New 600 x 300 Estillo 3 Blue Grey Slates, fixed with aluminium nails. This will ensure a smooth consistent finish over the whole roof whilst maintaining the traditional look of the roof.

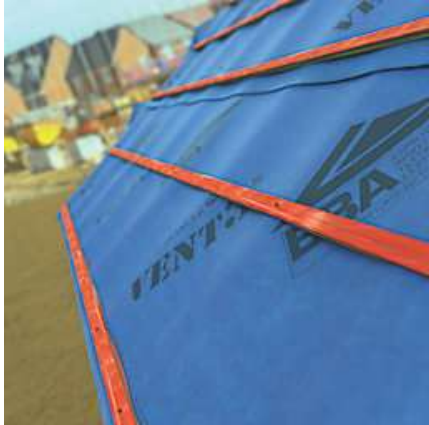
02	Roof Membrane	Cromar Vent 3 BLUE High Performance Breathable Roofing Membrane

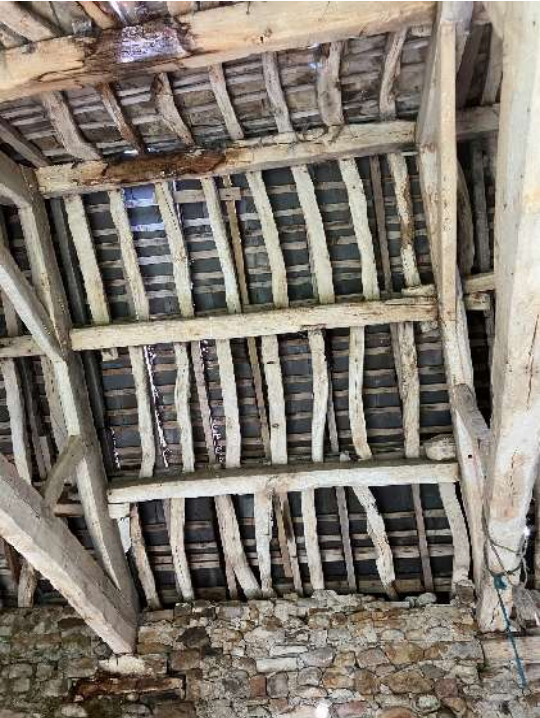
ITEM	ELEMENT	MATERIAL / PRODUCT	IMAGE
03	Replacement Roof Timbers	<p>Subject to inspection following roof covering removal.</p> <p>Those timbers to be used where replacement will be required will be inspected and retained, where possible. All new timber to be used shall be of high quality and shall be free of shakes, knots and wany edges. No sapwood is to be used. All timber to be used in carpentry shall be wrot and carpenters work shall be rough.</p> <p>Where the timber can be repaired / treated, the timbers will be spliced with reclaimed timber sourced from a local reclamation yard or new timber to remove the deficient timber.</p> <p>All works to be approved by the SE prior to completing.</p>

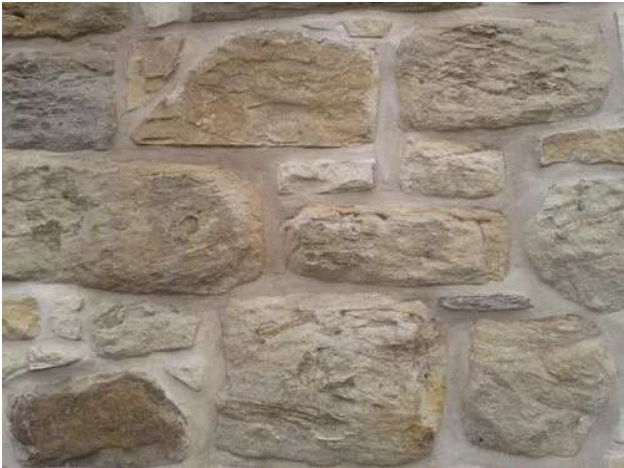
ITEM	ELEMENT	MATERIAL / PRODUCT	IMAGE
04	Replacement Timber Lintels	Once work commences, the condition of existing timber lintels are to be inspected. Existing lintels are to be treated in the first instance to secure their position within the building, if the timber is not suitable for re-use then the wall is to be temporary propped to allow the lintel to be removed and replaced with a suitable timber from a local reclamation yard or steel lintel, subject to SE approval.	
05	Mortar Mix	<p><i>Traditional mix of 1 part mature lime putty / quick lime and 3 parts well graded aggregates from 2.5mm to 75 microns. All aggregates to be to BS EN 13139:2002 and to be well graded, non-staining clean, sharp, coarse sand and be uncontaminated by clay and silt. Pozzolanic additive i.e. brick/stone dust, pulverised fuel ash or Argical M1000 to be added to mix. The use / amount of pozzolan added is to be in accordance with the manufacturers instructions and guidance. The pozzolan will ensure a more rapid and durable set. Mortar mix to be applied throughout complete with stipple brush finish. Joint / mortar thickness to be well proportioned. Water used in the preparation of the mortar and for the dampening down of the walls and washing out shall be clean and fit for consumption.</i></p>
