Listed Building Application
Design, Access and Heritage Statement
for

Repairs and Alterations
to

FAIR OAK FARM BARN
Leagram in Bowland
Nr Preston, Lancs, PR3 2QT

Prepared for
Mr John West
August 2024

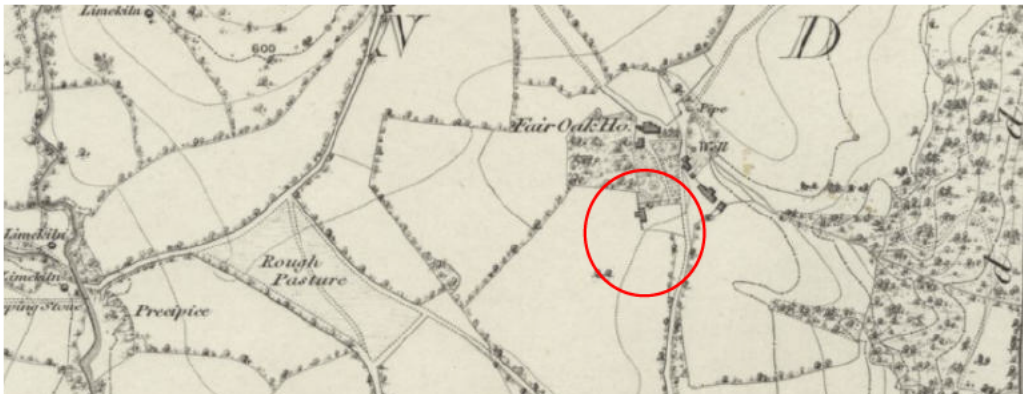
OS six inch maps 1840-80's – Circle around Fair Oak Barn to the southeast of the group of buildings identified as Fair Oak House. There appears to be a track through a wooded or landscaped area from the House down to the Barn and other agricultural buildings with open land in front.

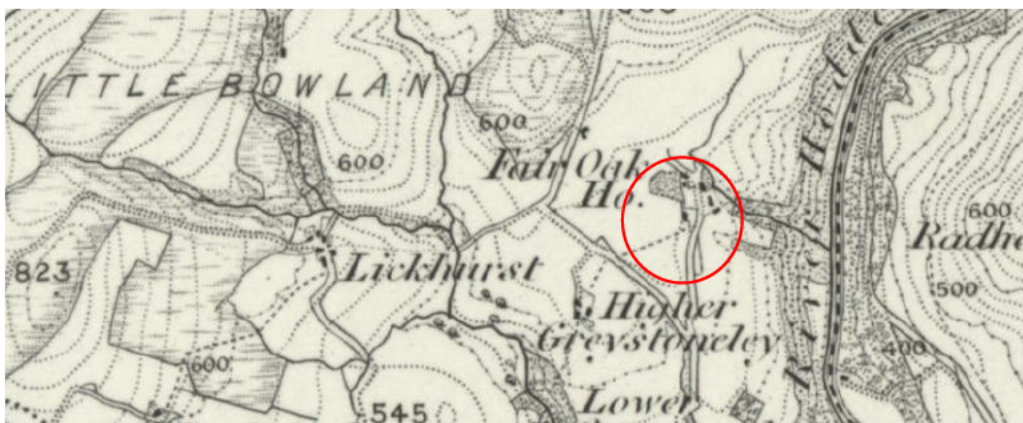
OS one inch map 1885 – 89 – Site identified as Fair Oak House, but the buildings around the House and Farm can clearly be seen including Fair Oak Barn.

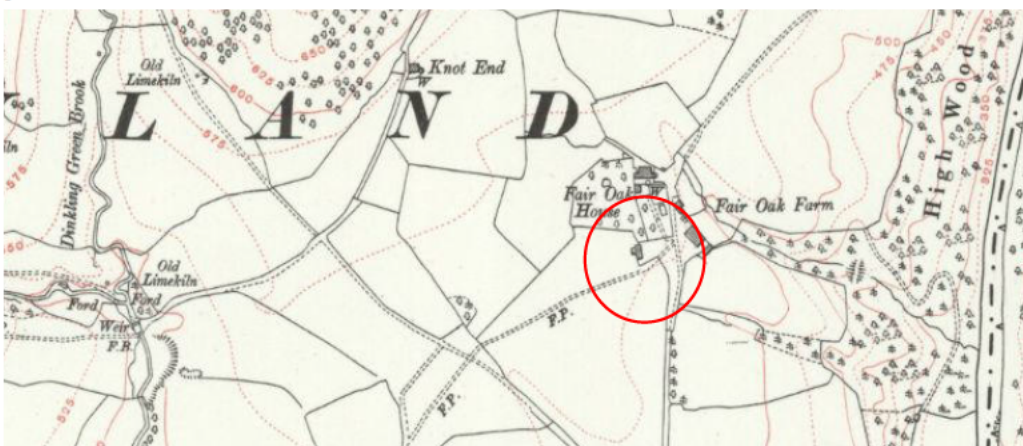
OS six inch map 1888- 1915 – Circle around Fair Oak Barn. Fair Oak House and Fair Oak Farm now individually named, although the layout of farm, track and woodland remains unchanged.
