Job Title  
**PROPOSED REPAIR AND REFURBISHMENT WORKS AT CROW TREES FARMHOUSE CROW TREES BROW CHATBURN LANCASHIRE BB7 4AA**

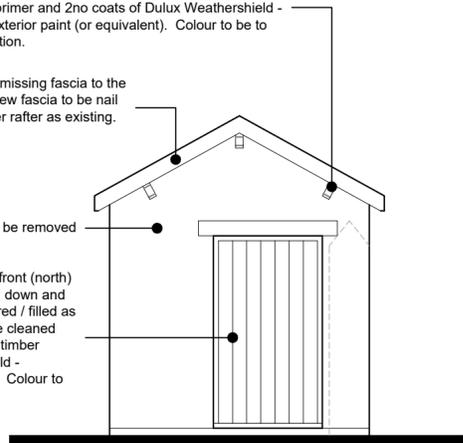
**PROPOSED NORTH FACING ELEVATION**

The existing timber fascia boards, exposed ridge ends and decorative purlin ends are to be fully cleaned down. The timber components are to then be finished with 1no coat of exterior timber primer and 2no coats of Dulux Weathershield - Weatherproof exterior paint (or equivalent). Colour to be to clients specification.

New timber board required to replace the missing fascia to the front (north) end of the east roof slope. New fascia to be nail fixed to the front face of the existing timber rafter as existing.

Wall climbing ivy to be removed

The existing timber door and frames to the front (north) side of the coal shed are to be fully cleaned down and any areas of minor decay cut out and repaired / filled as appropriate. The door and frames are to be cleaned down and finished with 1no coat of exterior timber primer and 2no coats of Dulux Weathershield - Weatherproof exterior paint (or equivalent). Colour to be to clients specification.

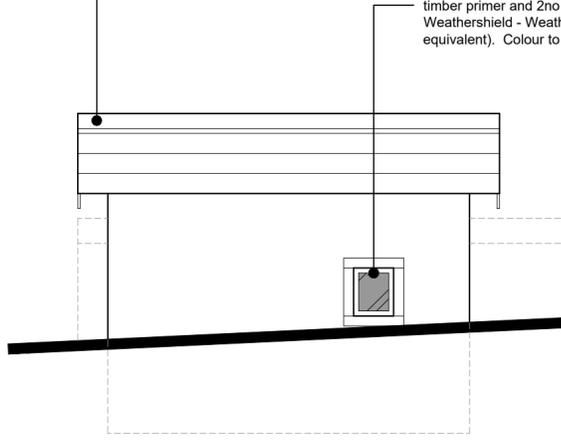
**PROPOSED WEST FACING ELEVATION**

The existing breach to the front end (north) of the ridge to the coal shed roof is to be repaired with new slates to match the existing. The timber ridge, battens and raters are to be probed for decay and treated with a suitable timber preservative if / where required. Should any decay be present which is beyond treatment then the affected timbers shall be repaired or replaced as required with new treated structural timbers to Structural Engineers design and specification. 1no new matching ridge tile required.

Cracked and dislodge slates present to the east roof slope to be replaced with new matching slates.

New treated s.w. timber window to be installed to opening with toughened safety glass. Window frames to be finished with 1no coat of exterior timber primer and 2no coats of Dulux Weathershield - Weatherproof exterior paint (or equivalent). Colour to be to clients specification.

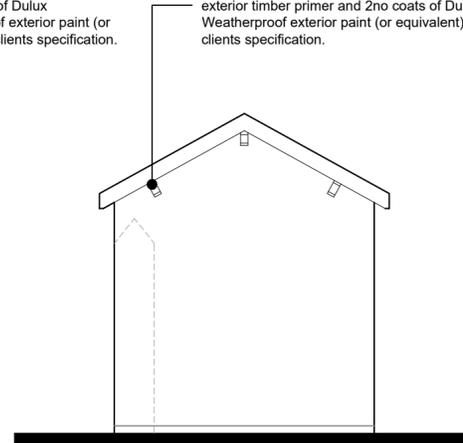
**PROPOSED SOUTH FACING ELEVATION**

The existing timber fascia boards, exposed ridge ends and decorative purlin ends are to be fully cleaned down. The timber components are to then be finished with 1no coat of exterior timber primer and 2no coats of Dulux Weathershield - Weatherproof exterior paint (or equivalent). Colour to be to clients specification.

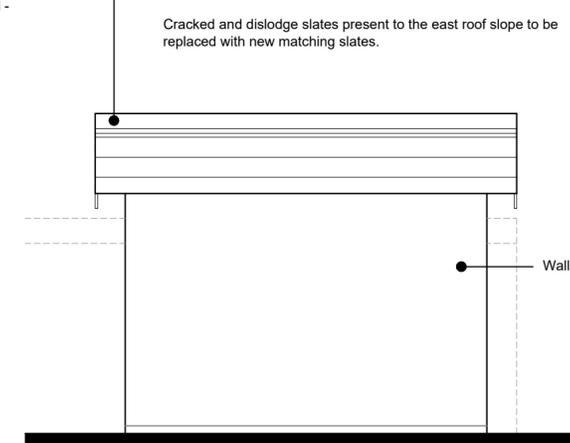
**PROPOSED EAST FACING ELEVATION**

The existing breach to the rear end (south) of the ridge to the coal shed roof is to be repaired with new slates to match the existing. The timber ridge, battens and raters are to be probed for decay and treated with a suitable timber preservative if / where required. Should any decay be present which is beyond treatment then the affected timbers shall be repaired or replaced as required with new treated structural timbers to Structural Engineers design and specification. 1no new matching ridge tile required.

Cracked and dislodge slates present to the east roof slope to be replaced with new matching slates.
