**STRUCTURAL APPRAISAL  
OF  
MAIN BARN,  
LOWER REAPS FARM,  
WHINNEY LANE,  
MELLOR**

<b>CONTRACT NO. 3549</b>	<b>PHILIP WRIGHT ASSOCIATES LTD 21 UNION STREET RAMSBOTTOM BURY BL0 9AN</b>
<b>JANUARY 2025</b>

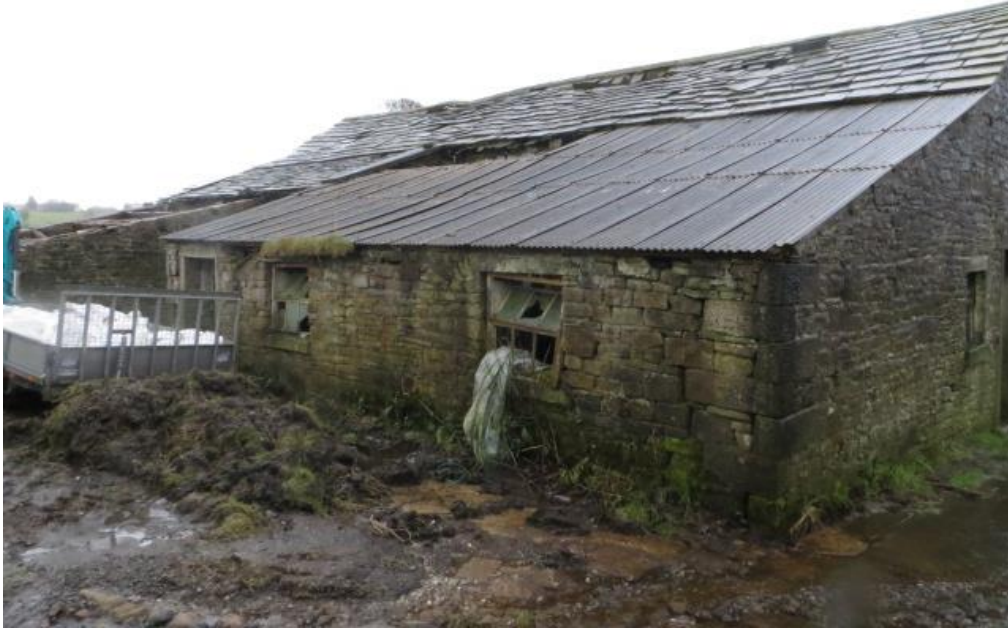
The barn is of single storey although with a double storey height to the middle incorporating a shippen to the rear to the full width of the building and with two projections to the left hand and right hand side of the front. Two substantial stone walls form the entrance to the front. The barn is constructed in a traditional manner with solid stone external walls and with a duo pitched ridged roof with a combination of stone tiles and corrugated steel cladding. The ground floor is of part stone cobbles and part earth.
