Method statement and specification for proposed renovation works.

### **For Mark Lincoln**

Reference: 2025-55 | Version 1.0

This report aims to provide further details in order to discharge condition 3 from planning permission 3/2025/0412 with Ribble Valley Borough Council, as follows:

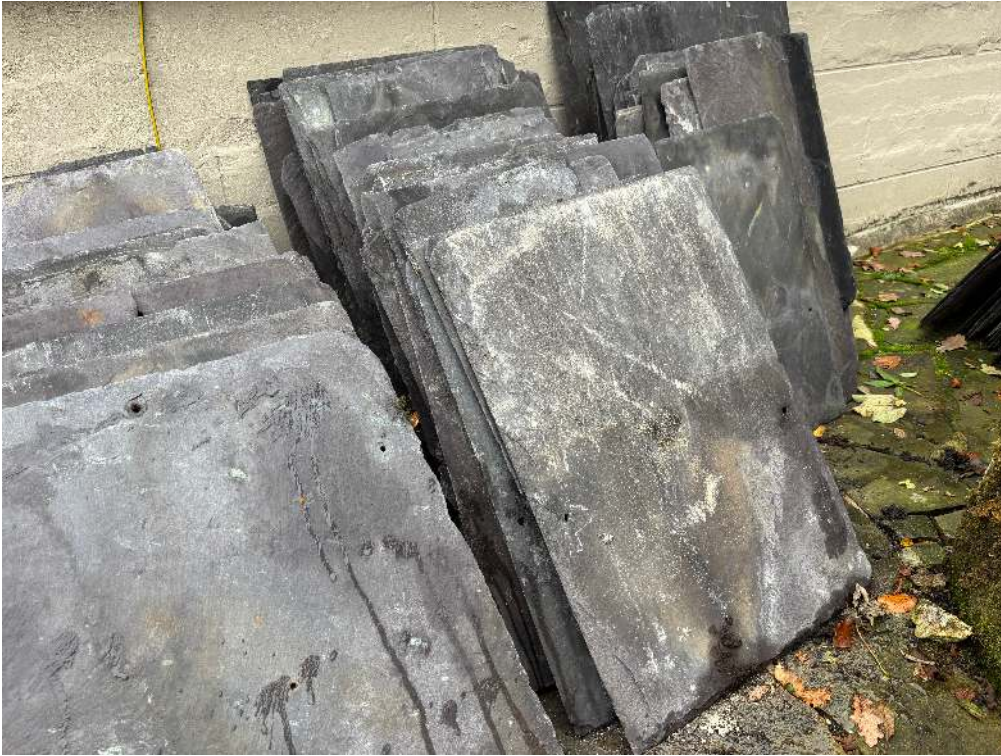
Figure 1: Reclaimed Welsh graduated slates.

| J | <p>Remove concrete roof tiles and replace with breathable felt membrane, tanalised timber battens and slates with stone ridge tiles.</p> <p>DWG1:2025-55[REV1]<br/>Ref J</p> | <p>Remove existing tiles and battens and dispose.</p> <p>Retain rafters where possible. Localised repairs where required (eaves etc).</p> <p>Install breathable membrane atop rafters.</p> <p>Install tanalised timber battens.</p> <p>Fix slates using copper nails.</p> <p>Fix ridge tiles with lime mortar.</p> | <p>Reclaimed graduated Welsh blue slates.</p> <p>Reclaimed ridge tiles.</p> <p>(Reclaimed from a similar aged barn in the Ribble Valley).</p> <p>See images below.</p> |
