**SAMLESBURY AERODOME  
BUILDING**

**REMEDIATION STRATEGY**

**Project 7274**

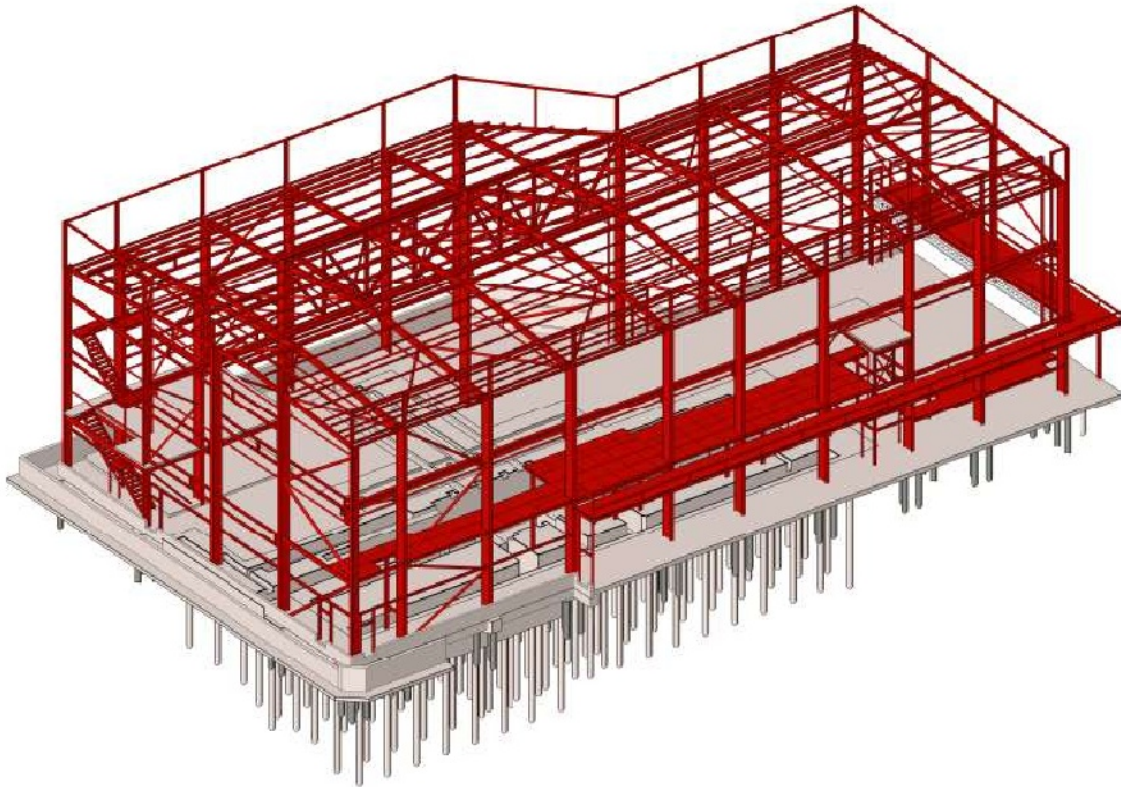
The proposed extension comprises a single-storey portalised steel frame with full overhead crane coverage and a deep reinforced concrete raft foundation [REDACTED]. The extension is to be constructed on an area of existing car park within the development site. The development will abut a number of existing Buildings.

Figure 2.1: 3D view of structure

The proposed 3D view of proposed building is shown in Fig 2.1 below.

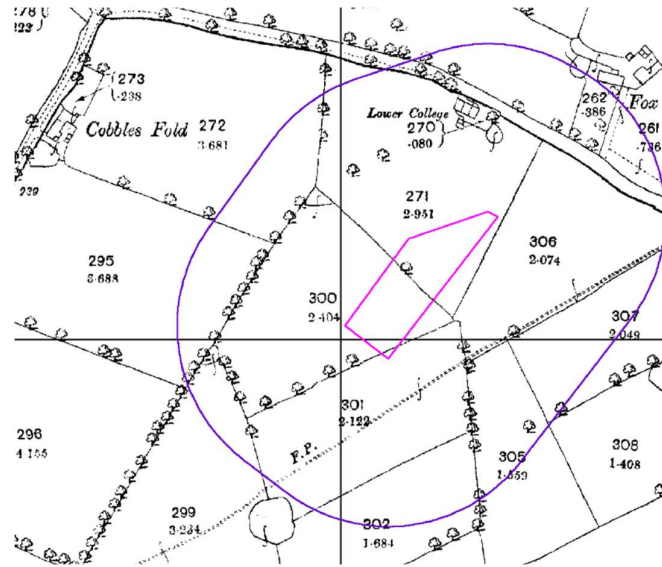
The ordnance survey mapping of 1892 shows the site of the extension to be open fields as shown outlined in Fig 2 below. There are ponds indicated in the vicinity of the site but not beneath the proposed development site. There are no watercourses on or in the vicinity of the site.

Fig 3.1.2 Ordnance Survey Map of 1892

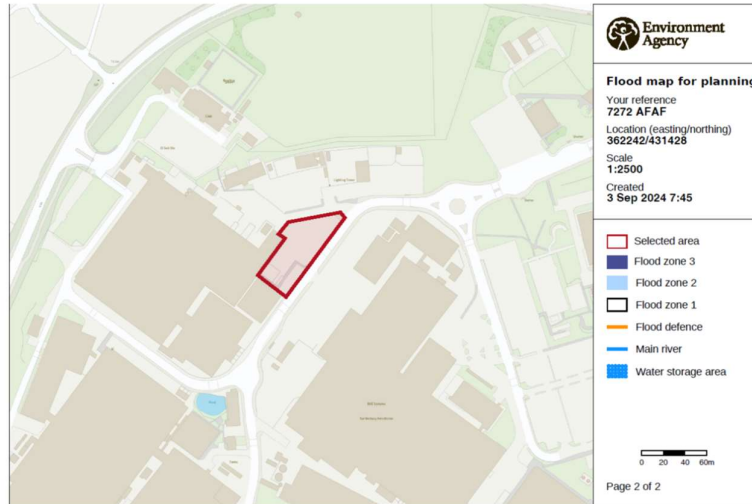
Environment Agency Flood Mapping indicates that the site is in Flood Zone 1 (low probability of flooding). Flood Zone 1 land has been assessed as having 0.1% (1 in 1000 year) chance of flooding from rivers or the sea in any given year. The location of the site is outlined in red in Fig 3.5.1 below.

Figure 3.5.1: Flood Map for Planning reproduced from the Environment Agency website.

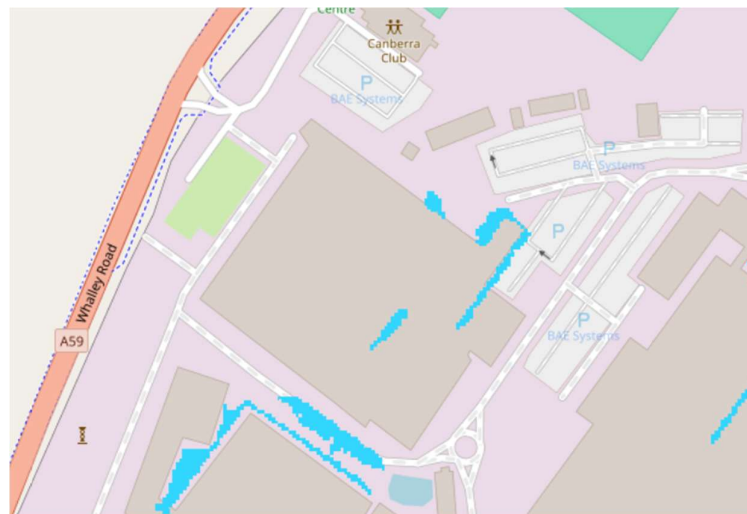
Environment Agency surface water flood mapping indicates that there is a risk of surface water flooding on the site along the path at the side the western building. The car park drains to a series of surface water gullies along the sidewall of this building and this represents the lowest part of the site, with an annual probability of exceedance of 1 in 30. There is no identified risk of surface water flooding elsewhere on the proposed development site. The extent of surface water flooding with an annual probability of 1 in 30 is shown in the mapping in Fig 3.5.2 below.

Figure 3.5.2: Environment Agency surface water flood mapping 1 in 30 Year

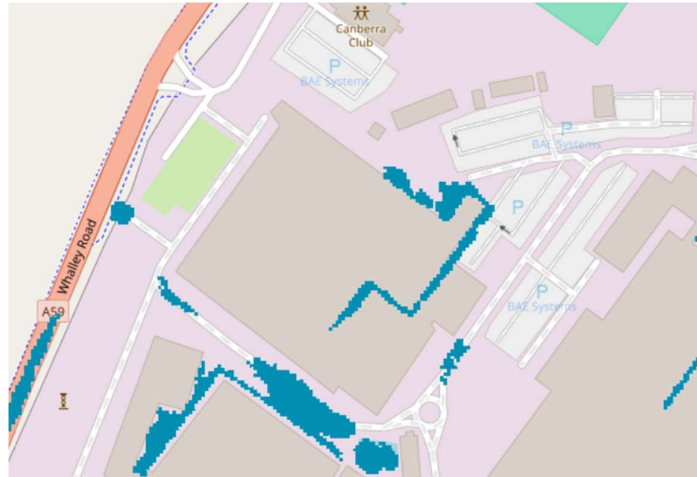
The extent of surface water flooding with an annual probability of exceedance of up to 1 in 100 is shown in Fig 3.5.3 below. The potential zone of surface water flooding is similar to the 1 in 30-year event.

Figure 3.5.3: Environment Agency surface water flood mapping 1 in 30 – 1 in 100 Year
