### Arboricultural Impact Assessment Overview

in Relation to Proposed Construction of Four Detached Residential Properties at

Moorcock Inn, Slaidburn Road, Waddington, Lancashire, BB7 3AA

June 2016

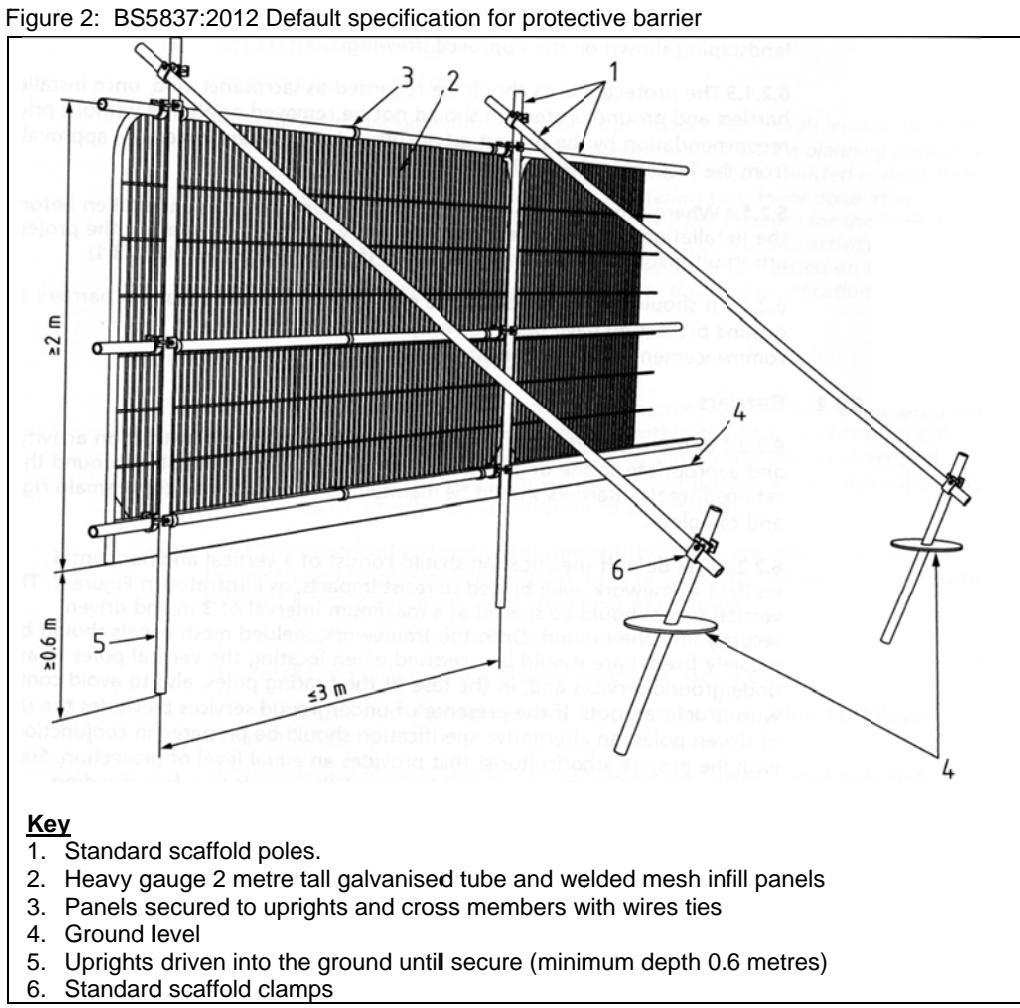
- be retained in place throughout the development process, as specified in the 'Temporary Protective Fencing Construction' section below and detailed in BS5837:2012 Figure 2 (overleaf);
- 2. be sited in the area defined on the Tree Protection Plan (TPP);
- 3. be erected prior to any construction, demolition or excavation works and remain in place for the duration of the project;
- 4. preclude any delivery of site accommodation and/or materials and/or plant machinery;
- preclude all construction related activity, with the sole exception of specified arboricultural works and any other works to be carried out under supervision that have been agreed by all parties; and
- 6. preclude the storage of all development related materials and substances including fuels, oils, additives, cement and/or any other deleterious substance.

- 1. Temporary protective fencing panels shall be weldmesh "Heras" panels of at least 2.0 metres in height.
- 2. The panels shall butt together and be securely fixed to a scaffold framework, as per 3 to 5 below.

- 3. The scaffold framework shall comprise of upright poles of at least 3.0 metres in length driven no less than 0.6 metres into the ground at maximum 3.0 metre centres with horizontal and diagonal poles fixed to the uprights, as per 4 to 5 below.

- 4. The two horizontal rail poles shall be attached to the uprights at heights of 0.6 and 1.8 metres with 3 no. clamps to each joint.
- 5. The diagonal scaffold pole struts be clamped to the top rail of the scaffold framework at a 45° angle and extend back into the CEZ and clamped to a 0.7 metre length of scaffold tube that shall be driven no less than 0.5m into the ground.

- 6. No fixing shall be made to any tree and all possible precautions shall be taken to prevent damage to tree roots when locating posts.
- 7. A 600mm x 300mm warning sign reading "TREE PROTECTION AREA KEEP OUT" (see Figure 1, below) shall be fixed to every 10.0 metre length of protective fencing.
