Arboricultural Impact Assessment

in Relation to Proposed Conversion of Existing Farm Buildings to Residential Usage of 8 Units at

Brockhall Farm, Old Langho, Lancashire, BB6 8BB

Prepared by: Bowland C Tree Consultancy Ltd

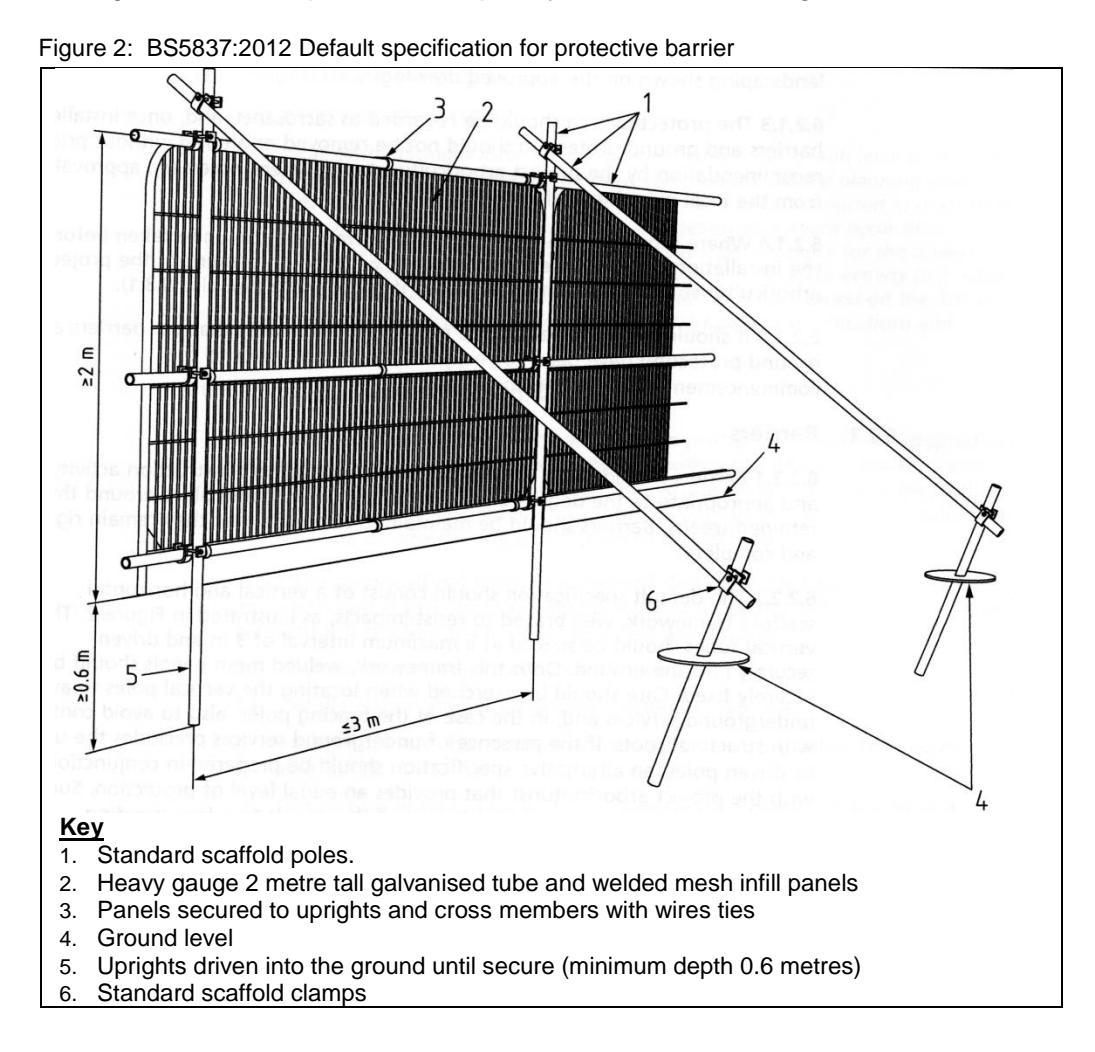
- 6. No fixing shall be made to any tree and all possible precautions shall be taken to prevent damage to tree roots when locating posts.
- 7. A 600mm x 300mm warning sign reading "TREE PROTECTION AREA KEEP OUT" (see Figure 1) shall be fixed to every 10.0 metre length of protective fencing.

- 8. On completion of erection, and prior to any demolition or construction works, site preparation, excavation or delivery of plant and materials, the Consulting Arboriculturist or the LPA Tree Officer, as agreed, shall inspect the Temporary Protective Fencing.

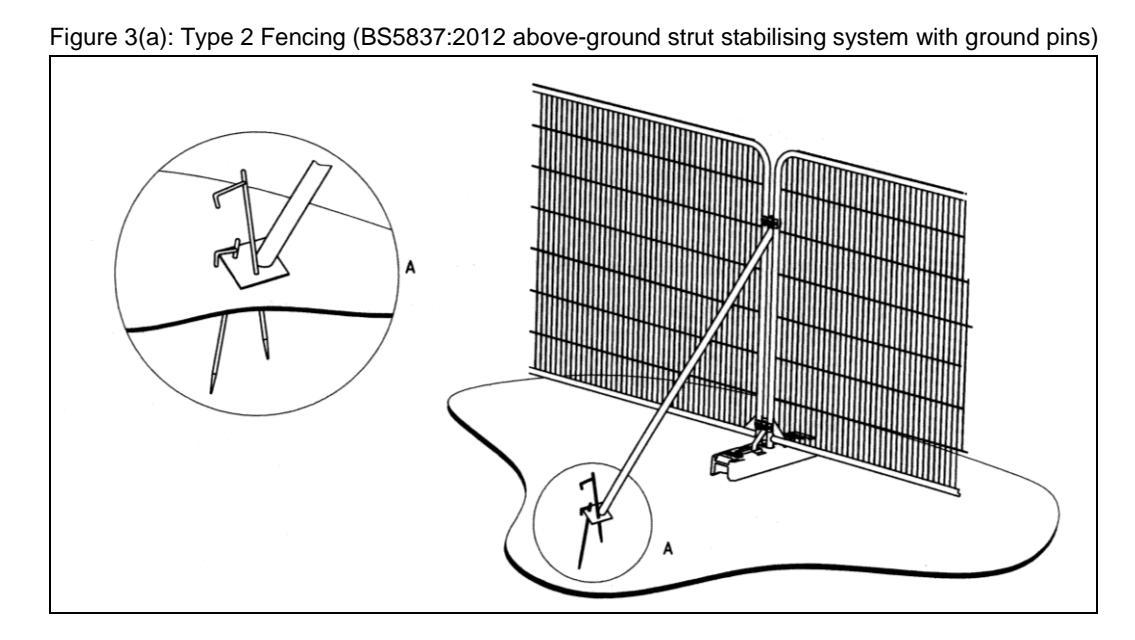
Type 2 Temporary Protective Fencing Construction (see Figure 3(a), below)

- 1. Temporary protective fencing panels shall be weldmesh "Heras" panels of at least 2.0 metres in height.
- 2. The panels shall stand on rubber or concrete feet.

- 6. No fixing shall be made to any tree and all possible precautions shall be taken to prevent damage to tree roots when locating posts.
- 7. A 600mm x 300mm warning sign reading "TREE PROTECTION AREA KEEP OUT" (see Figure 1) shall be fixed to every 10.0 metre length of protective fencing.

- 8. On completion of erection, and prior to any demolition or construction works, site preparation, excavation or delivery of plant and materials, the Consulting Arboriculturist or the LPA Tree Officer, as agreed, shall inspect the Temporary Protective Fencing.

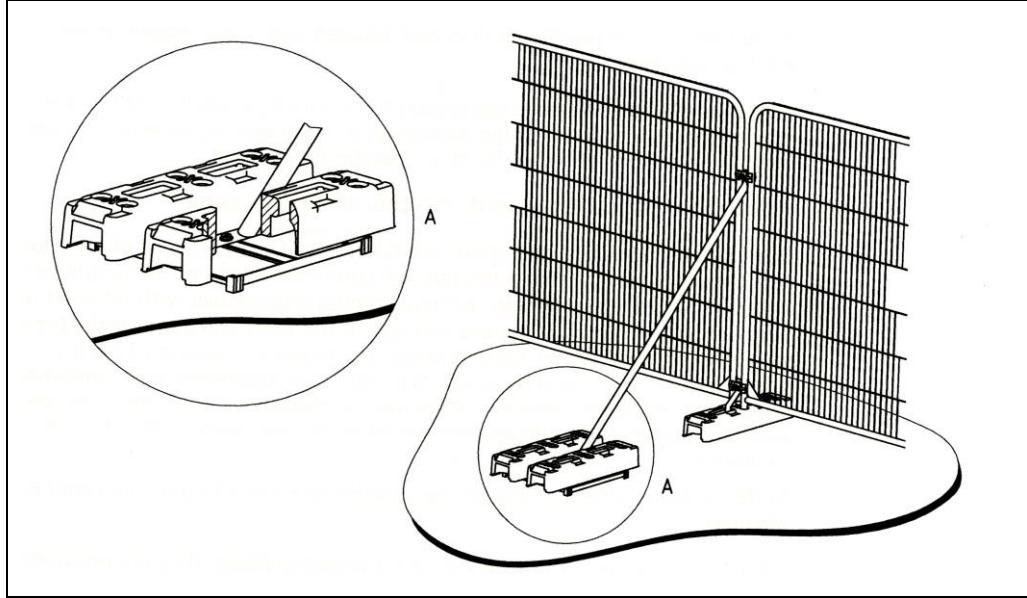
Figure 3(b): Type 3 Fencing (BS5837:2012 above-ground stabilising system with strut on block tray)

Type 3 Temporary Protective Fencing Construction (see Figure 3(b), overleaf)

- 1. Temporary protective fencing panels shall be weldmesh "Heras" panels of at least 2.0 metres in height.
- 2. The panels shall stand on rubber or concrete feet.

- 6. No fixing shall be made to any tree and all possible precautions shall be taken to prevent damage to tree roots when locating posts.
- 7. A 600mm x 300mm warning sign reading "TREE PROTECTION AREA KEEP OUT" (see Figure 1) shall be fixed to every 10.0 metre length of protective fencing.

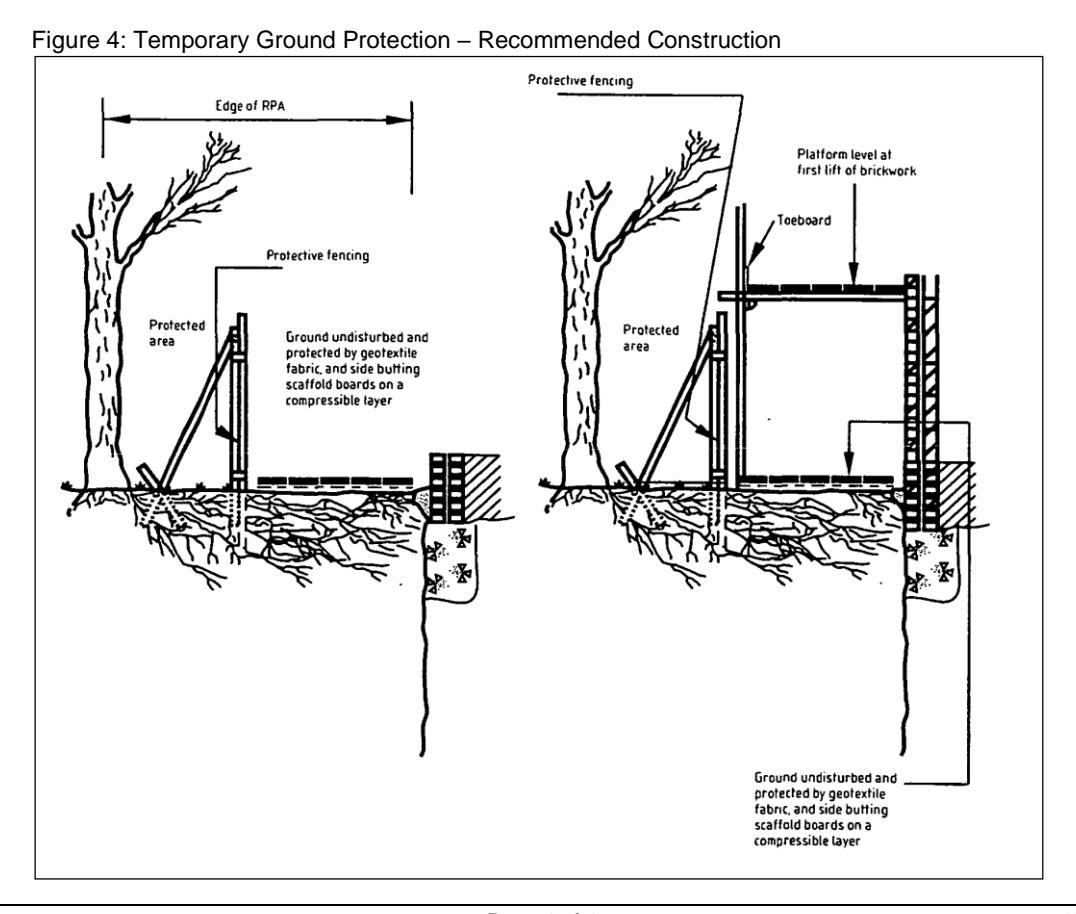
Temporary Ground Protection

- 1. Any necessary Temporary Ground Protection areas shall conform to Figure 4, below, unless otherwise agreed with the LPA.
- 2. The Ground Protection Area shall be left undisturbed and covered by a semi-permeable geotextile membrane which shall, in turn, be covered by a compressible layer consisting of a material such as woodchip.
- 3. Side-butting scaffold boards shall then be fitted to cover the Ground Protection Area.
- 4. On completion of installation, and prior to any demolition or construction works, site preparation, excavation or delivery of plant and materials, the Consulting Arboriculturist or the LPA Tree Officer, as agreed, shall inspect the Temporary Ground Protection.
- 5. The Temporary Ground Protection shall remain in place until completion of the project and only removed following receipt of written permission from the LPA.
