Appendix B6: Ecology Assessment -Ribble Crossing

Haweswater Aqueduct Resilience Programme -Proposed Bowland Section

Supplementary Environmental Information

February 2022

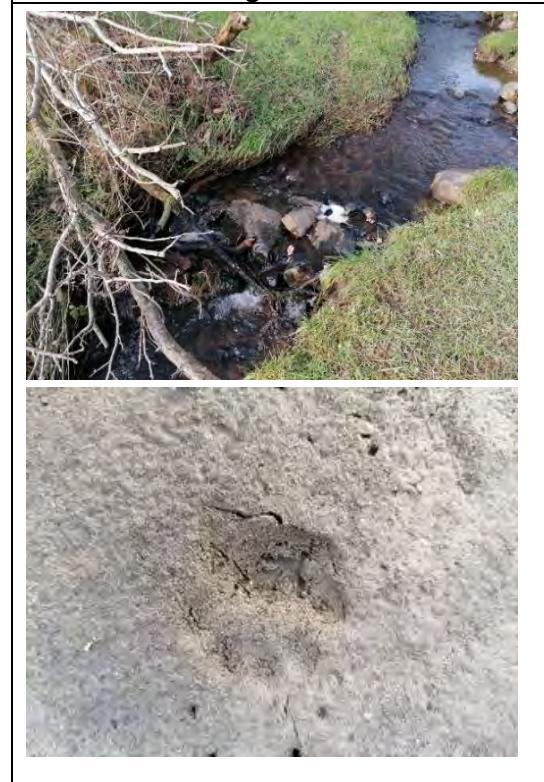
#### T04: W2321 Greg Sike

The gently sloping banks were vegetated with herbs, grasses and <i>Juncus</i> sp The in-channel substrate was comprised of boulder, cobble, gravel, silt, and clay.
As the watercourse flows downstream, the gently sloping banks are replaced by steep forested banks which have minimal herbaceous vegetation. The substrate was boulder, cobble, and gravel, with frequent coarse woody debris.

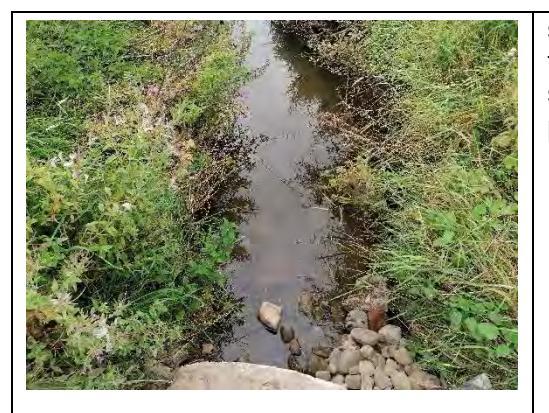
Suitable refuges which could provide habitat for crayfish (e.g. boulders) were observed in low abundance. No crayfish were recorded during the surveys at W2349.
	Within the survey extent the width of the channel is <i>c</i> . 1.5 m and at the time of the survey the depth was <i>c</i> . 0.05 m. The survey extent is bordered on both banks by grazed pasture.
	Cattle have direct access to the channel at multiple locations within the survey extent and during the

survey cattle faeces was observed in the channel at two locations. This is likely to reduce the sites suitability to support white-clawed crayfish which prefer to inhabit streams with good water quality.

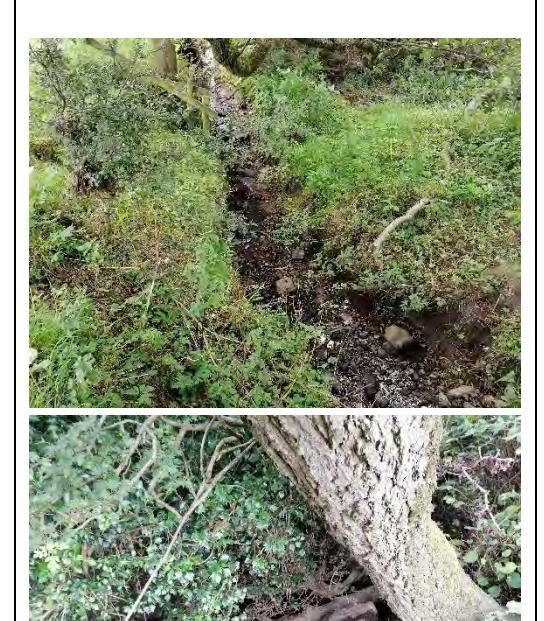
T04: W2321 Greg Sike

# No crayfish captured or observed. Habitat of moderate suitability at W2321.

Although suitable refuges were recorded (boulders and undercut banks) they were infrequent. More than 25 refuges were searched during the survey but no evidence of crayfish was found on W104. Food sources such as macroinvertebrates however were readily available providing suitable foraging for crayfish.

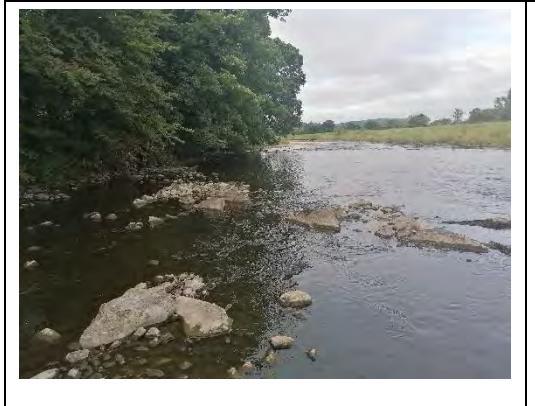
### T04: W2325 River Ribble

# No crayfish captured or observed. Suitable habitat present at W2321.

Suitable refuges were observed, predominantly boulders but no crayfish were recorded at W498. Otter spraint also was observed during the survey, none of which contained crayfish remains.
