Client: Mr & Mrs Whitwell – Lime Tree Farm, Whalley Road, Clitheroe, Lancs.

ARBORICULTURAL IMPACT ASSESSMENT FOR PROPOSED AGRICULTURAL BUILDING

Prepared by Antony Wood Cert Arb RFS Yew Tree+Gardens

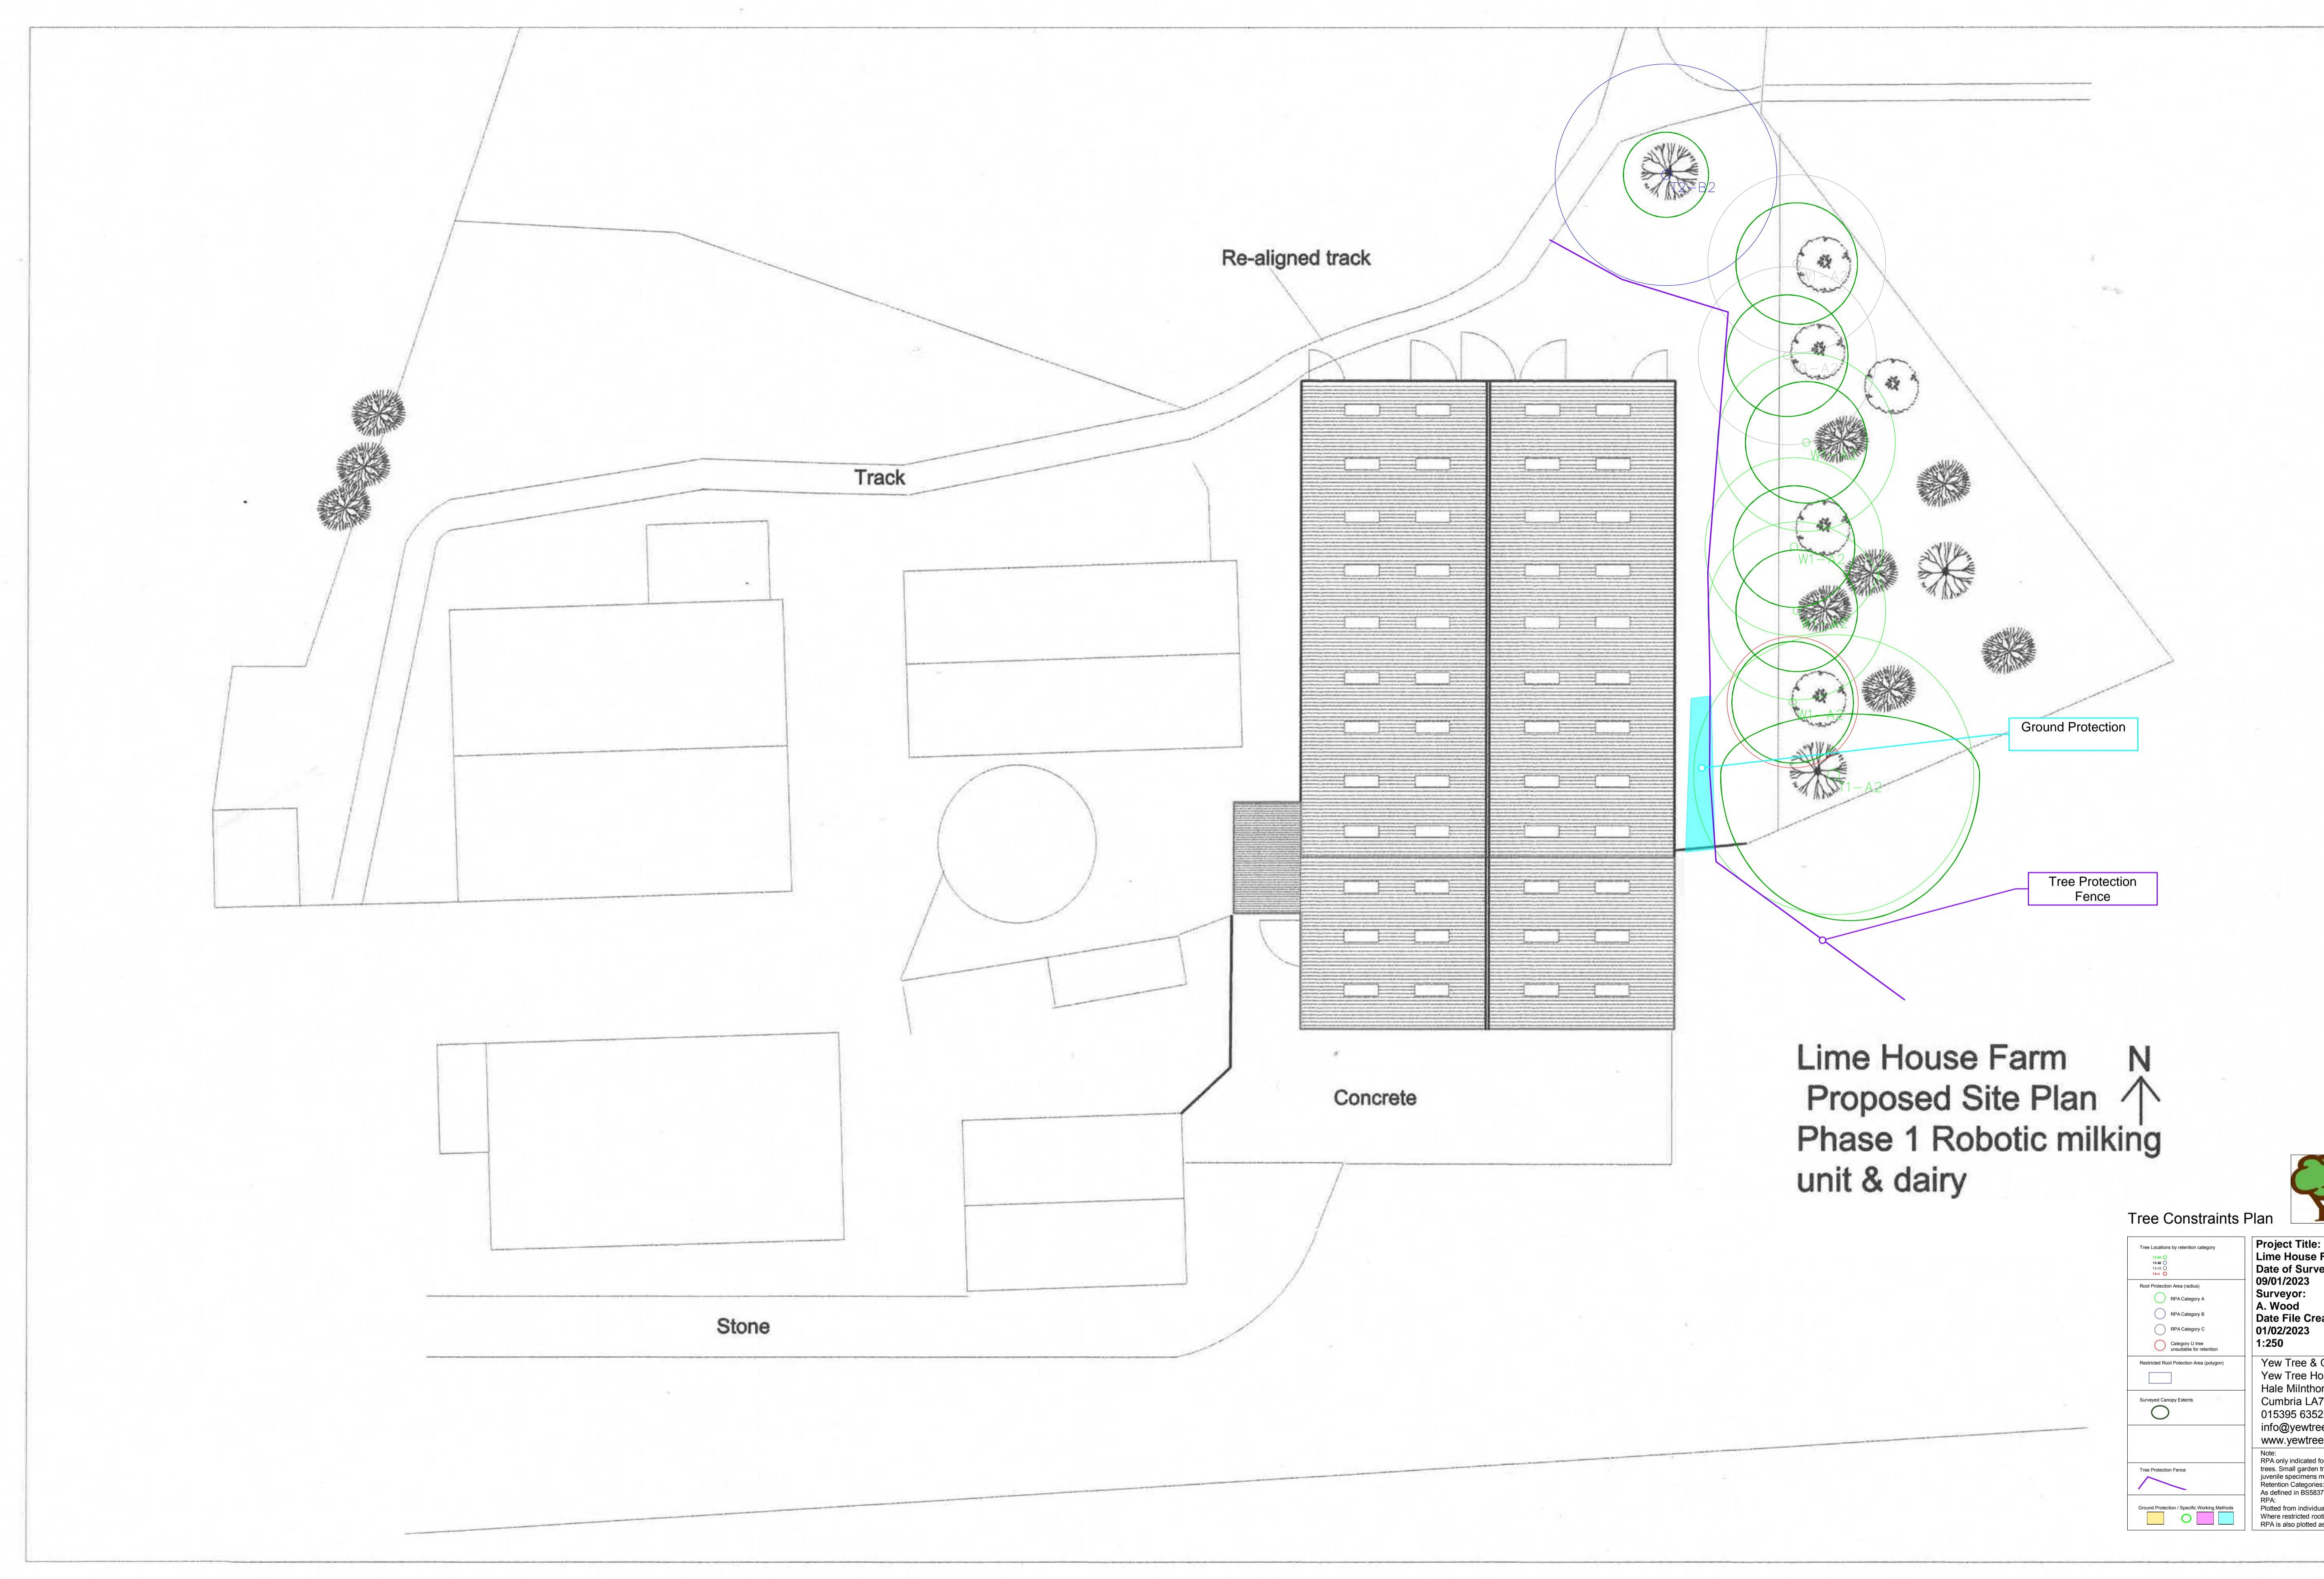
13-AE () 13-82 () 13-62 () 13-02 ()	Lime House Farm Date of Survey:
Root Protection Area (radius)	09/01/2023 Surveyor:
RPA Category B	A. Wood Date File Created:
RPA Category C Category U tree unsuitable for retention	01/02/2023 1:250
Restricted Root Potection Area (polygon)	Yew Tree & Garden
	Yew Tree House Hale Milnthorpe
Surveyed Canopy Extents	Cumbria LA7 7BJ 015395 63527 07813897631
	info@yewtreegardens.co.uk www.yewtreegardens.co.uk
	Note: RPA only indicated for significant
Tree Protection Fence	trees. Small garden trees and juvenile specimens may not be indicated Retention Categories: As defined in BS5837: 2012
Ground Protection / Specific Working Methods	RFA: Plotted from individual RPA sheets. Where restricted rooting conditions are present RPA is also plotted as an area polygon

- 6. Indicative positions for protective fencing are shown in purple on Appendix 2: Tree Constraints Plan.

D. TEMPORARY GROUND PROTECTION AND SURFACES (CYAN SHADING): ON APPENDIX 2
