Bat Survey Report and Method Statement European Protected Species (Bats)

Reasonable Avoidance and Mitigation Measures

The Hawthornes, West Bradford Road, Waddington, BB7 3JE.

12.02.2023

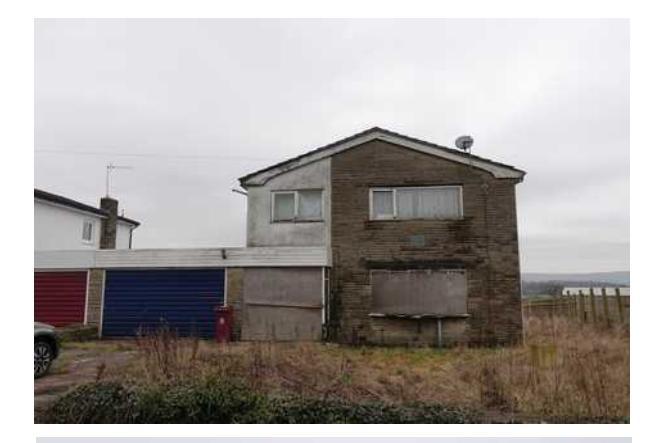
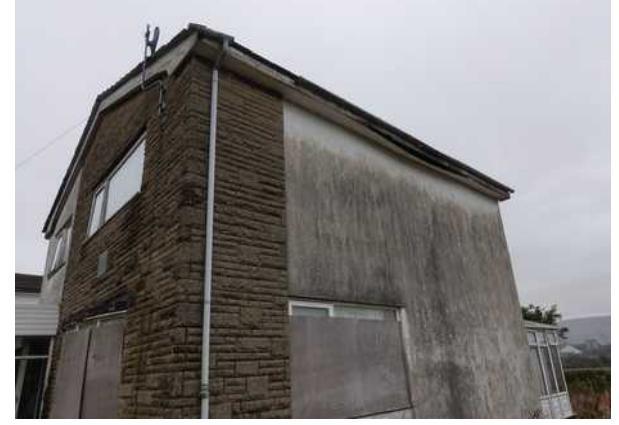
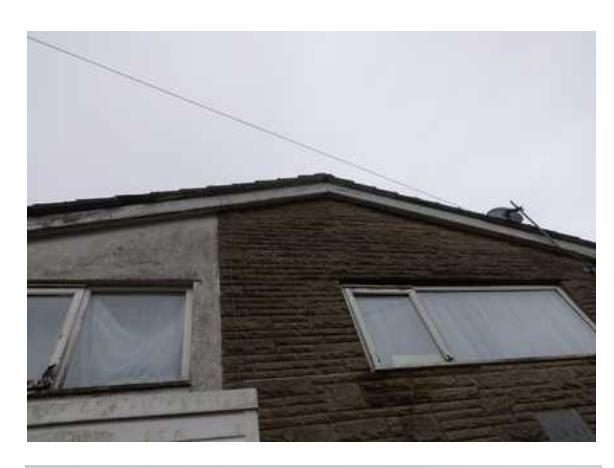
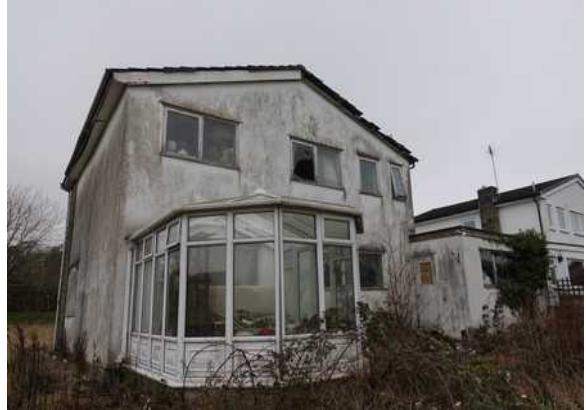
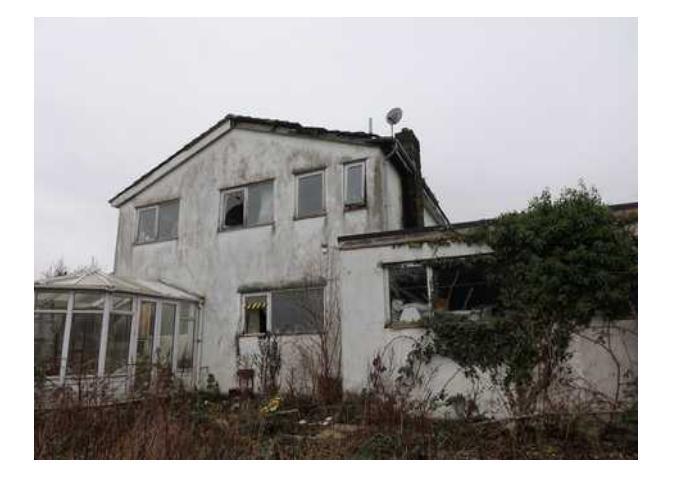
The property consists of a stone built twos storey detached house with a double pitched tiled roof, the building has single storey flat roofed garage present to the northern facade. Walls are well pointed and partially rendered with no obvious cracks, gaps or crevices present. Timber soffits are in poor condition.

Roof tiles are generally close fitting with no obvious lifted, missing or slipped slates present. Pointing on gable ends is deteriorating and in places missing.

The property was assessed as offering low bat roost potential.

No physical evidence, such as grease staining or presence of bat droppings was observed.

Presence of house sparrow was observed using the soffits to nest which is likely to have a negative effect on the bat roost potential.

Timber soffits are deteriorating and in places collapsing, considerable deterioration was observed between surveys and weather penetration is evident.

It is recommended that a precautionary emergence survey is carried out prior to works on the roof and soffits to confirm absence of roosting bats. The emergence survey should be carried out between May and August inclusive.

It is recommended that a precautionary emergence survey is carried out prior to works on the roof and removal of soffits to confirm absence of roosting bats.

Roof slates should be removed by hand and under supervision where necessary.
