# BAT SURVEY OUTBUILDING at TWINBROOKS FARM UPBROOKS CLITHEROE

DATE AND TIME OF VISIT 10<sup>th</sup> May 2021 1.30pm 19<sup>th</sup> May 2021 9.00pm UPDATE 22<sup>nd</sup> Feb 2023 9.00am

**REFERENCE NO. 5765**

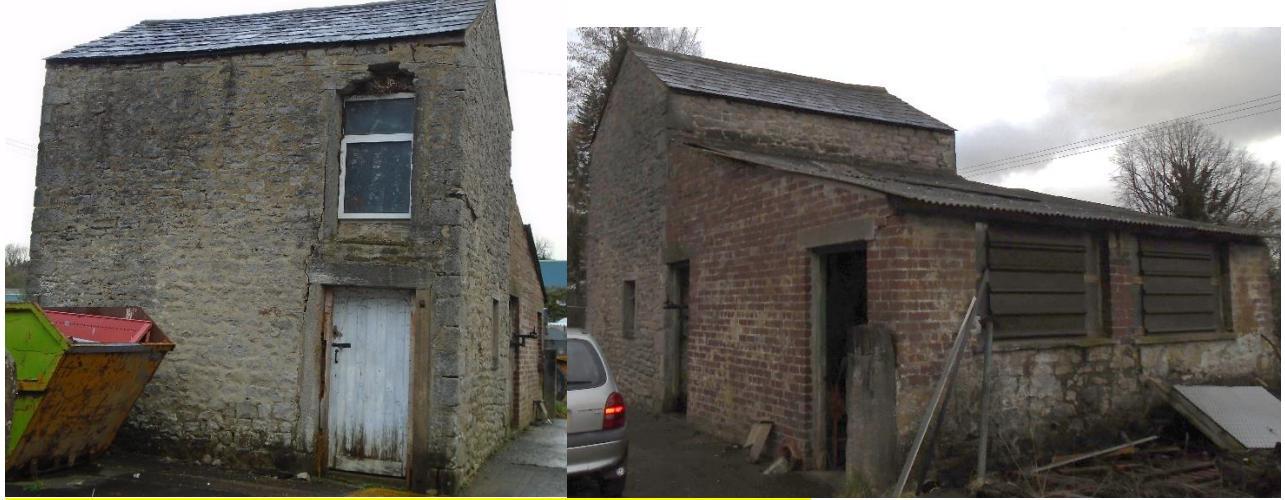
South and west elevation

**Rear north elevation**

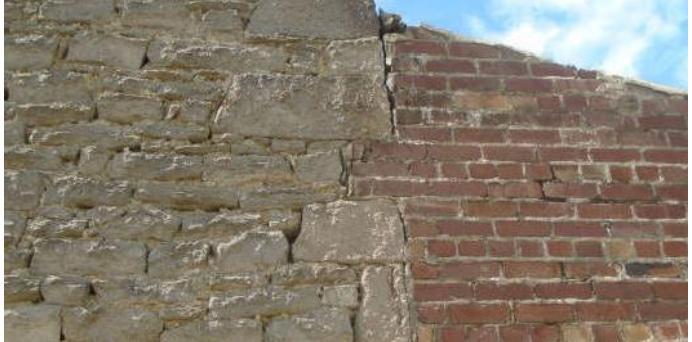
The main building walls are random natural stone with flush pointing The lean to has brick walls.

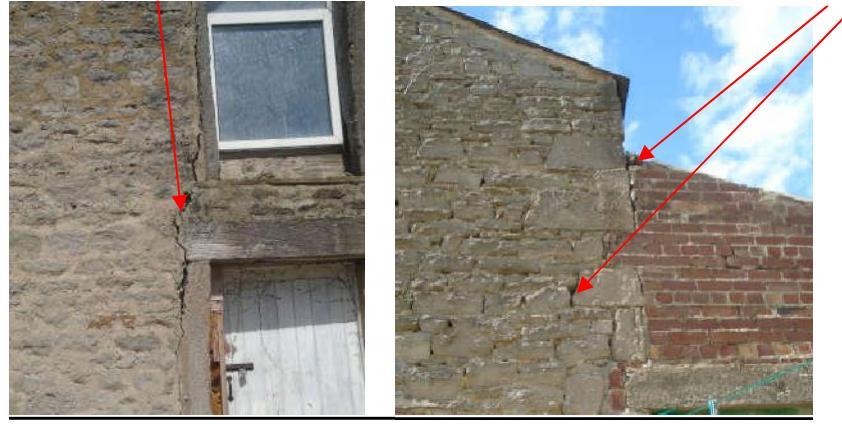
The front elevation pointing is generally in tact with the exception of a crack to the left hand side of the door and window jamb. The east elevation has a couple of cracks/ crevices

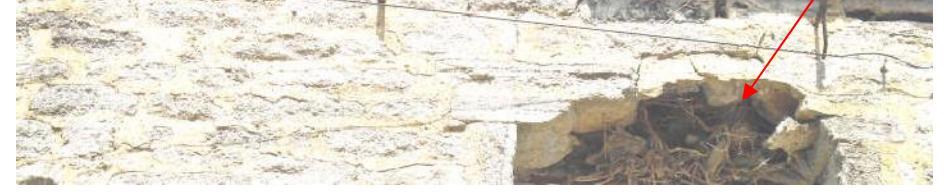
The head of the front window was missing and has some historic plant growth.

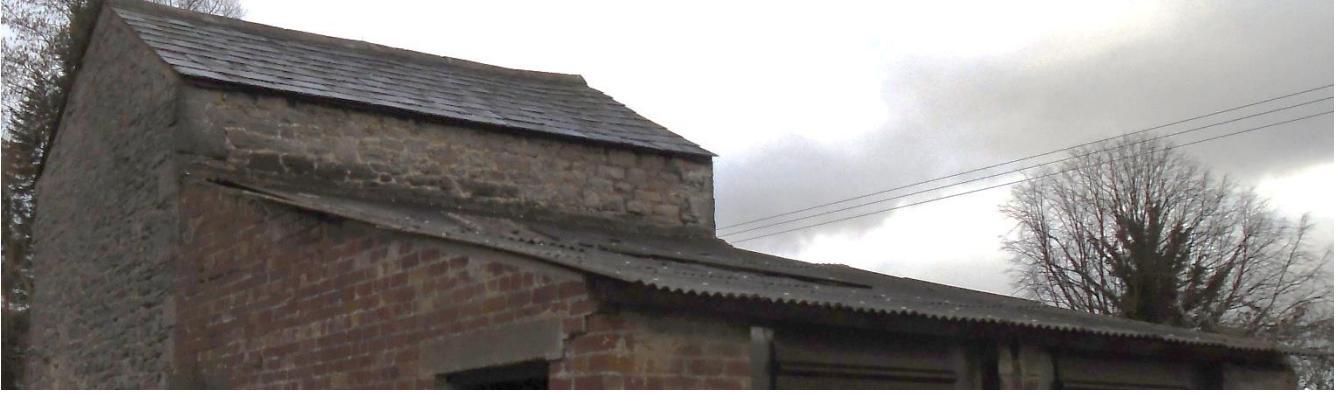
The pitched roof was examined from ground level with the aid of binoculars. The blue slate finish is in good condition with no gaps or slipped slates. The ridge tiles are well pointed with no cracks. The roof does not provide any access points to the interior nor any cracks or crevices accessible to bats.

The lean to roof is corrugated fibre cement sheet , it is in poor condition with some missing and slipped sheets.

The interior is accessible to bats however the sheets do not provide any potential roost habitat.

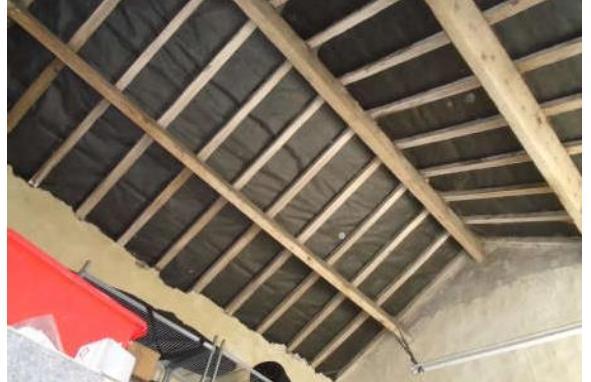
Main pitched roof did not have an enclosed roof space and was examined from the first floor level the structure appeared relatively new, the timbers and underlay were in excellent condition free from any cracks, crevices or rot. The eaves were inspected to ensure there were no access points. Evidence of current or historic use by bats or other protected species was not recorded.

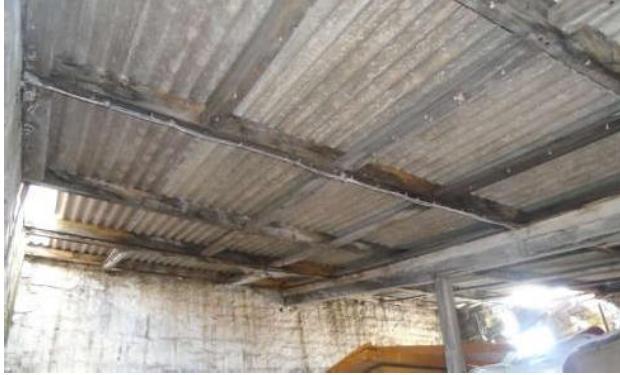
The lean to roof does not have an enclosed roof void, it has a timber supporting structure with corrugated sheets fixed directly over. Although the building was not fully accessible the structure was totally visible. The roof did not provide any potential roost habitat for bats.

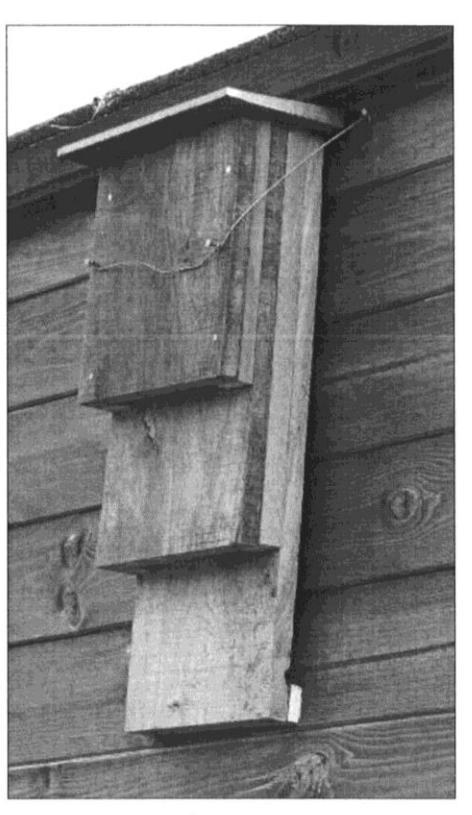
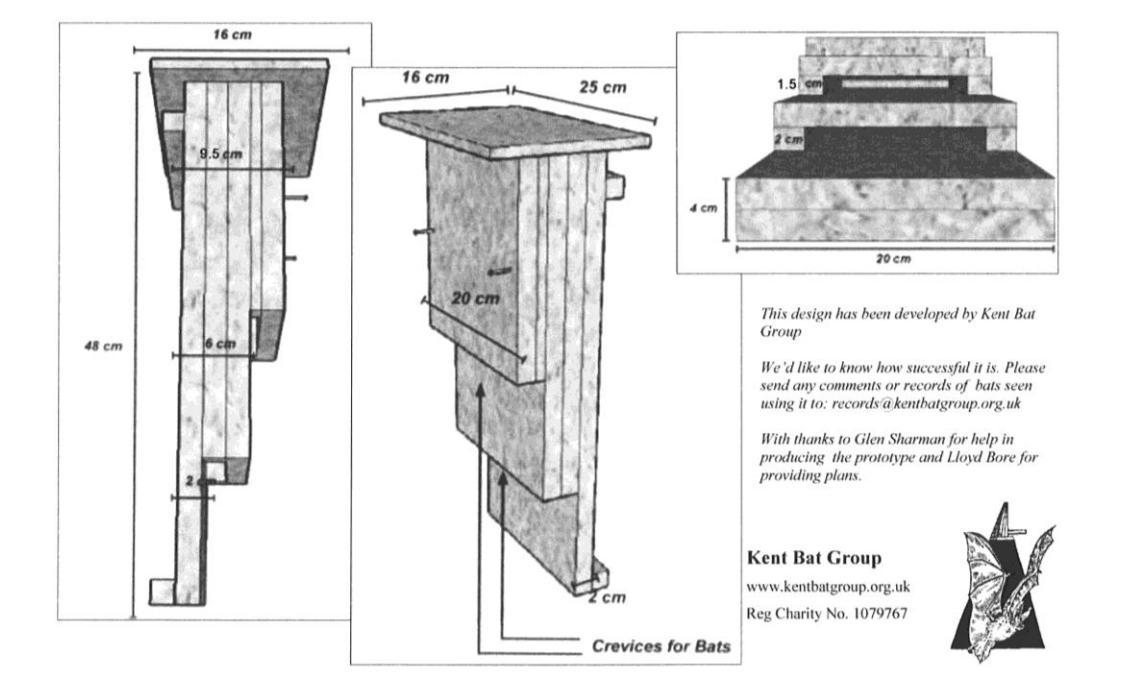
# The Kent bat box

Simple to construct, self-cleaning and low maintenance.

The only critical measurement is the width of the crevices—these should be no larger than suggested. Other measurements are approximate.

Box to be made from untreated rough-sawn timbers Timber should be c,20mm thick The box should be rainproof and draught-free Crevices can be between 15 and 25 mm wide

Fixing may be by use of brackets, durable bands or wires

Due to the previous lack of Bat activity in this location .No mitigation or further scoping survey effort is required however due to the high level of forage and roost potential near the location, roost enhancement should be Included on the new House and Outbuilding by fixing Kent bat boxes to the walls in the locations shown on dwg no.5765-13A See below for details
