Bat Survey Report (preliminary day-time survey): 2 Station Close, Wilpshire, BB1 9PT

Survey Date: 21/3/24

Report Date: 27/3/24

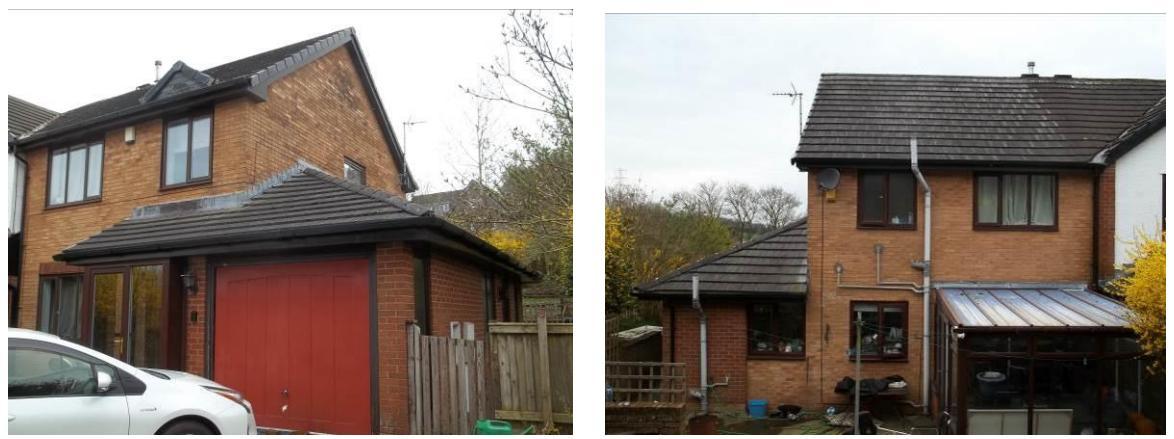
Front (west) and rear elevations

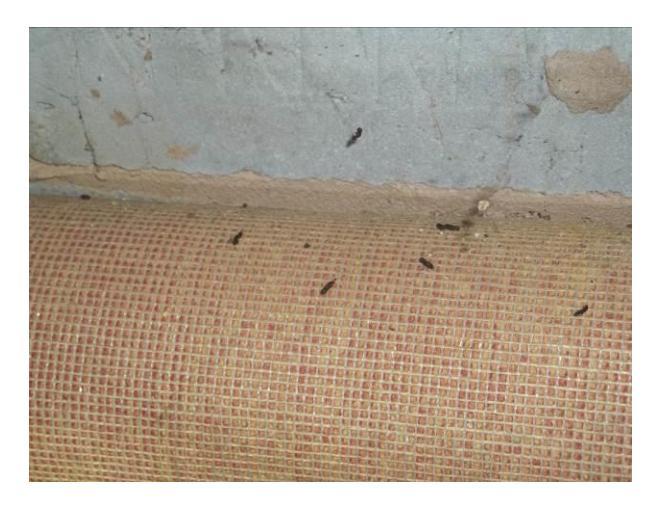
However, a few bat droppings were evident on a roll of stored carpet and on the wall:

These droppings looked quite fresh.

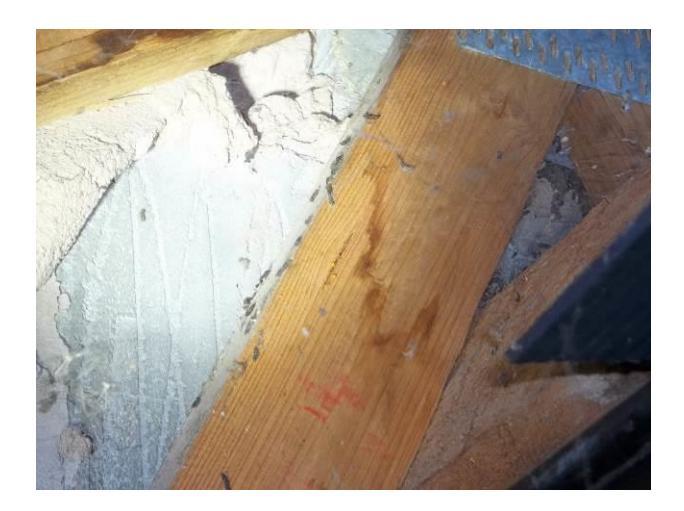
It was possible to photograph behind the water tank, revealing more droppings on the truss alongside the gable wall:

These looked older.

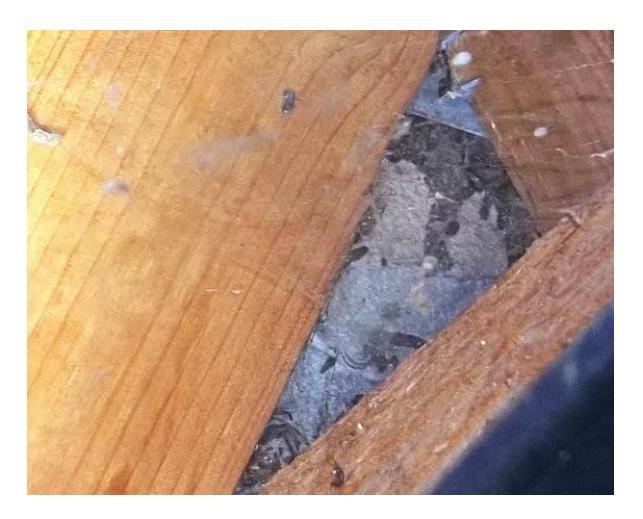
A few more were evident on the wall immediately below the apex:

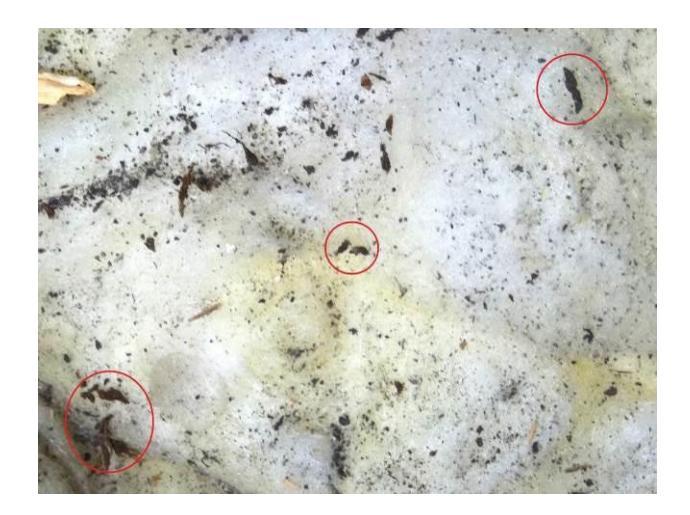
Amongst general debris, a few more were seen on top of the insulating material:

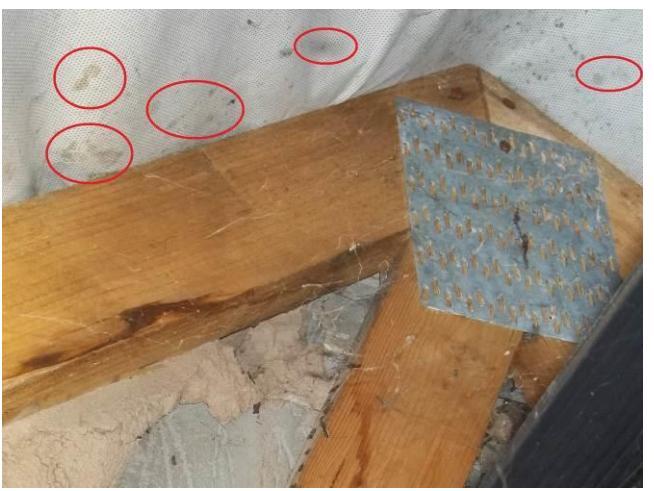
It is possible some of the staining on the breathable membrane, with which the roof is lined, is the result of bats roosting between the tiles and felt:

Possible staining from bat presence above, illustrated in red

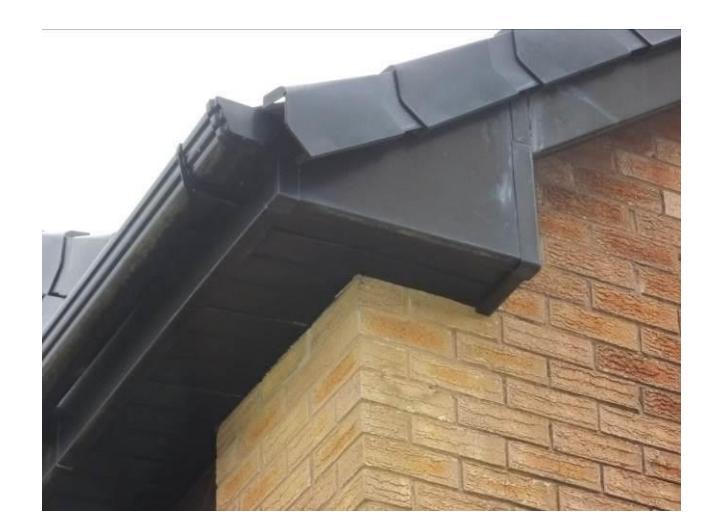
Externally, the property is fitted with a dry verge and the eaves are sealed:

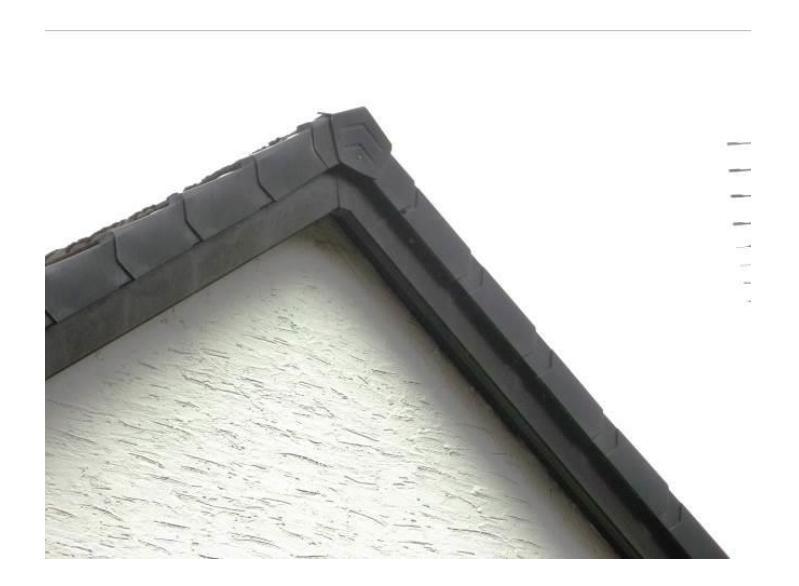
Although it wasn't possible to stand next to the wall to visualise and photograph the soffit, due to the presence of the single-storey garage, this seemed to include the gable end, including the gable apex:

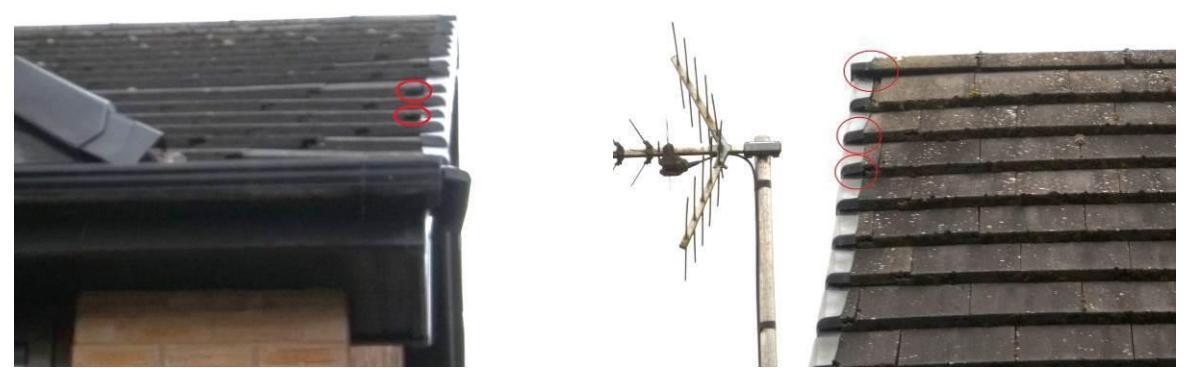
Accordingly, it's uncertain how bats are gaining access, but if it's not at the soffit, it's probable there are some gaps where bats can get behind the dry-verge:

Gaps possibly allowing bats access, shown in red

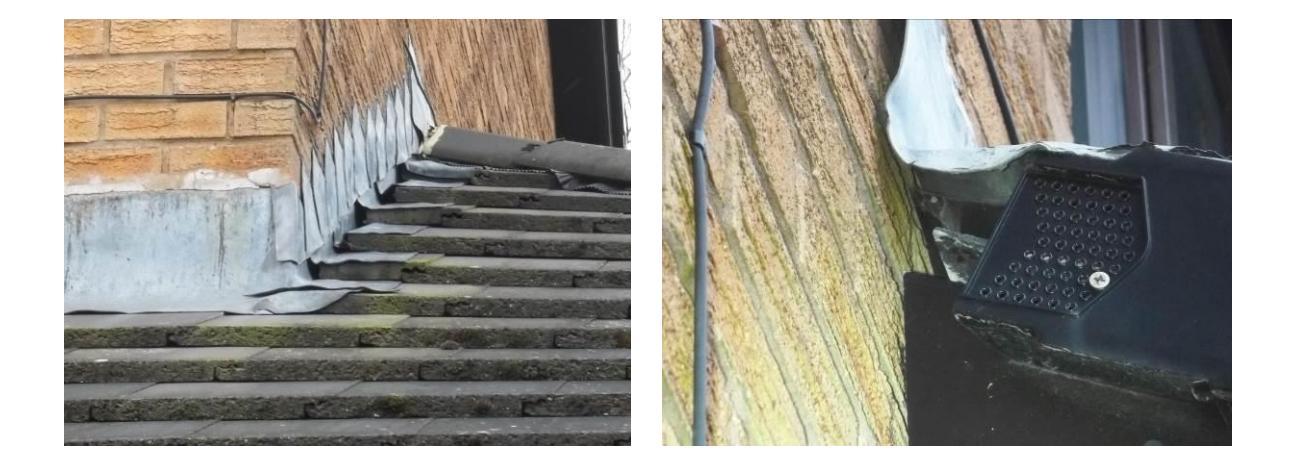
Otherwise, there is bat access behind both flashing and the dry-verge to the singlestorey, attached garage:

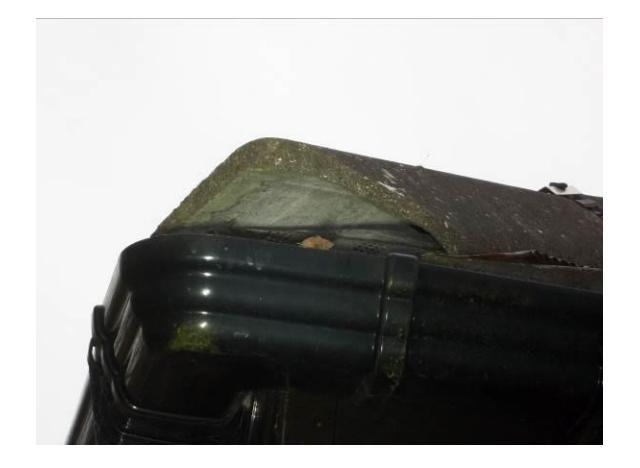
There is also access available under hip ridge tiles to the garage:

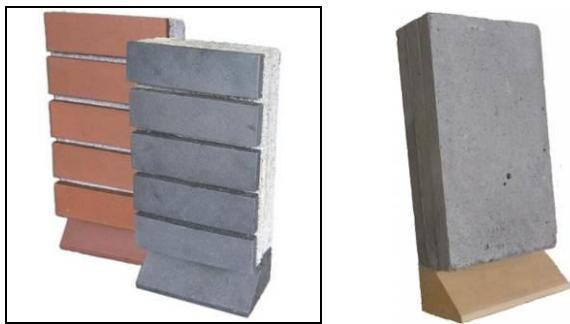
"Designed to be built into an exterior wall and is available in a variety of faces to match the building. Standard facings of red or blue brick - ideal for new builds - are normally available from stock, or boxes can be made to your specific requirements with a face of brick, stone, timber, or plain (for rendering). Supplied un-pointed."

Example of Habibat boxes Can also be faced with stone.

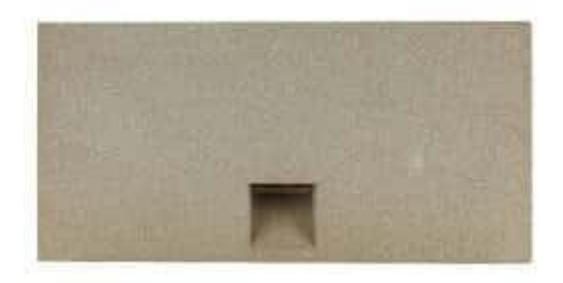
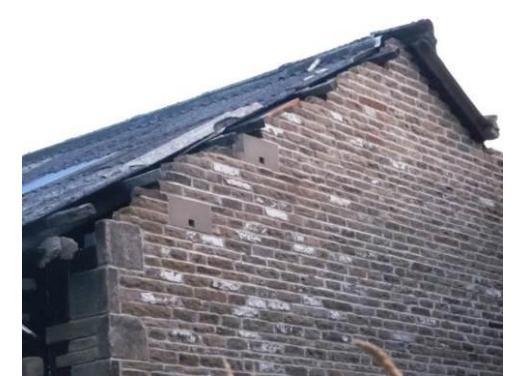
Dimensions: 440 x 100 x 215mm, with a 60 x 55mm aperture.

Above: typical unit of this design in situ. Photo © Angela Graham

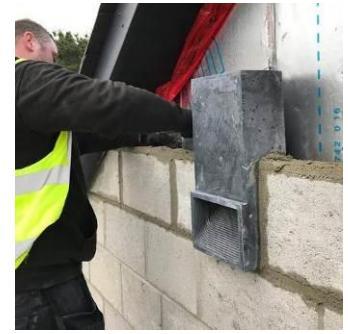
Green and Blue Bat Block/Brick in situ
