## BS 5837:2012 Arboricultural Impact Assessment

Report No. 2026\_AIA.01 Project: Barnacre Road Primary School Authored by: Matthew Lally

#### ARBORICULTURAL IMPACT ASSESSMENT

Barnacre Road Primary School Barnacre Road Longridge Preston PR3 2PD

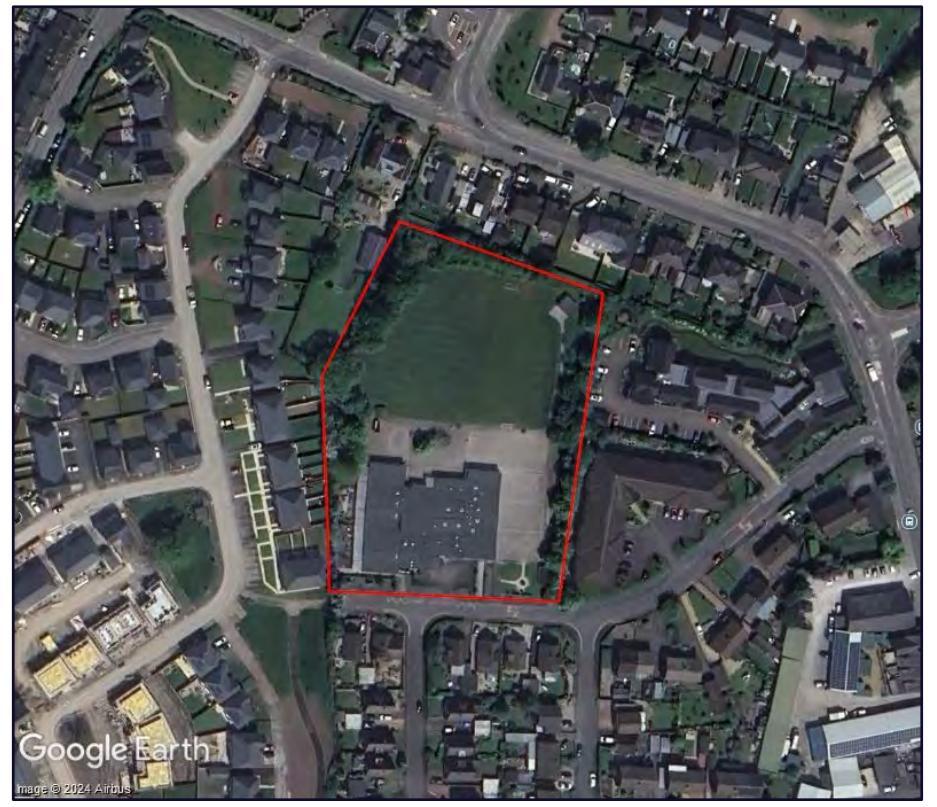
Figure 1. Assessment boundary plan.

1.4.3. I attach below an outline overhead photograph of the area that was assessed on the 18/09/2024. (This is not necessarily the site boundary but includes trees that I deem could be impacted by the development regardless of ownership)

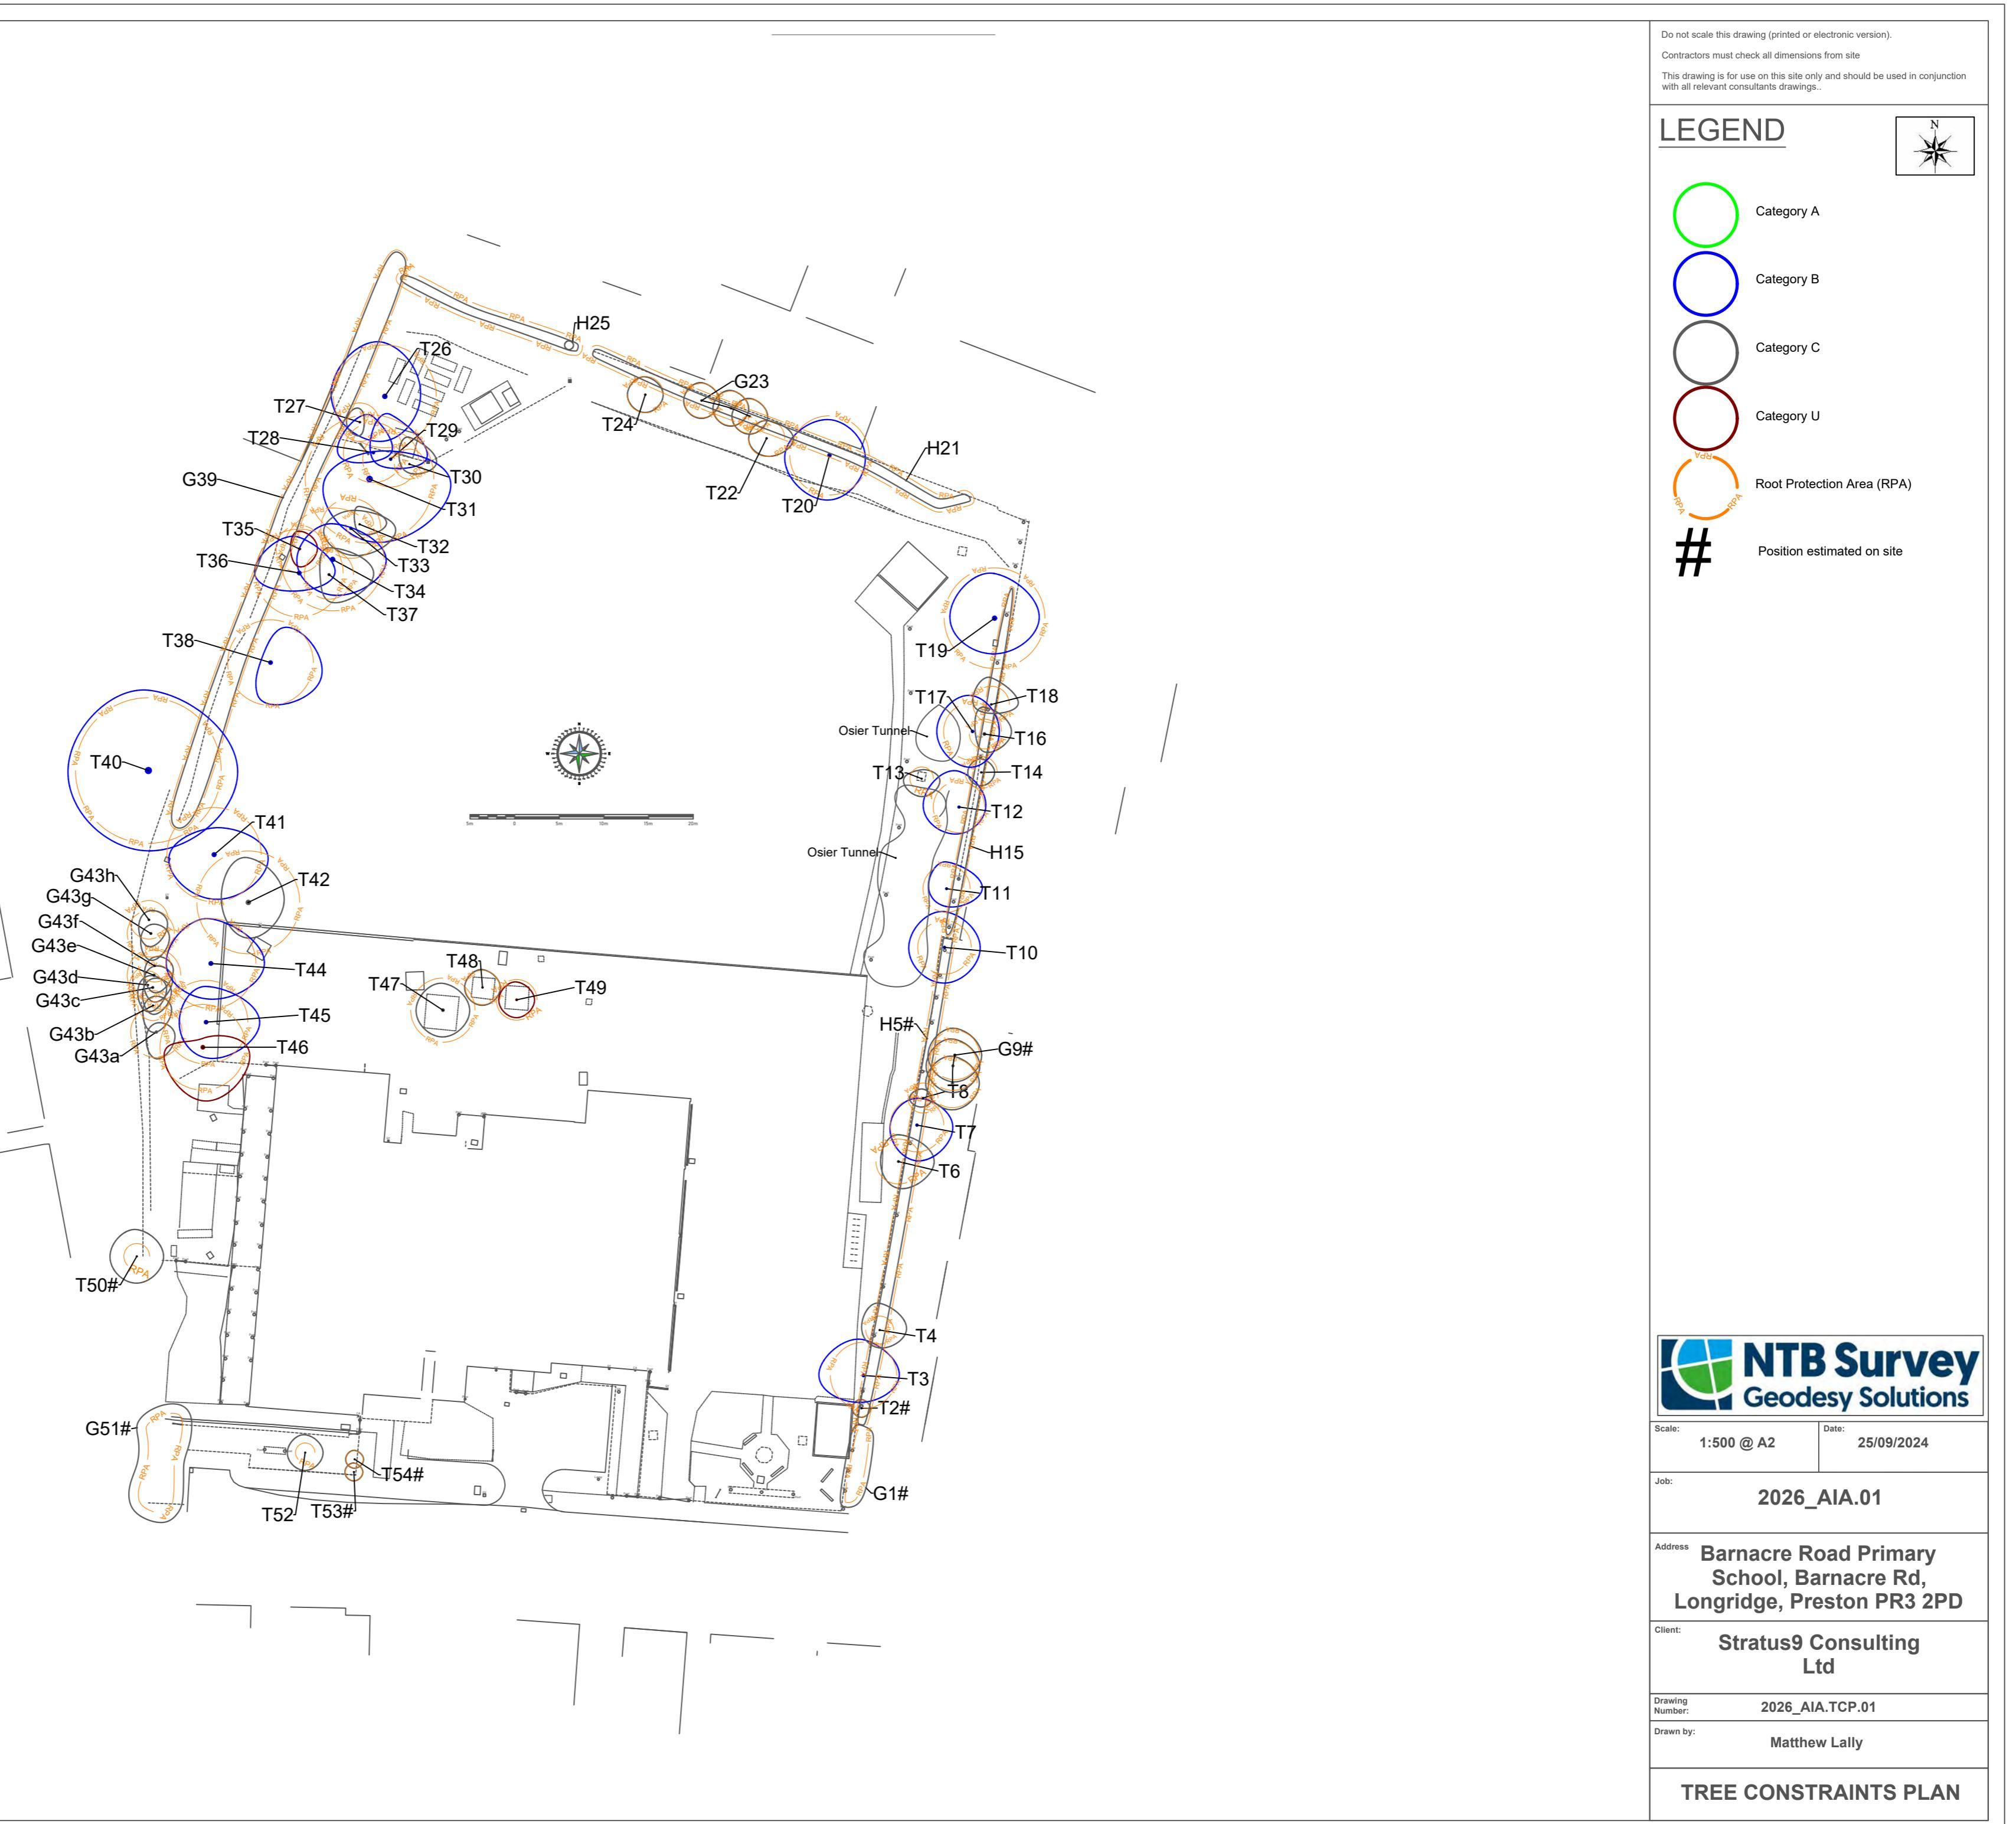
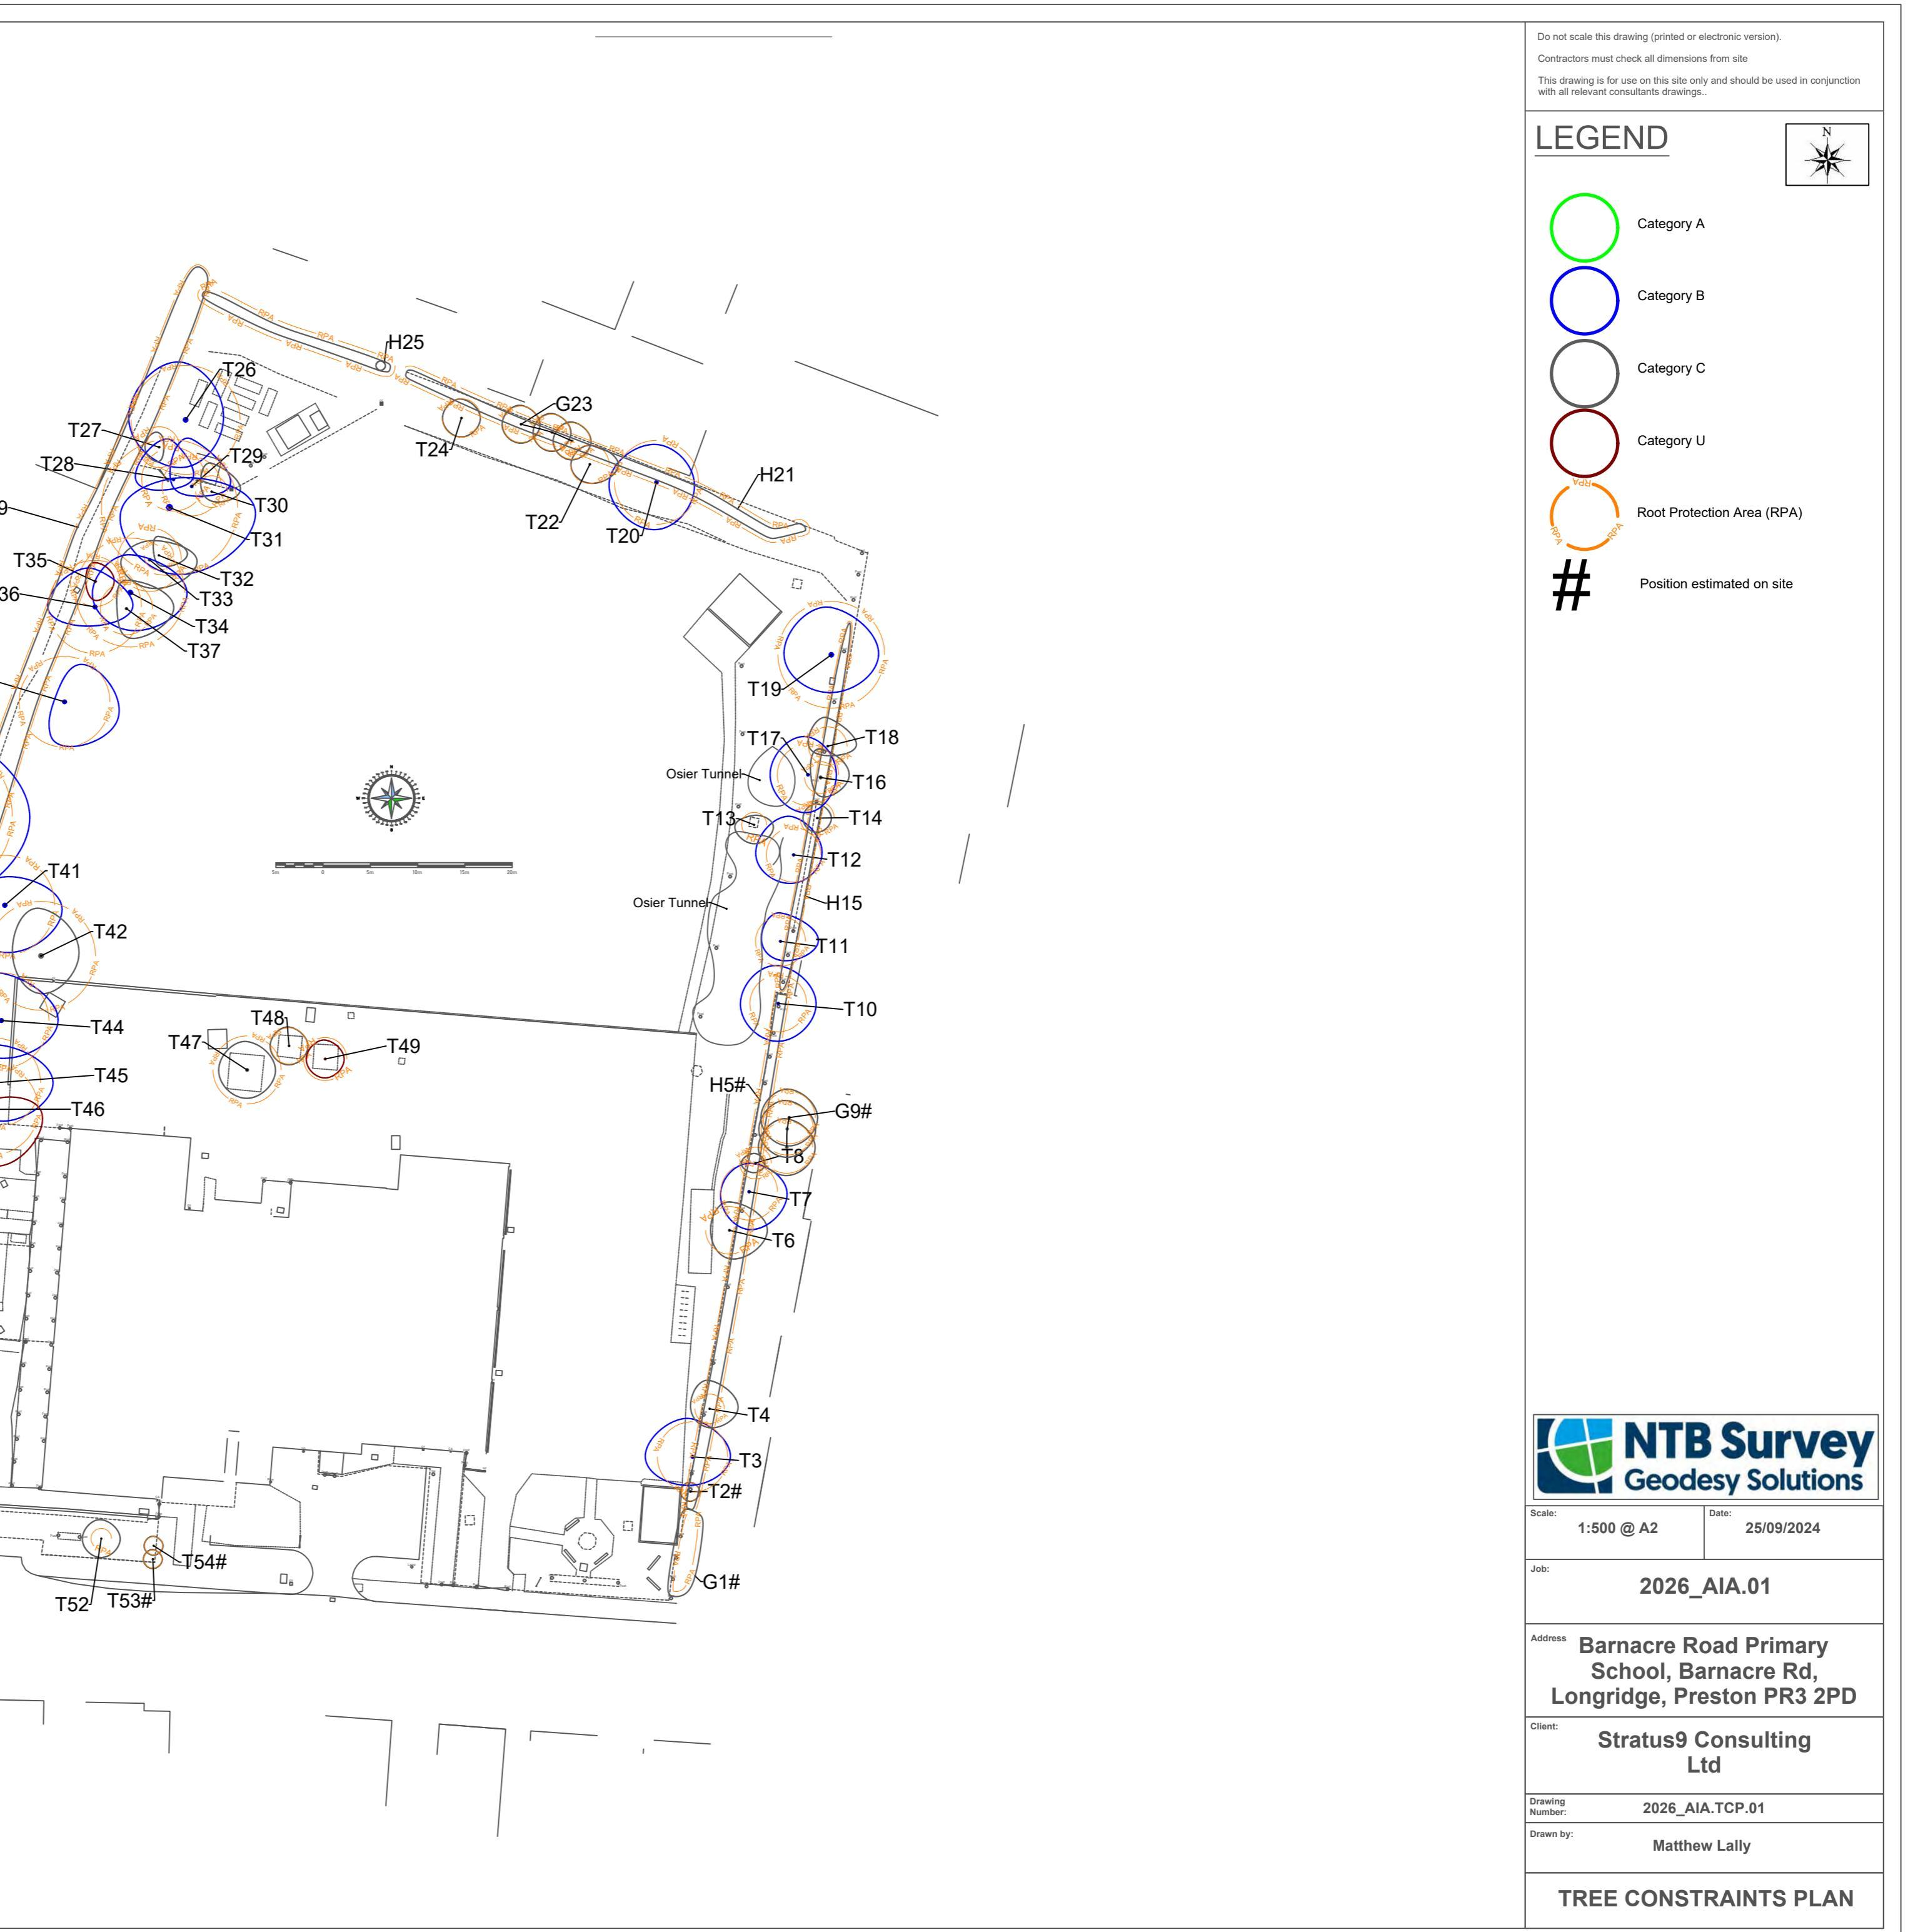
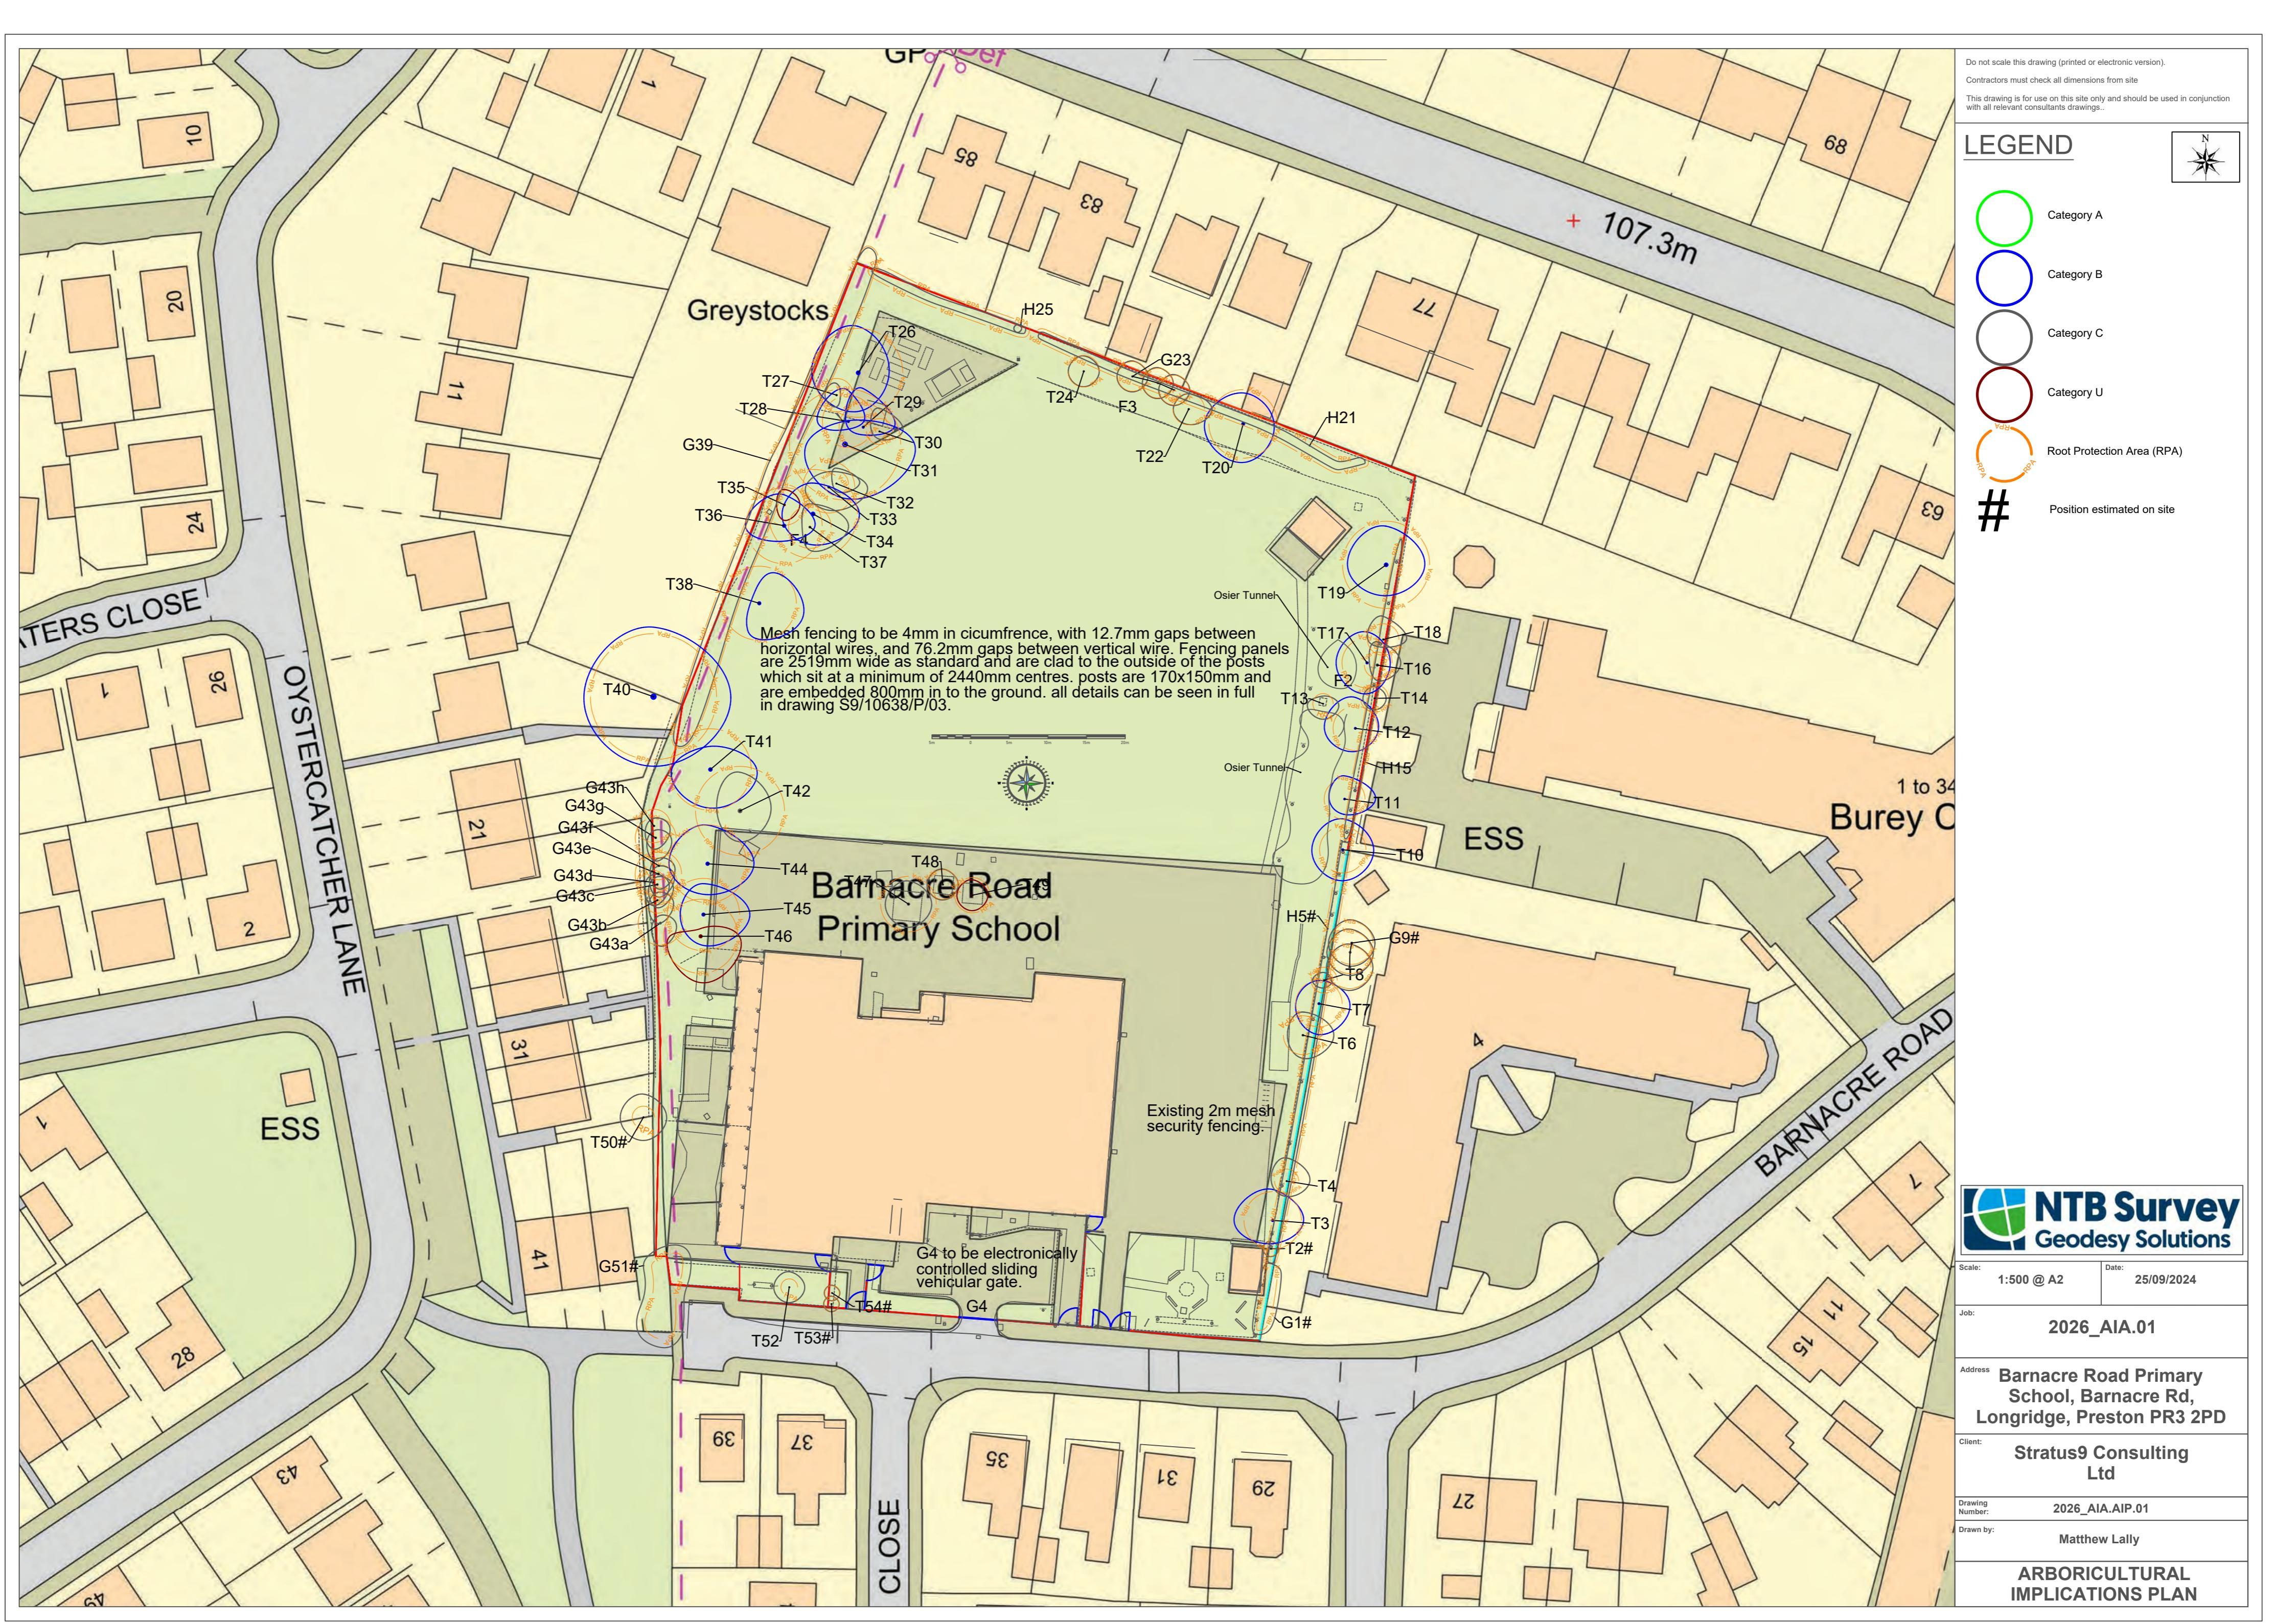
## Appendix IV Tree Constraints Plan & Arboricultural Implications Plan

- 2.2.2. The Tree Constraints Plan was created using computer aided design software and the topographical survey. The plan shows the tree crowns, tree stems and the root protection areas in relation to the surrounding buildings and other site features.

- 2.2.5. I have shown the Root Protection Area (RPA) on the plans in appendix IV for each individual tree as a circle centred on the base of the stem which is based on the recommendation of the British Standard.

- 6.2.1. I have overlayed the proposed site plan ref: 10638-P-01onto the existing site plan using computer aided design software and found a number of locations in which there are conflicts with existing trees. I have made this plan available in appendix IV titled Arboricultural Implications Plan.

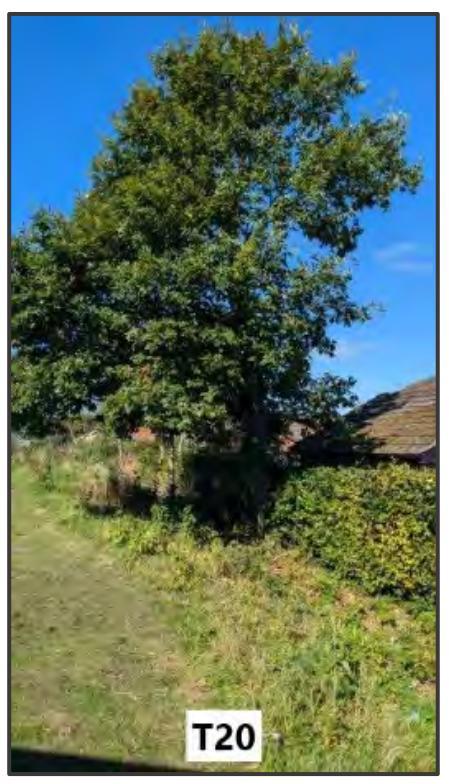
Picture 22. T20

T20	English Oak	370	62	4.44	12	SM	4	4	5	5	2	A	Good form and vitality. Open balanced spreading crown. Limb on N side of crown recently failed on to adjacent third party garage. Dense ivy covering stem and primary branch framework - prevented detailed inspection.	Sever ivy and complete a risk of harm survey.	40+	B1
H21	Beech	75	3	0.9	2	SM to EM	0.5	0.5	0.5	0.5	0	A	Well maintained boundary line hedgerow. 1.75m in height. No significant defects noted.	No action required.	10+	C2
T22	Rowan	170	13	2.04	4	EM	2	3	2	2	2	В	Reduced vitality. Low aesthetic value. Open balanced crown. Acute primary unions.	No action required	10+	C1
G23	Beech	160	12	1.92	7	SM	2	2	2	2	2.5	В	Linear group of x3 trees. Stems from lapsed hedgerow management historically. Single roughly straight stems. Reduced vitality - chlorotic foliage. Low aesthetic value.	No action required.	10+	C2

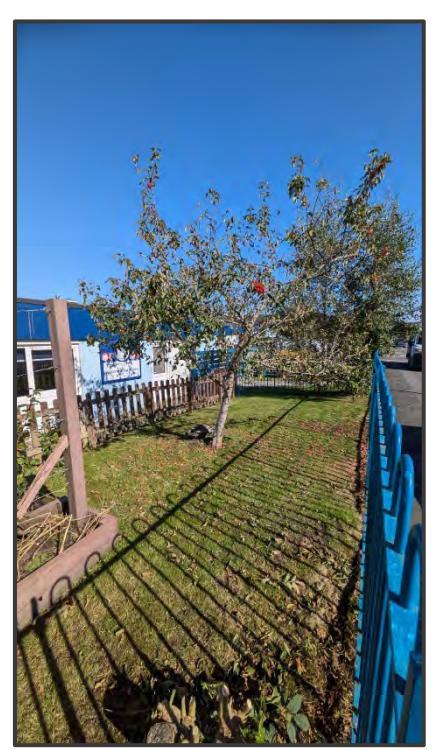
Picture 47. T52

T52	Crab Apple	90	4	1.08	3	SM	2	2	2	2	1	A	Open balanced crown. Minor strimmer damage at base. No significant defects noted.	No action required.	10+	C1
T53#	Silver Birch	75	3	0.9	4	Y	1	1	1	1	0	A	Single straight stem. No defects noted.	No action required.	10+	C1
T54#	Silver Birch	80	3	0.96	4	Y	1	1	1	1	0	А	Single straight stem. No defects noted.	No action required.	10+	C1
