PRINGLE HOMES
Job Tifle PROPOSED REPAIR AND REFURBISHMENT WORKS AT CROW TREES FARMHOUSE CROW TREES BROW CHATBURN LANCASHIRE BB7 4AA
Drawing Title ARBOUR: PROPOSED PLAN AND ELEVATIONS
Scale Date Drawn 1:50 @ A2 FEB 2025 MF
SUNDERLAND PEACOCK SUNDERLAND PEACOCK & ASSOCIATES LTD. HAZELMERE, PIMLICO ROAD, CLITHEROE LANCAHIRE, BB7 ZAG 1020 423178 F 01200 427328 E info@sunderlandpeacock.com www.sunderlandpeacock.com
7200 - P10 A

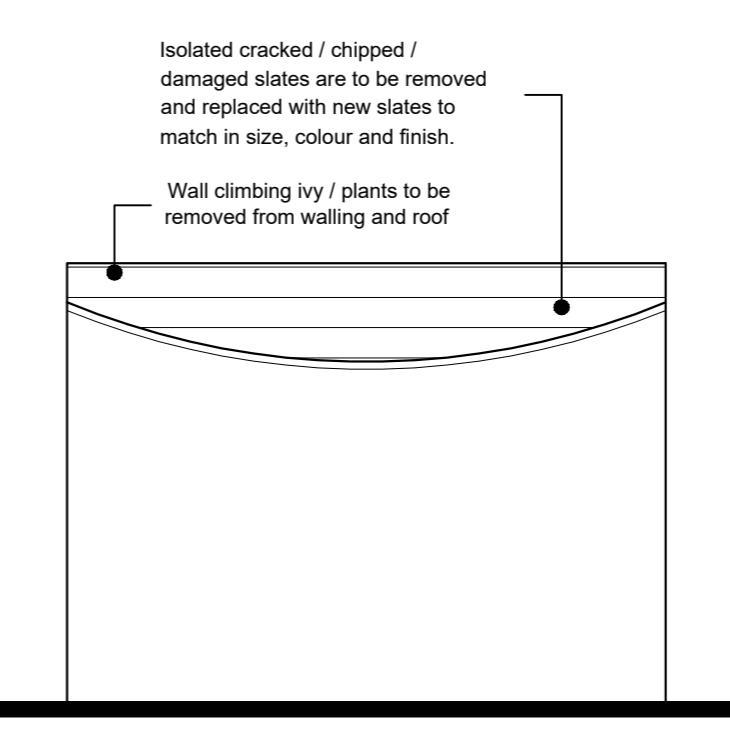
PROPOSED SOUTH FACING ELEVATION

re-pointed.

All re-pointing work is to be undertaken during a period of suitable weather so as to avoid periods of low and high temperatures. This will ensure that the new mortar dries correctly. Where required the existing mortar is to be raked out to a minimum depth of 25mm or twice the width of the joint (whichever is greater). Raking out should be undertaken by hand to prevent damage to the stonework. The exposed joints are to be carefully cleared with compressed air to remove any remaining debris and to ensure that it is not washed down the wall. Affected areas are to be washed with clean water to ensure that the wall is damp. This will encourage a good bond between the stonework and new mortar.

The re-pointing of the affected stonework is to be undertaken using the following mortar specification - 1 part NHL 3.5 to 3 parts well graded, clean / washed, sharp sand. Colour of mortar to have a buff-coloured finish. Mortar to be applied throughout complete with stipple brush finish. Joint / mortar thickness to be well proportioned.

of a churn brush.

The curing of the completed re-pointing is to be managed to prevent it from drying too quickly. This is to be undertake through the use of protective sheeting and the dampening of the affected areas by hand to prevent it from drying too quickly. This should be undertaken for a minimum period of one week after the mortar has cured.

The external stone walls of the Arbour (including verges) are to be inspected for areas of perished and degraded mortar and are to be

All pointing is to take place at the top of the affected areas moving downwards to prevent any dripping water from washing out the new mortar. The new mortar is to be applied and compressed within the joint using a pointing key of a suitable width for the size of the joints. The entire joint should be filled with mortar until it is over filled The new mortar should then be allowed to set before cutting back the excess mortar to create a slight recess between the stones. The surface of the mortar is to receive a stipple finish through the use

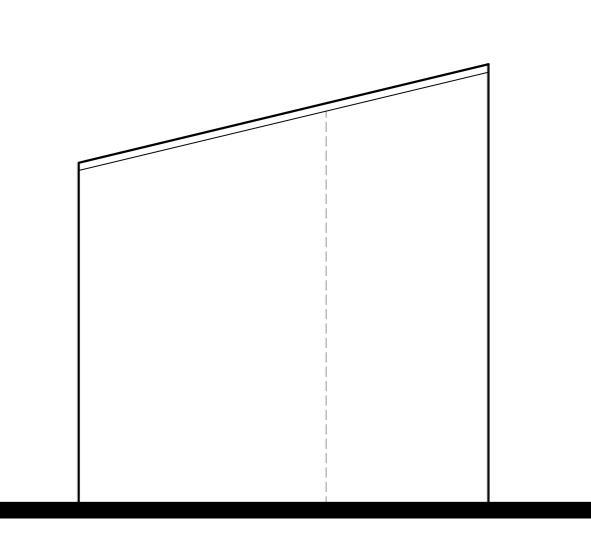
PROPOSED EAST FACING ELEVATION SCALE 1:50

Existing timber purlin to be removed and replaced with a new treated structural timber purlin to Structural Engineers Design and specification.
