Tree Survey

in Relation to Retrospective Planning Application for Formation of Outbuilding to Serve Holiday Let at

Thorneyholme Hall, Dunsop Bridge, Lancashire, BB7 3BB

TREE SURVEY THORNEYHOLME HALL, DUNSOP BRIDGE

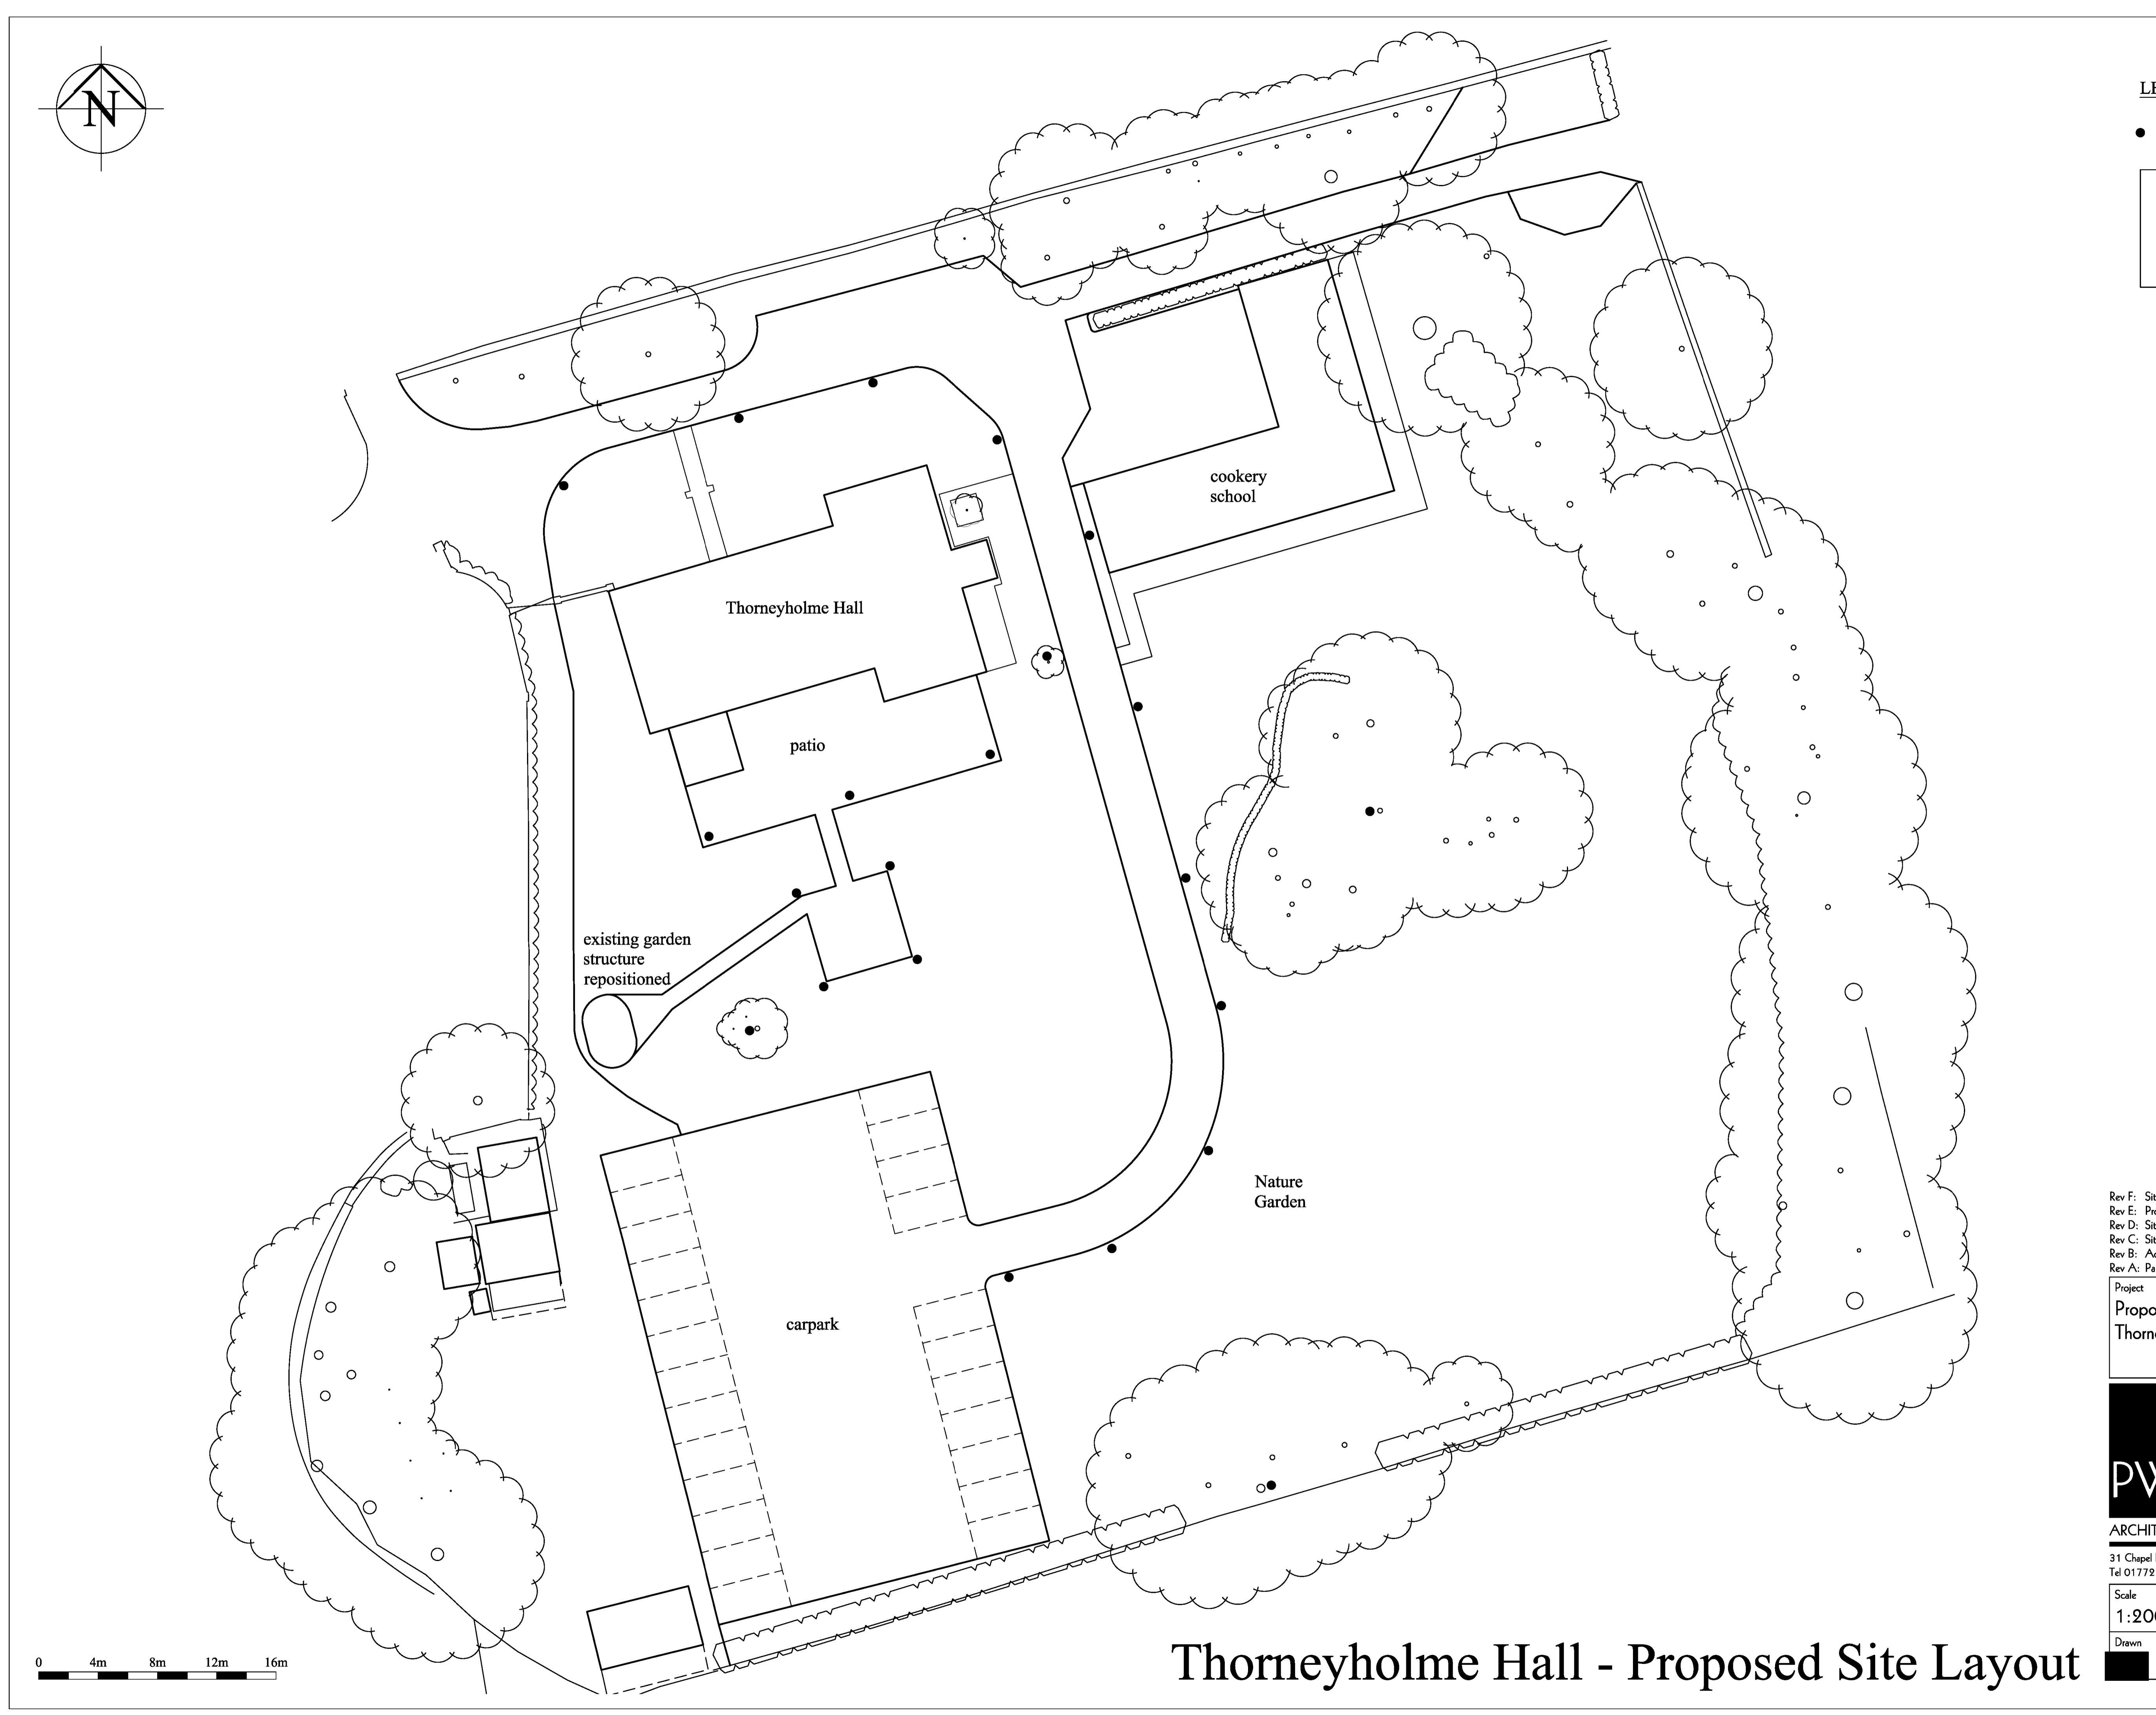
Rev F: Site Layout updated Rev E: Proposed bollard positions indicated Rev D: Site Layout updated Rev C: Site Layout updated Rev B: Accommodation notation altered Rev A: Parking indicated 23-03-21 17-08-20 14-03-19 13-02-19 19-05-17 02-05-17 Project Proposed Development at Thorneyholme Hall, Dunsop Bridge Title Proposed Site Layout PWL ARCHITECTURE 31 Chapel Brow Leyland Tel 01772 467404 E d Preston PR25 3NH E Mail: info@pwlarchitecture.com Scale Date March 2017 1:200@A1 Drwg No 1178-PL-22F
