STATEMENT OF SIGNIFICANCE
Including Heritage Impacts and Mitigation Assessment
Moorcock Inn, Waddington Fell, BB7 3AA

Mssrs A & S Thornber

Rev. E. For Issue 12 April 2013

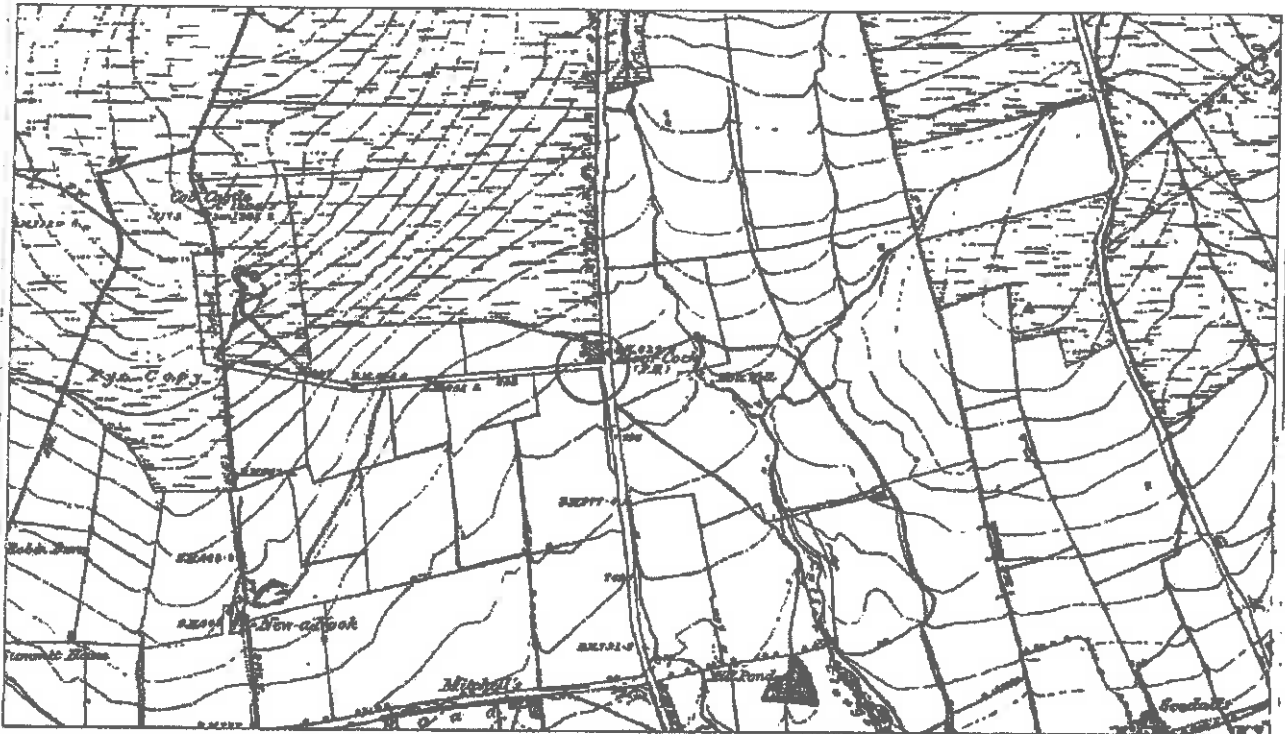
Moorcock Inn 1890

- 2.2 The 1890 map shows the name changed to Moor Cock (P.H) suggesting that the building was, by 1890, in use as a public house. Maps show what also appears to be a paddock or pound to the north. (Farmers moving livestock in the traditional way may have used a secure pound on overnight journeys to or from markets in Clitheroe).

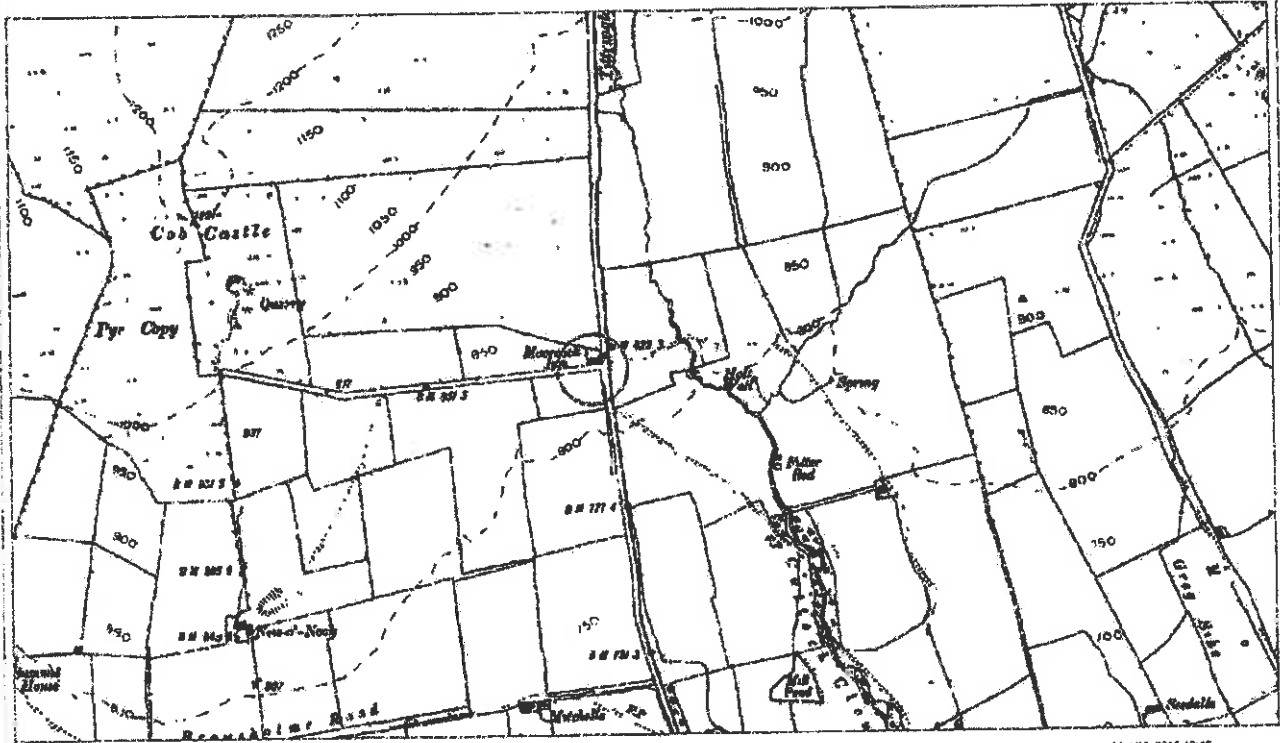
Moorcock Inn 1909

- 2.3 The 1909 map shows the name changed to Moorcock Inn and the paddock or enclosure at the rear is no longer shown. A single storey outbuilding is shown to the rear which is clearly ancillary to the main building and traditionally-built from stone and slate. There is also a lean-to on the east side of the building, possibly to provide travellers with cart storage. Image 5 of Appendix B we believe could be dated between 1890 and 1909 by tallying the name of the building in the photo to the map regression. This image also shows that the east road-facing section (referred to in the footprint analysis as Range B, as not yet being built).

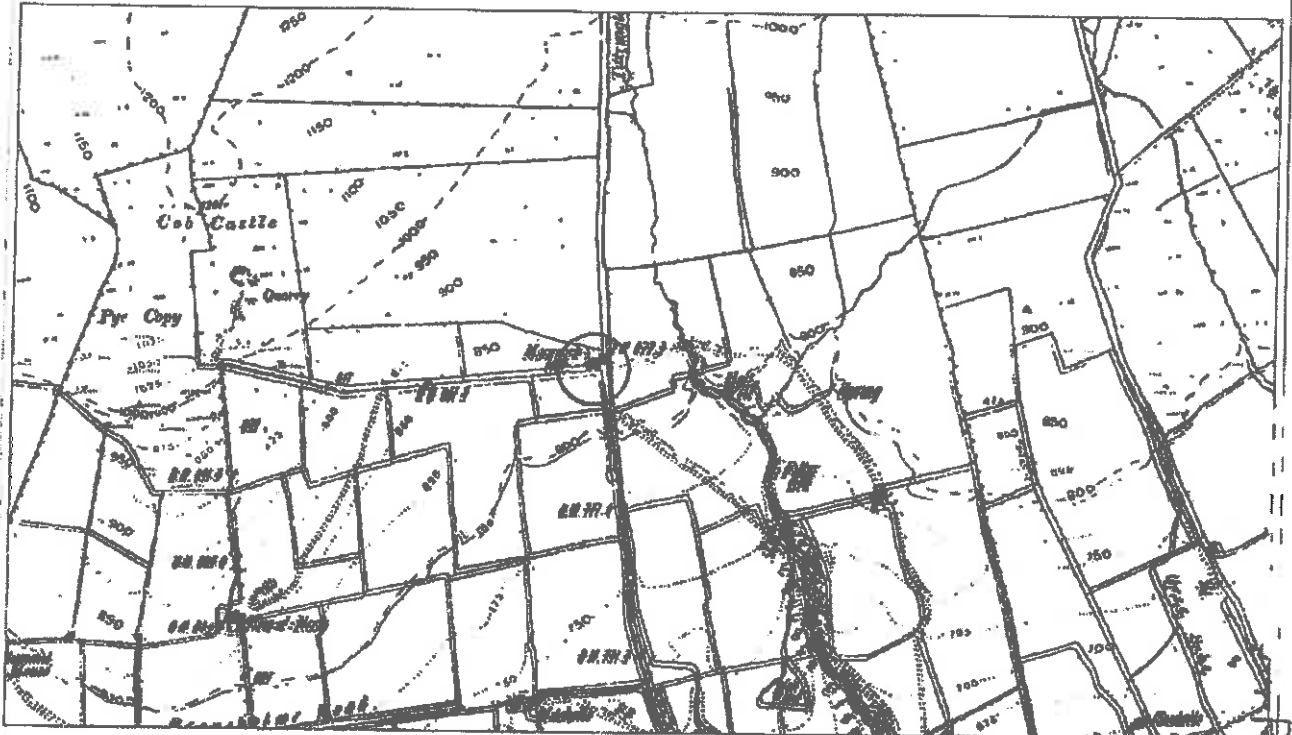
Moorcock Inn 1914

- 2.9 The quality of the 1914 and 1930 maps are poor and show little change to the building. By 1955 there appears to be a side extension and the chamfered cornered building (Range B) extant. In fact, Image 2 at Appendix B is dated 1925 and also shows Range B as extant. It is fair to conclude, then, that the single storey range to the rear of the old farmhouse (Range A) was demolished and Range B was constructed between 1909 and 1925. This observation is wholly consistent with the observations made on site.
