Heritage Statement

Re: Newton House, Newton-in-Bowland, Clitheroe

For: Ivan Wilson Architects, Clitheroe

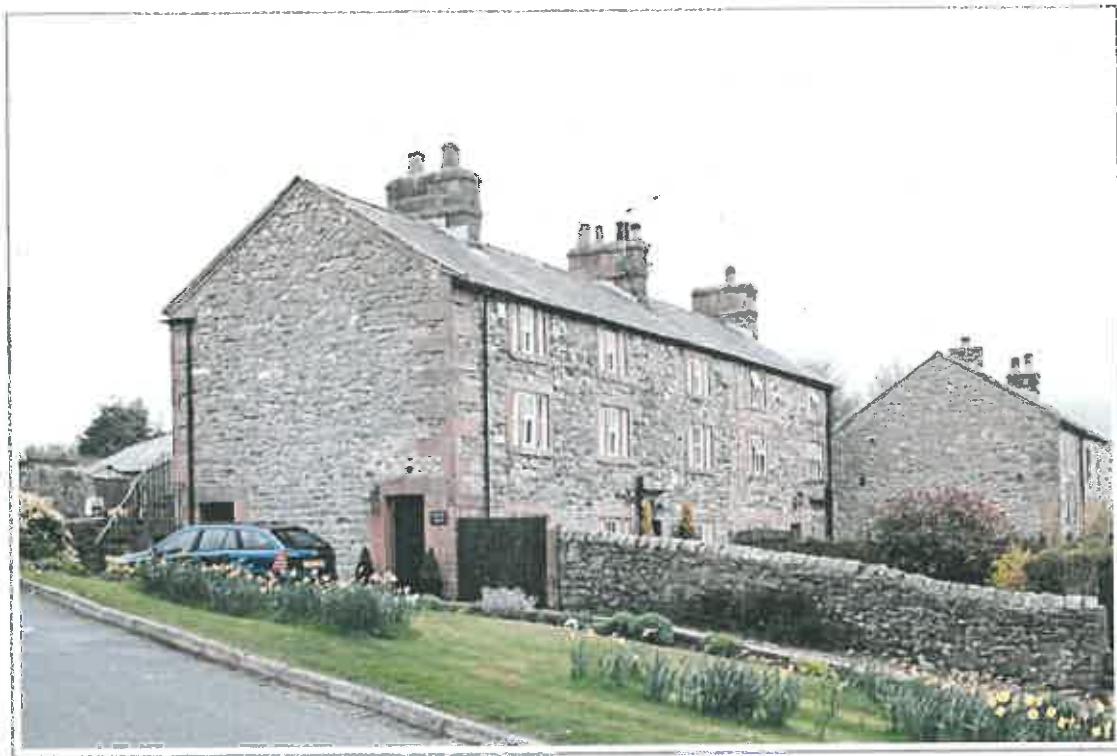
FIG. 1: GENERAL VIEW OF NEWTON HOUSE.

Within the village the building, which is located with its rear elevation to the main Dunsop Bridge to Slaidburn Road and on the corner of the main one of a group of smaller roads which split off from the Clitheroe Road, is more important as a feature from the front. This elevation is by far the more significant and is visible when approaching from the Clitheroe direction. From this point the full three stories are visible with well proportioned and detailed windows (see Fig. 1 above). This elevation is not affected by this application.

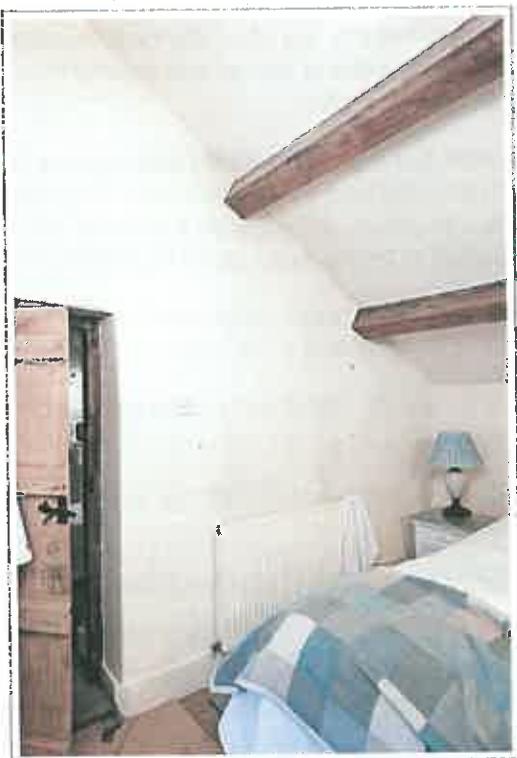
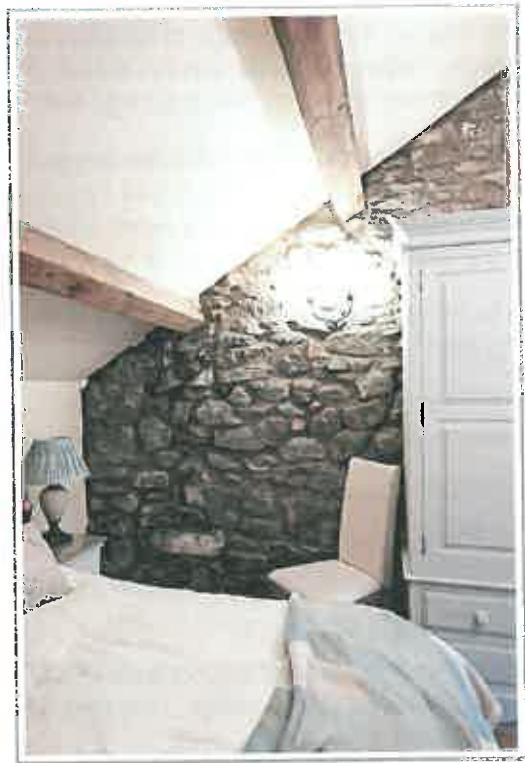
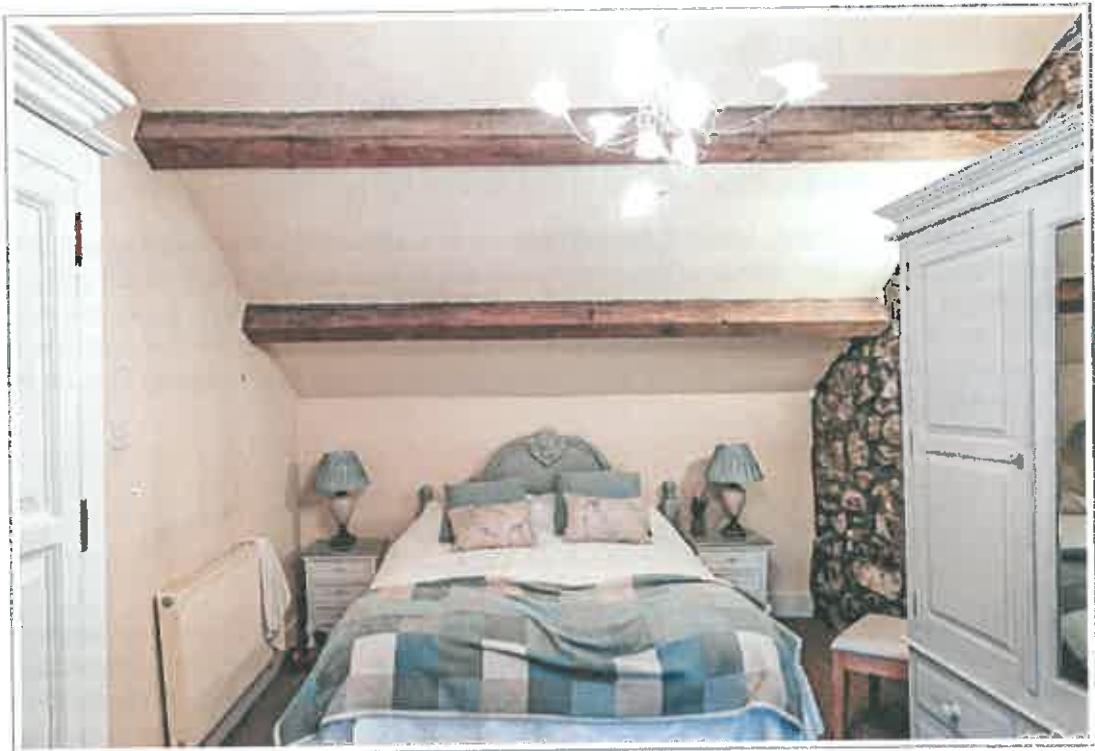
in front of or behind the exposed purlin (see Figs. 2, 3 & 4). Additionally, the fixings to the exposed stone wall should be carried out with minimal damage to the stonework.

If, for reasons of design or Building Regulations, the placing of the partition wall necessarily coincides with the purlin the fixing method should be such as to cause as little damage as possible to the purlin and be reversible in the future.

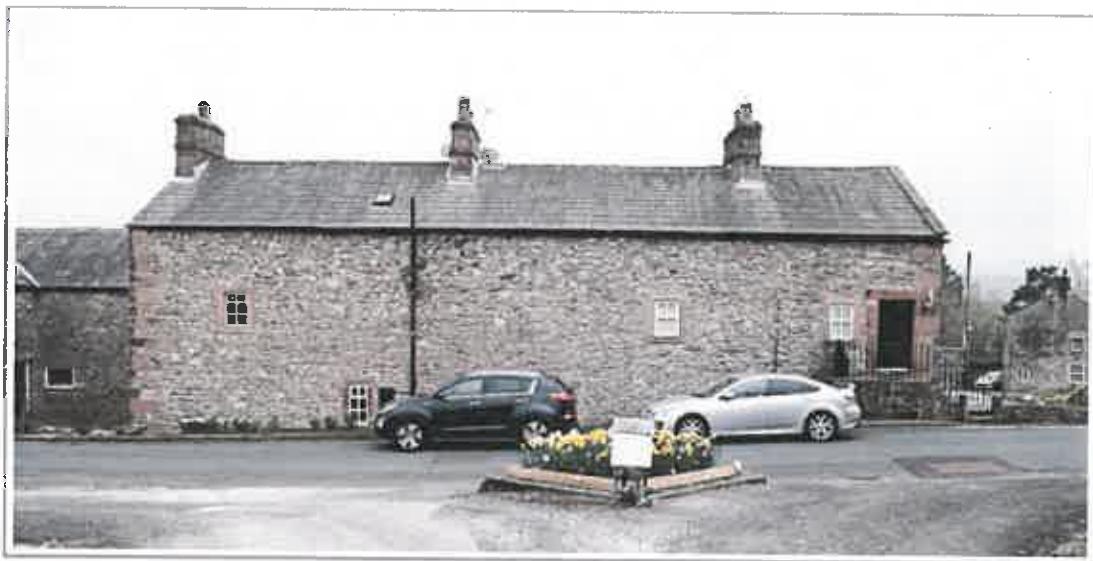
FIG. 5: REAR ELEVATION 1

The proposal to place a soil vent pipe (svp) on the rear elevation would not, in my view, detrimentally affect the appearance of either this building or the village in general. An existing svp is already in existence on this elevation (see Figs. 5 & 6) and these are entirely consistent with many other buildings in the village that have had internal bathrooms fitted over a long period of time. So long as this is fixed and has an appearance and material consistent with the village character I can see no issues arising.

A similar position exists in relation to the proposed roof-light. I am informed that this may not now be included in the planning application; however, figs. 5 & 6 show that an existing 'Heritage' roof-light has been fitted to the roof without visual intrusion. From road level this existing roof-light is not readily visible and certainly not out of character for the village. So long as a new roof-light was of similar appearance and placing in relation to the proposed new svp I can see no issues with it.
