# Heritage Statement

Re: Newton House, Newton-in-Bowland, Clitheroe

For: Ivan Wilson Architects, Clitheroe

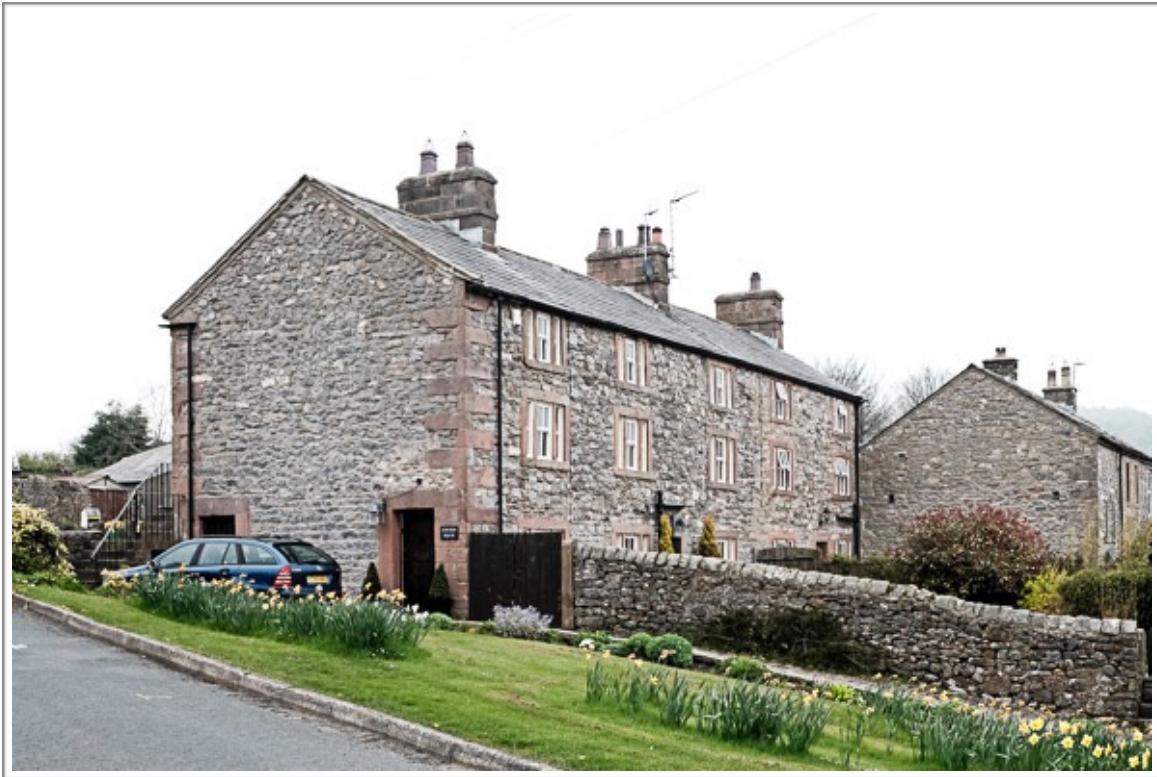
**FIG. 1: GENERAL VIEW OF NEWTON HOUSE.**

Within the village the building, which is located with its rear elevation to the main Dunsop Bridge to Slaidburn Road and on the corner of the main one of a group of smaller roads which split off from the Clitheroe Road, is more important as a feature from the front. This elevation is by far the more significant and is visible when approaching from the Clitheroe direction. From this point the full three stories are visible with well proportioned and detailed windows (see Fig. 1 above). This elevation is not affected by this application.

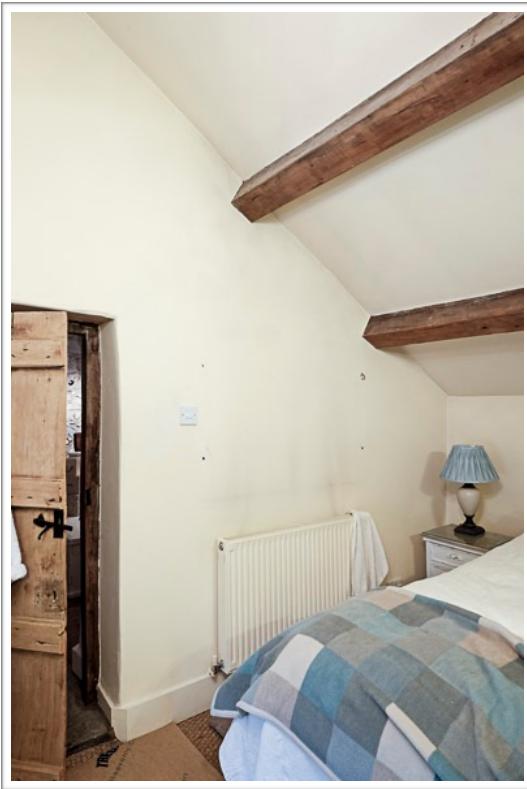
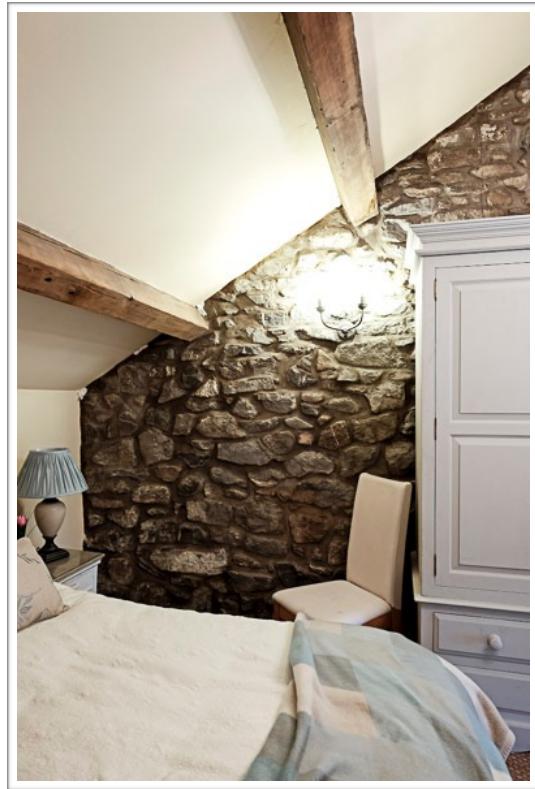
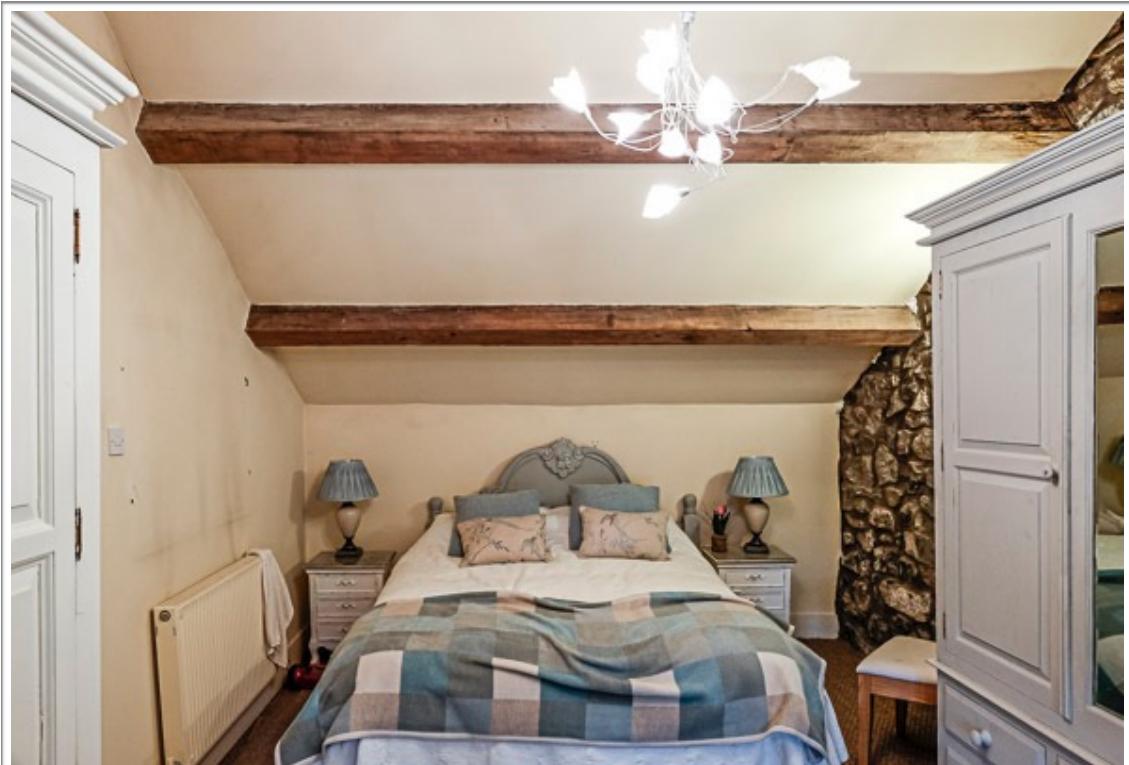
FIG. 2.

in front of or behind the exposed purlin (see Figs. 2, 3 & 4). Additionally, the fixings to the exposed stone wall should be carried out with minimal damage to the stonework.

The building, while still retaining some of its original internal features, has been much altered over a long period of time. However, it is still important that new works are carried out sympathetically. The insertion of an en-suite bathroom into bedroom one on the first floor of this property should be carried out in a reversible manner. If possible, the partition wall dividing the new area off should be built either

If, for reasons of design or Building Regulations, the placing of the partition wall necessarily coincides with the purlin the fixing method should be such as to cause as little damage as possible to the purlin and be reversible in the future.

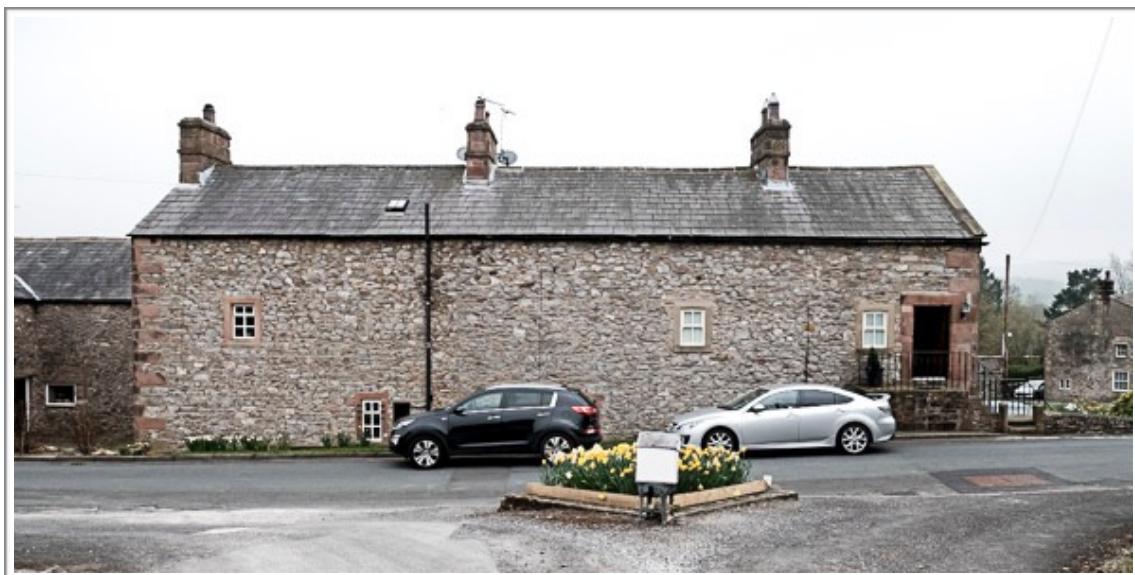
**FIG. 5: REAR ELEVATION 1**

The proposal to place a soil vent pipe (svp) on the rear elevation would not, in my view, detrimentally affect the appearance of either this building or the village in general. An existing svp is already in existence on this elevation (see Figs. 5 & 6) and these are entirely consistent with many other buildings in the village that have had internal bathrooms fitted over a long period of time. So long as this is fixed and has an appearance and material consistent with the village character I can see no issues arising.

A similar position exists in relation to the proposed roof-light. I am informed that this may not now be included in the planning application, however, figs. 5 & 6 show that an existing 'Heritage' roof-light has been fitted to the roof without visual intrusion. From road level this existing roof-light is not readily visible and certainly not out of character for the village. So long as a new roof-light was of similar appearance and placing in relation to the proposed new svp I can see no issues with it.
