**SITE CONTAMINATION ASSESSMENT  
IN CONNECTION WITH  
BARN AT HIGHER BOYCE FARM,  
RIBCHESTER**

**JOB REF: 4874, DATED: 28/09/2015, VERSION: 1.00.**

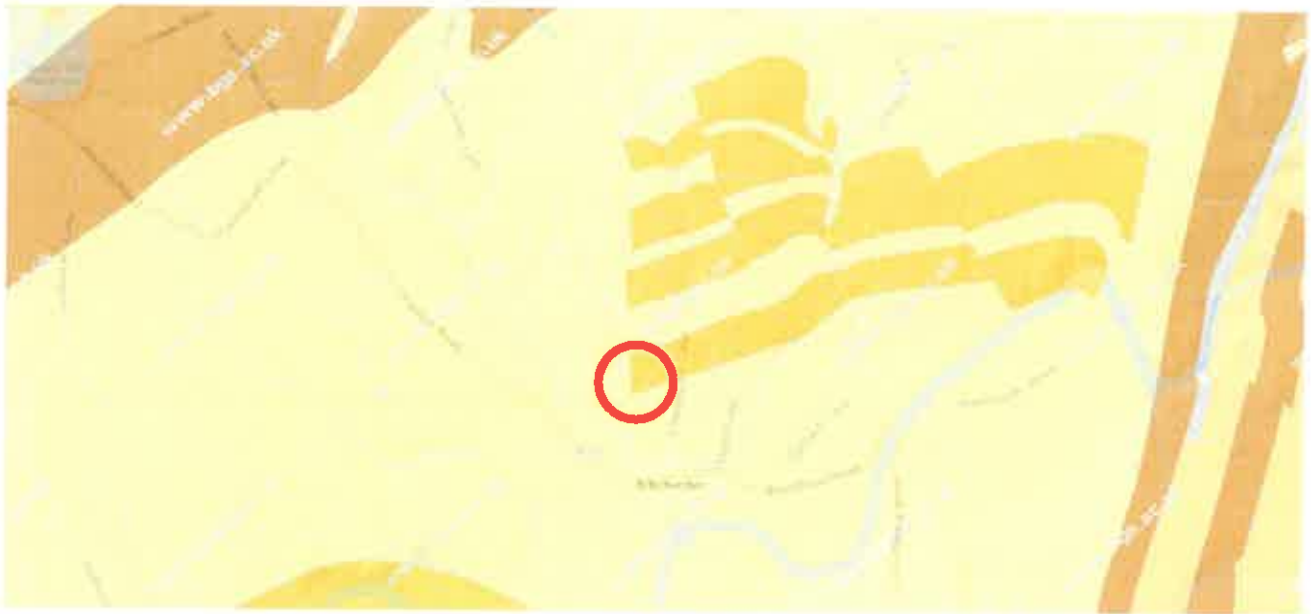
The geology of the application site consists of bedrock comprised of a mixture of Sabden shales in the form of mudstone, siltstone and sandstone. The superficial deposits located above the bedrock consist of a material known as Devensian Glacial Till which is an unsorted rock material which is directly deposited by glacial ice and has no stratification. The map below shows the geology of the site location.

**PL01: Extract of a British Geological Survey Map showing the location of the application site.**
