PROPOSED ELEVATIONS OF GARAGE TO EXISTING COTTAGE

Proposed Elevations

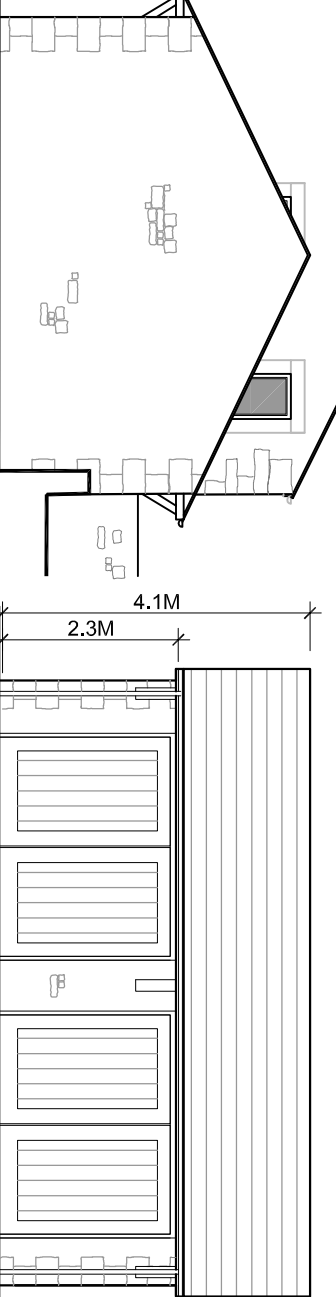
PROPOSED ELEVATIONS OF GARAGE TO BARN 1

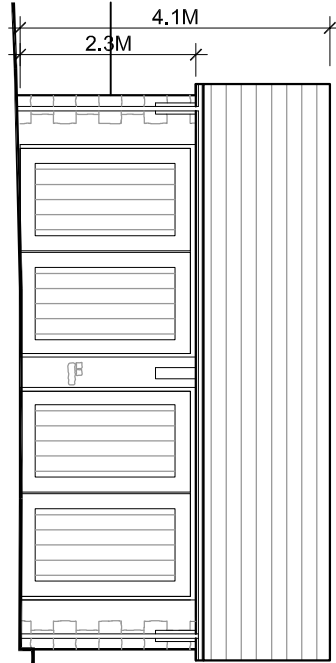
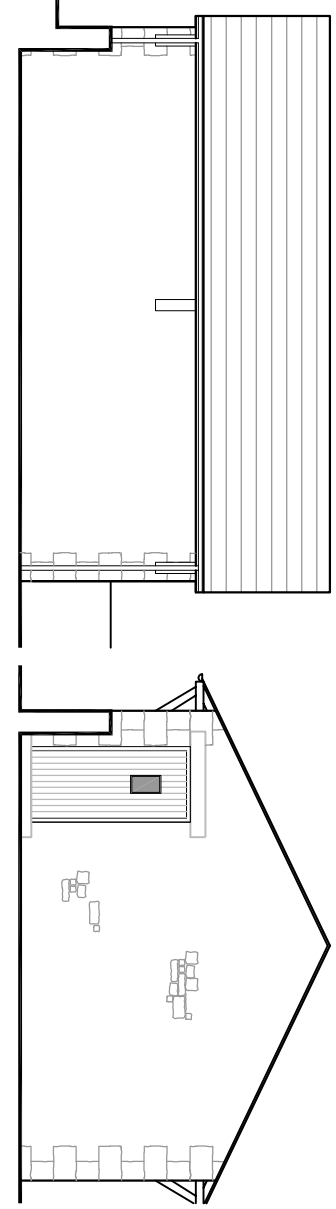
PROPOSED ELEVATIONS OF GARAGE TO BARN 2
