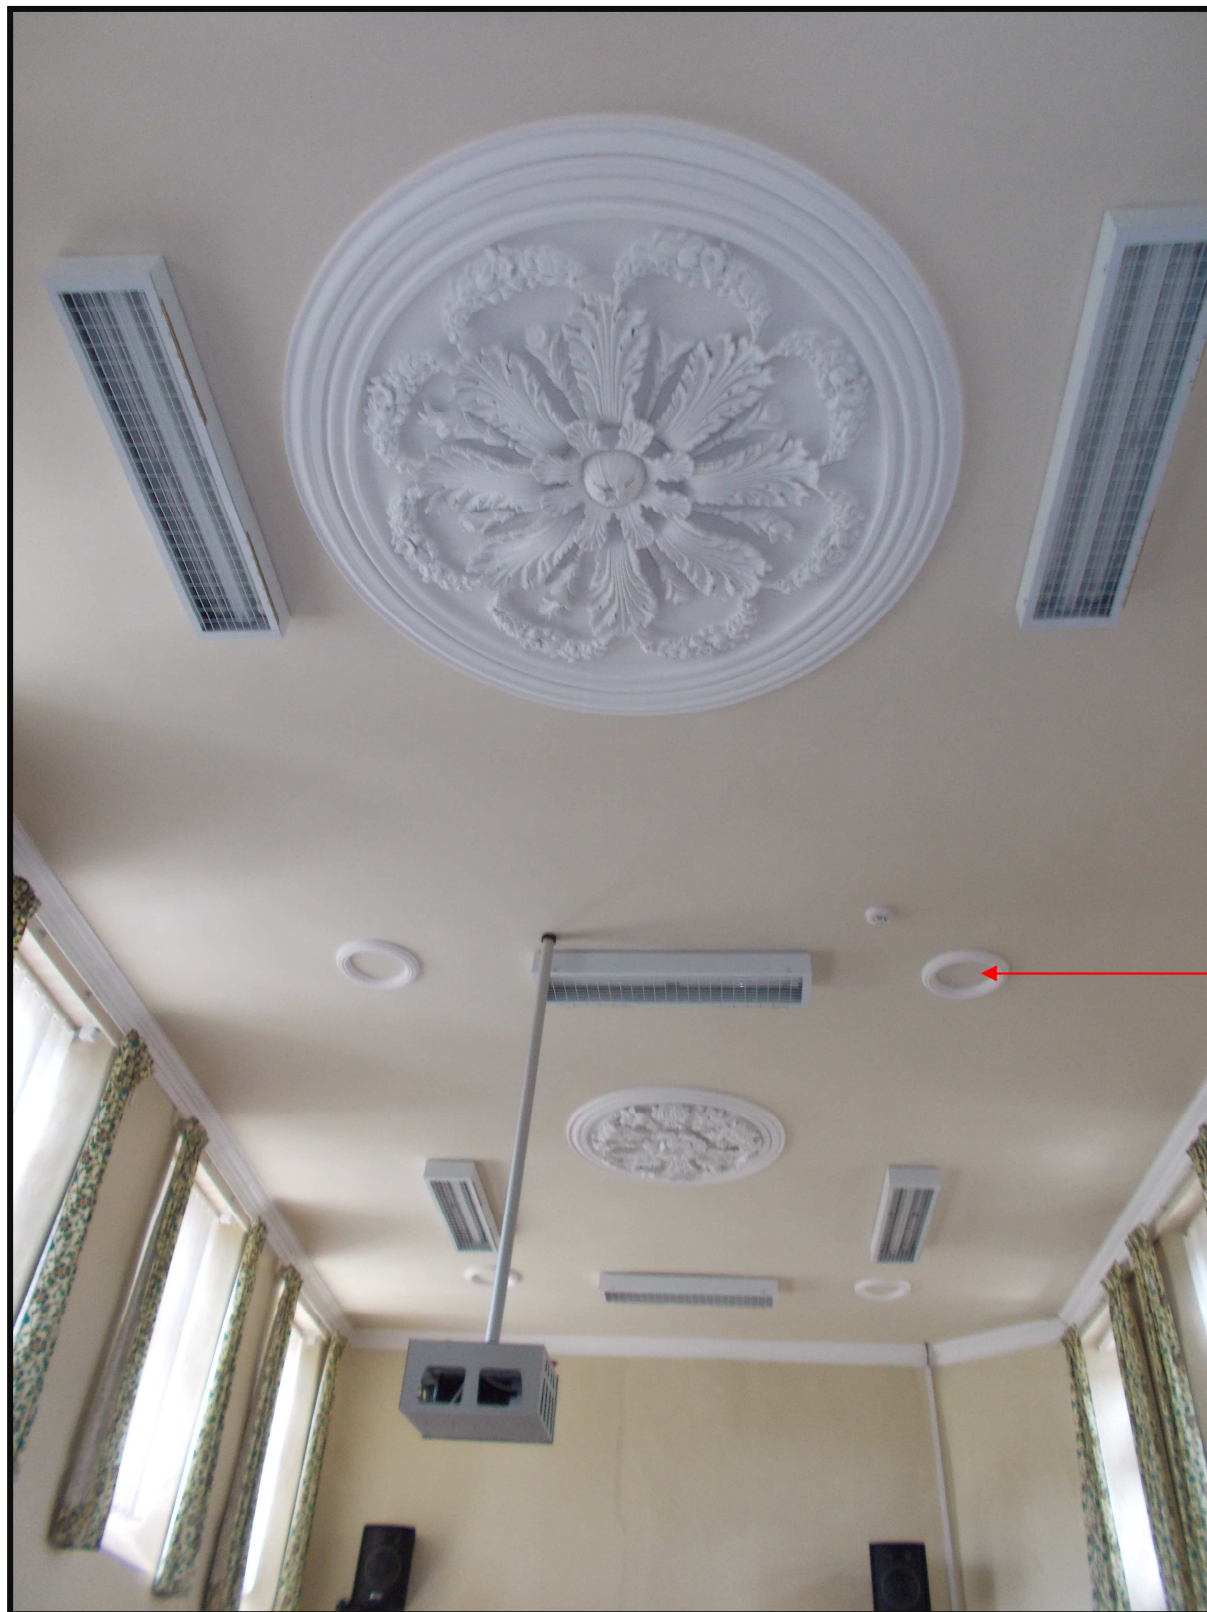
Figure 4 - Represents the existing plaster moulding detail where diffusers are to be installed

Diffusers to be placed within existing plaster moulding

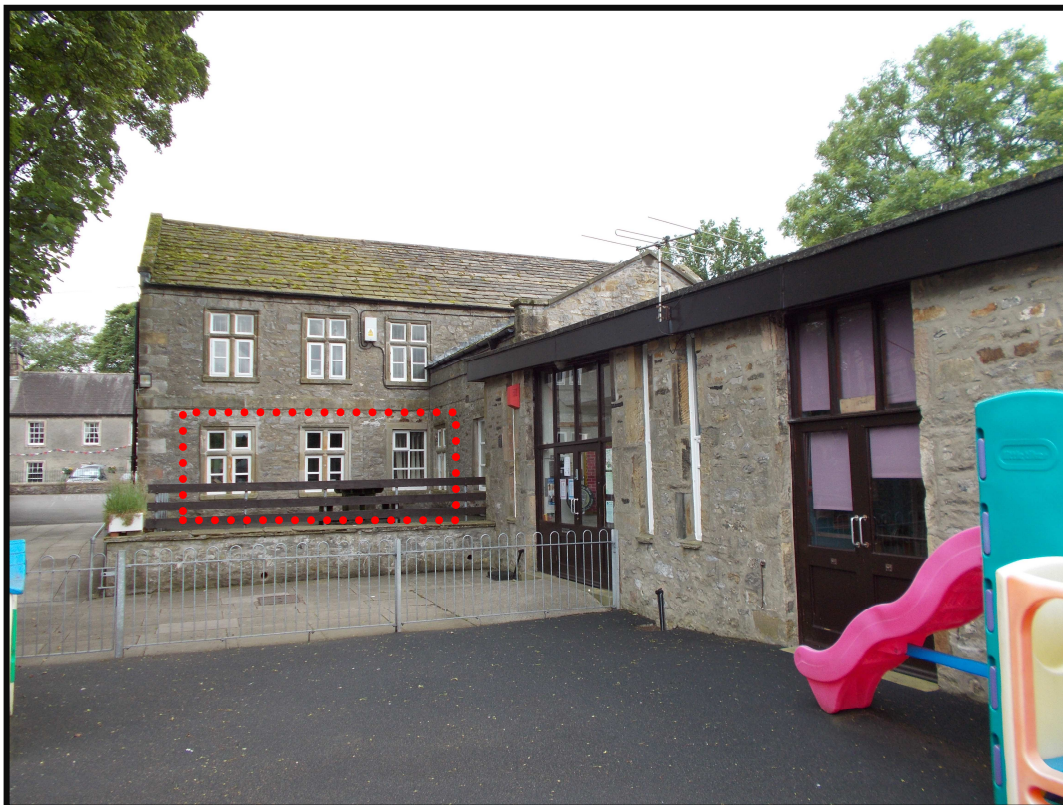
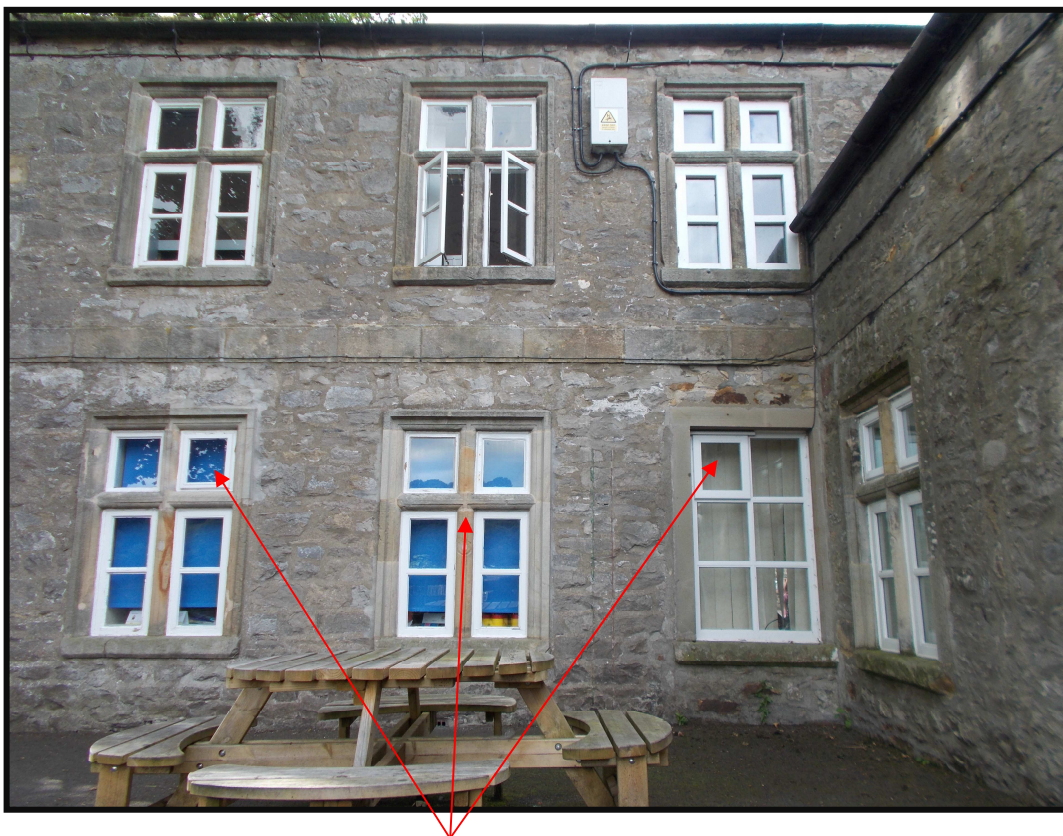
Figure 5 - Represents existing windows which are to be refurbished

Windows to be refurbished and opening lights to be made operable

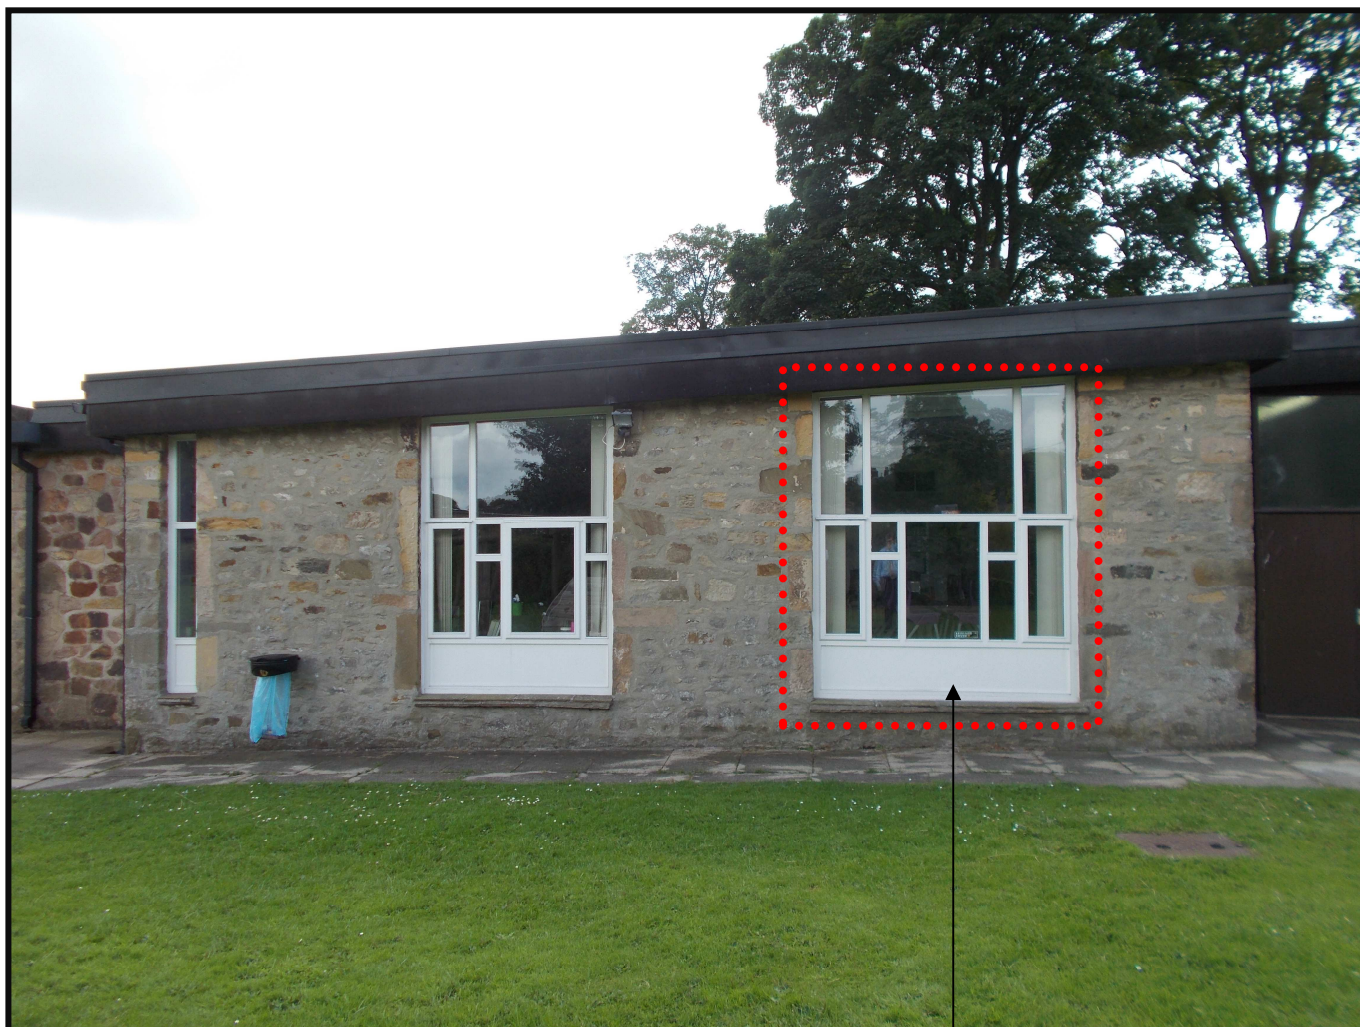
Figure 6 - Represents rear part of property where doors are to be installed which are to lead out to playing fields

Existing hardwood window, frames and stone flag cill to be removed.

New fenestration to have new aluminium double door sets.
