**BAT EMERGENCE SURVEY AT
DOWER HOUSE
PARK ROAD
GISBURN**

**BAT EMERGENCE SURVEY
CARRIED OUT TO SUPPLEMENT THE ORIGINAL SCOPING SURVEY DATED
14th January 2016**

REFERENCE NO. 4966 - A

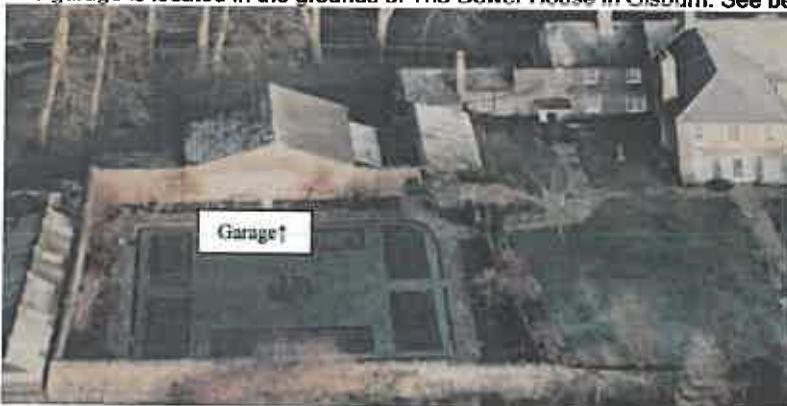
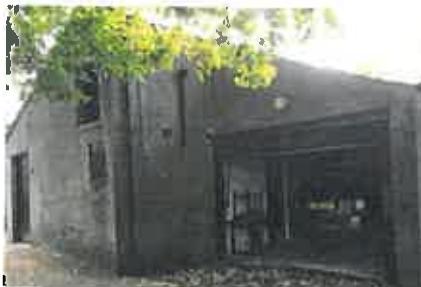
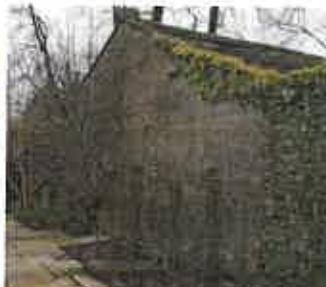
Elevations

The garage is located in the grounds of The Dower House in Gisburn. See below.

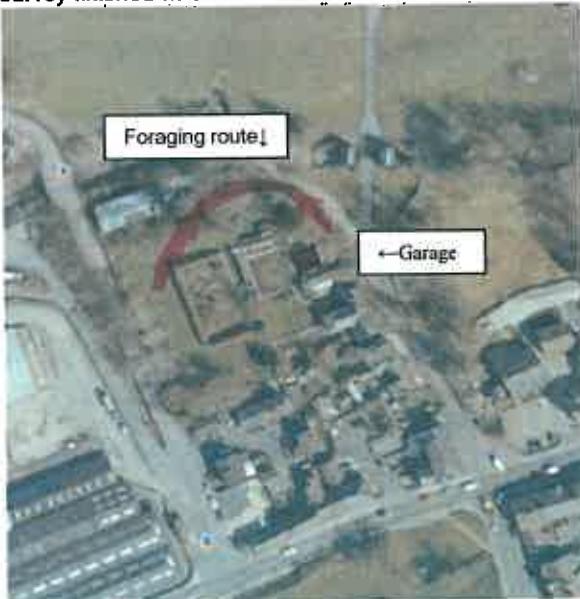
The detector picked up medium level foraging activity at 9.00pm. This activity was not concentrated around the garage it was in the mature tree line on the North west boundary, the red line below indicates the foraging activity. When observing the garage the echolocation signal was weak and no activity in the immediate locality was witnessed, no bats emerged or entered the garage. The foraging activity along the North west boundary involved approx 10no bats appearing and returning from a south west direction, this activity continued until the survey finished when it became too dark to see.
