## Design and Access Statement for Proposed Extension to Roefield Leisure Centre

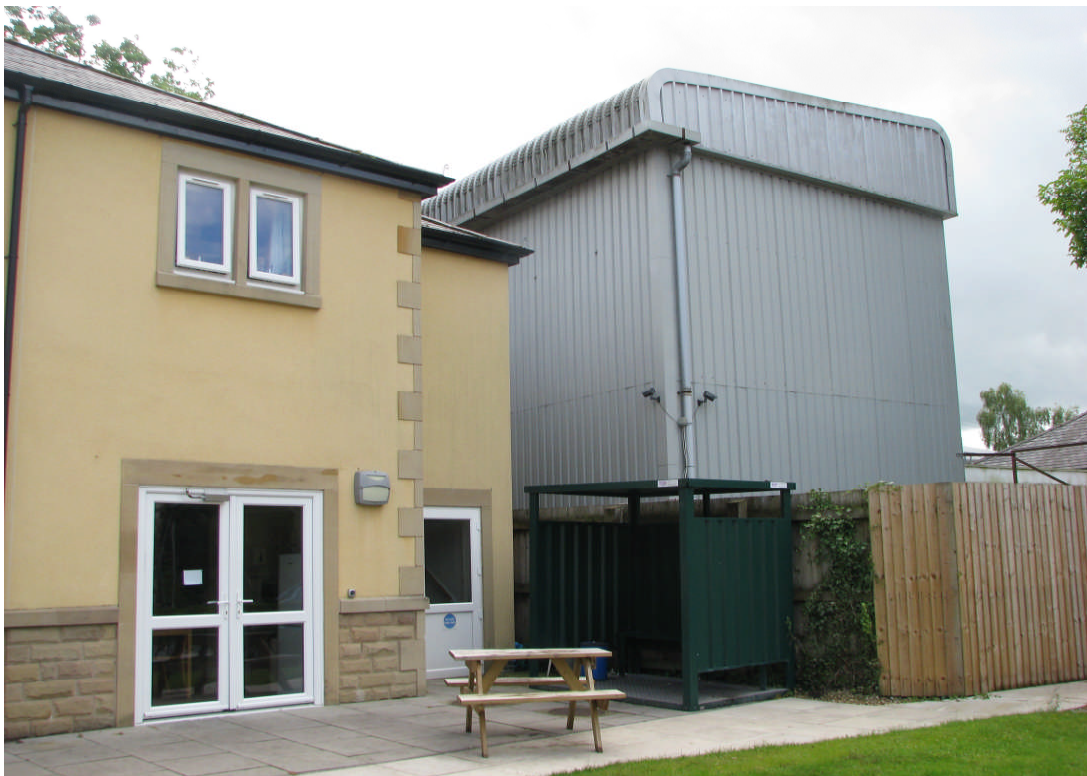
The view from Roefield Specialist Care entrance area

- 1.3 The 2 metre high vertical timber fence obscures the lower part of the buildings, almost hiding the toilet block formed in blockwork and bucket handle pointed. The vertical grey polycoat cladding was used to cover a building with a specific requirement that of housing a climbing wall.

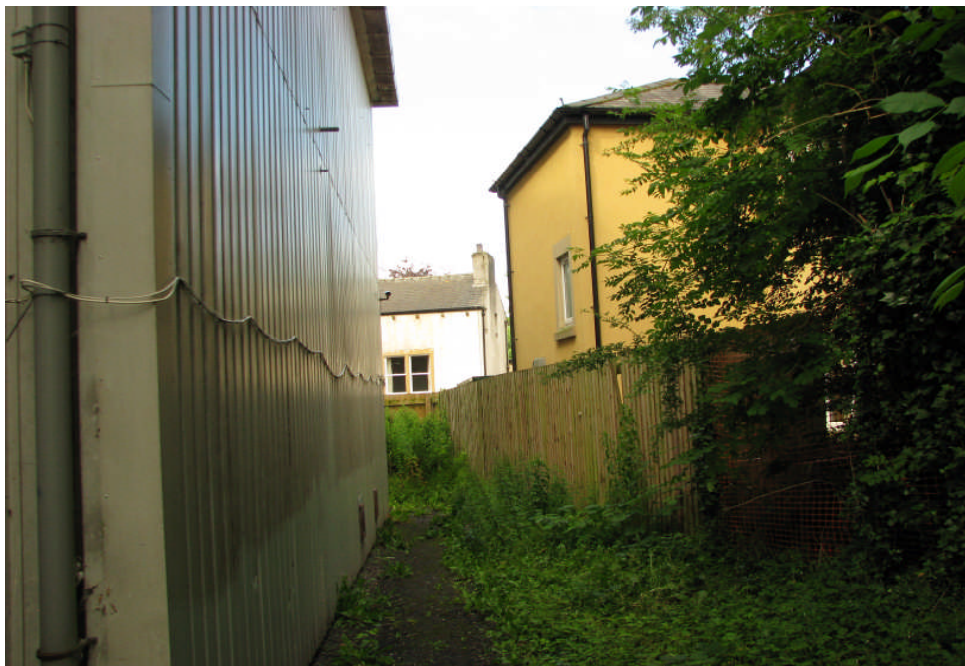
The rear fire escape route

- 3.7 The fire escape runs along the rear of the building at present and is approved by the fire authority so the relocated fire escape door will not reduce the escape conditions.

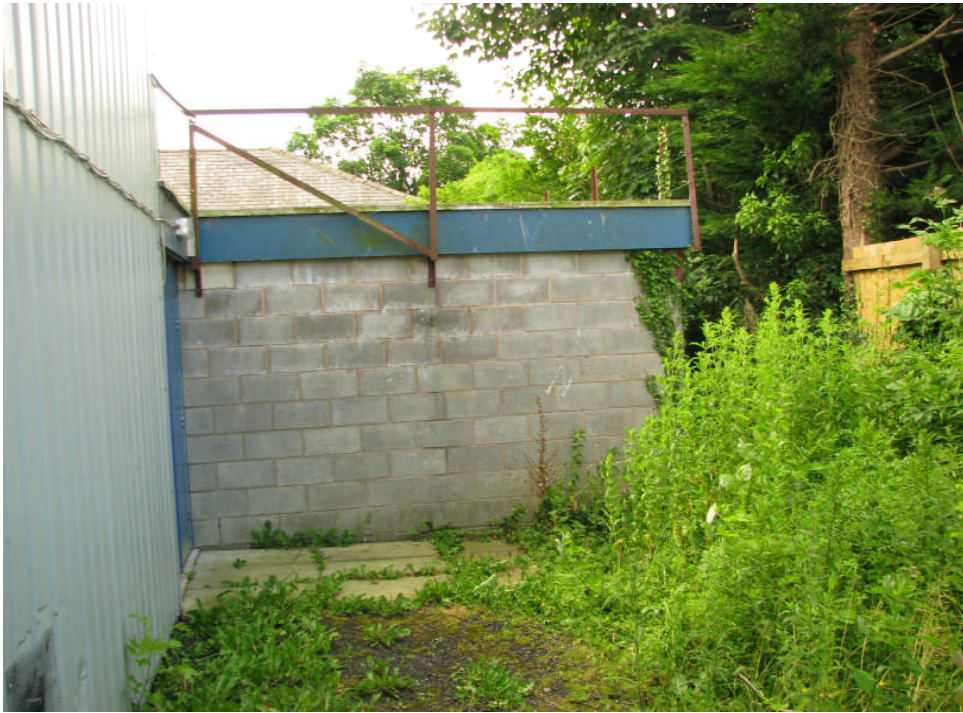
The existing changing room wall and rear service path

- 3.3 The size of the extension is set by the existing walls of the changing rooms and the climbing wall room on two sides and distance from the boundary set by the existing building lines. An increase in size is not practical beyond the building lines due to need for a service passage one way and a fire escape on the other.
