**SITE CONTAMINATION ASSESSMENT
IN CONNECTION WITH
BARN AT HIGHER BOYCE FARM,
RIBCHESTER**

MR M. SELLS AND MISS M. HOWORTH,
HIGHER BOYCE FARM,
STONEYGATE LANE, RIBCHESTER, PR3 3YN

JOB REF: 4874, **DATED:** 28/09/2015, **VERSION:** 1.01.

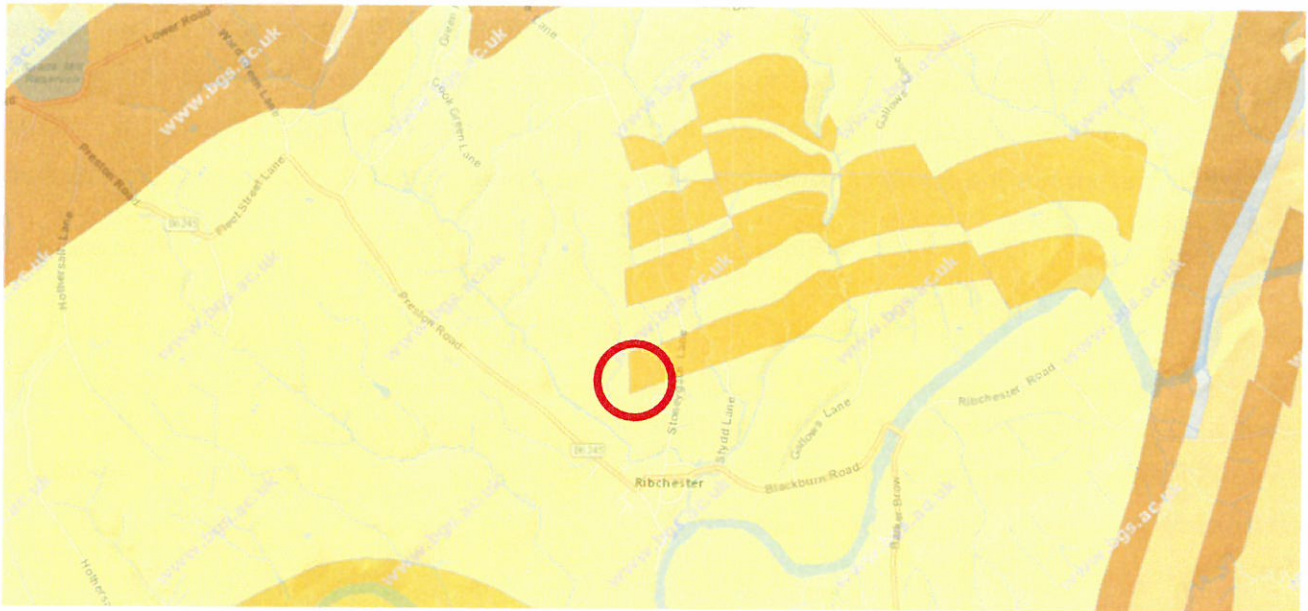
The geology of the application site consists of bedrock comprised of a mixture of Sabden shales in the form of mudstone, siltstone and sandstone. The superficial deposits located above the bedrock consist of a material known as Devensian Glacial Till which is an unsorted rock material which is directly deposited by glacial ice and has no stratification. The map below shows the geology of the site location.

PL01: Extract of a British Geological Survey Map showing the location of the application site.
