**Roof renewal works – Clitheroe Castle Museum Roof**

**Description of works:**

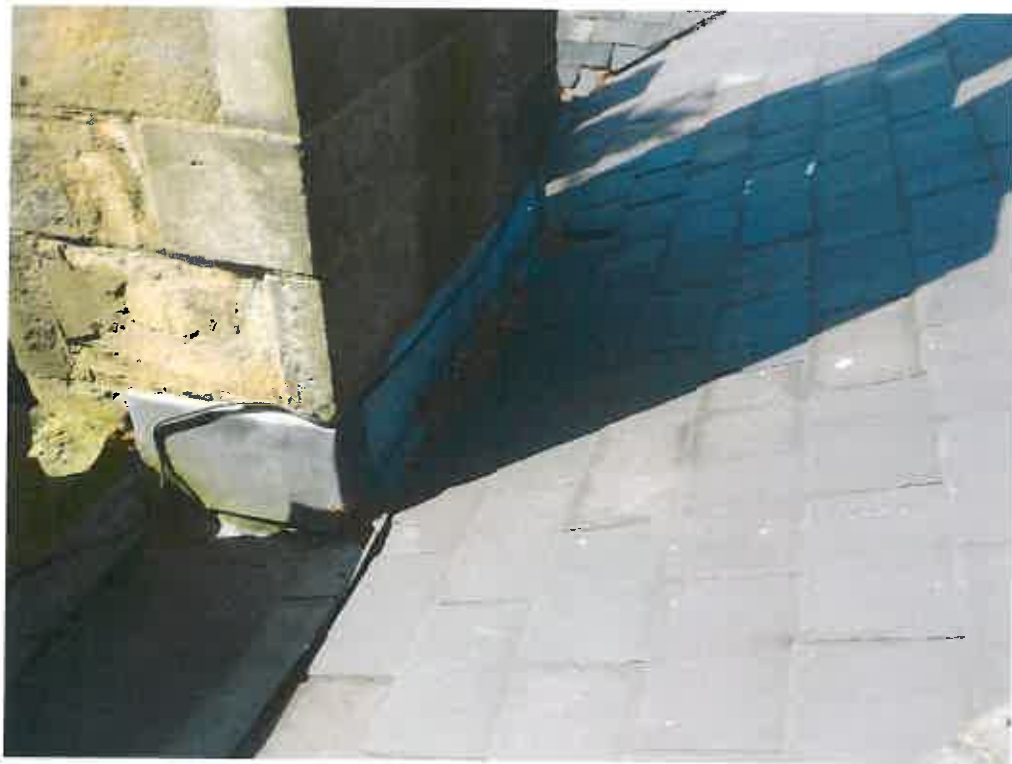
**Figure 1 – shows highest part of the slate. To the sides of the chimney the slates would be in 5 or 6 tiers**

There is evidence of patch repair in the past and different slate types have been used. It is proposed to remove existing slates and retain the slates which are in good condition for reuse. Then to inspect the condition of the felt and replace with new roofing felt if the felt is defective. If new felt is required then replace battens with new battens to the same dimensions and current British Standard as the existing. Re-slate the roof using as many of the existing reusable slates as possible and create a 3 tier band walkway on the lower 3 tiers of the slate to provide a resilient walkway for access to the required areas. The three tiers are proposed to start from the highest point of the slate so at some areas of the roof there may be 5 or 6 tiers in the TAPCOSHAK slates. If there are not enough reusable slates then a like for like replacement of the slates is proposed using the same slates as the existing slates.

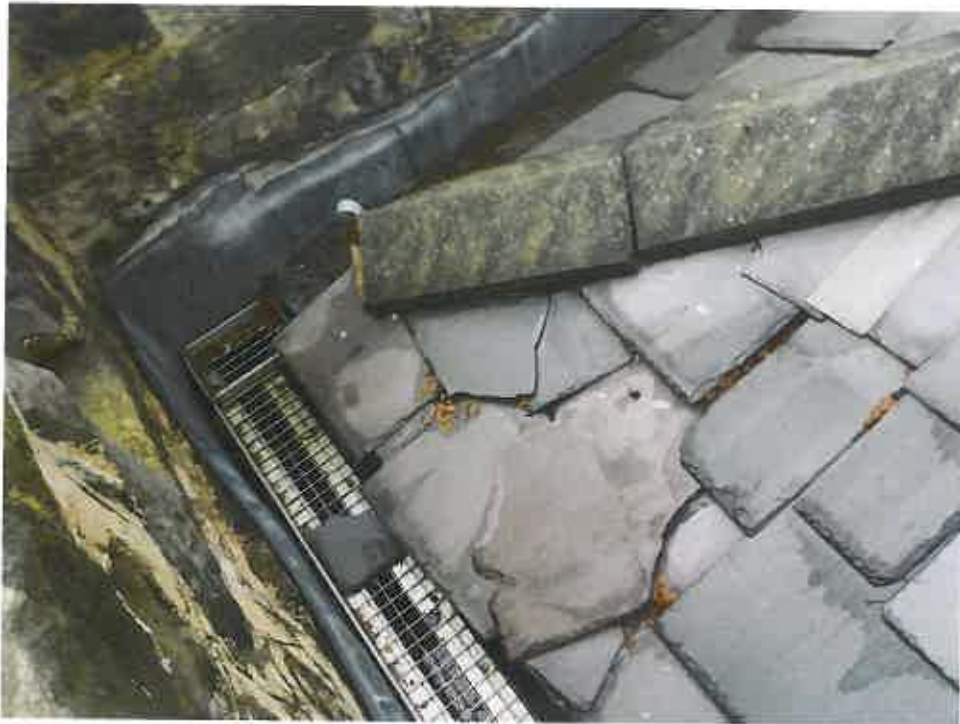
**Figure 2 – Shows damaged slates around the perimeter of the pitched roof in the area of the parapet gutter. It is also clear that different slate types have been used.**

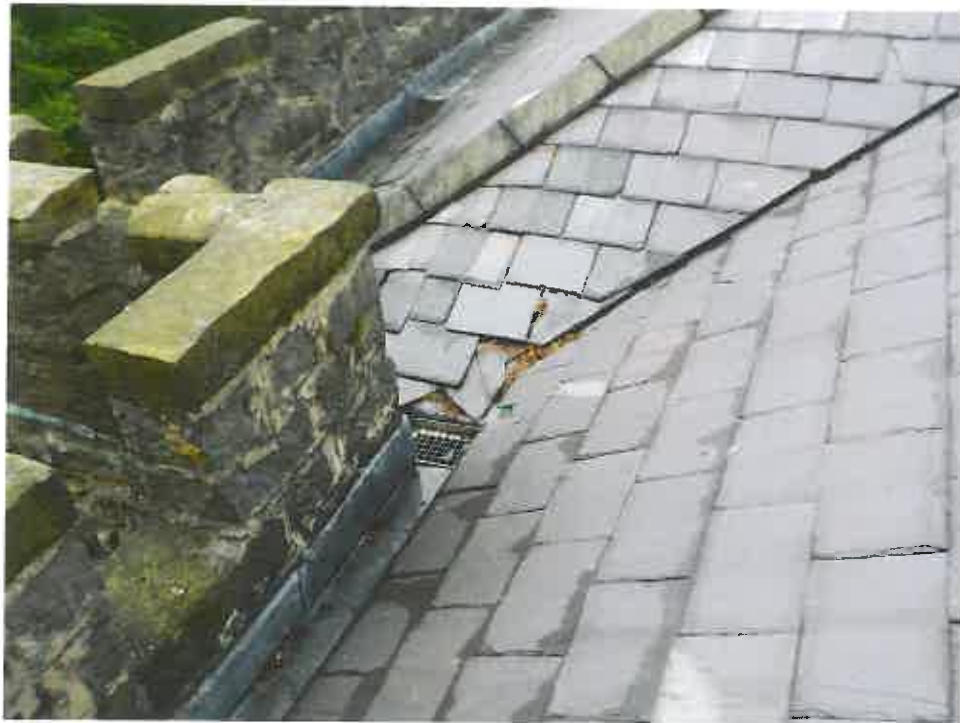
**Figure 3 – further evidence of broken slates and different slate types**
