STATEMENT OF SIGNIFICANCE
Including Heritage Impacts and Mitigation Assessment
Moorcock Inn, Waddington Fell, BB7 3AA

Missrs A & S Thornber

Rev. E. For Issue 12 April 2013

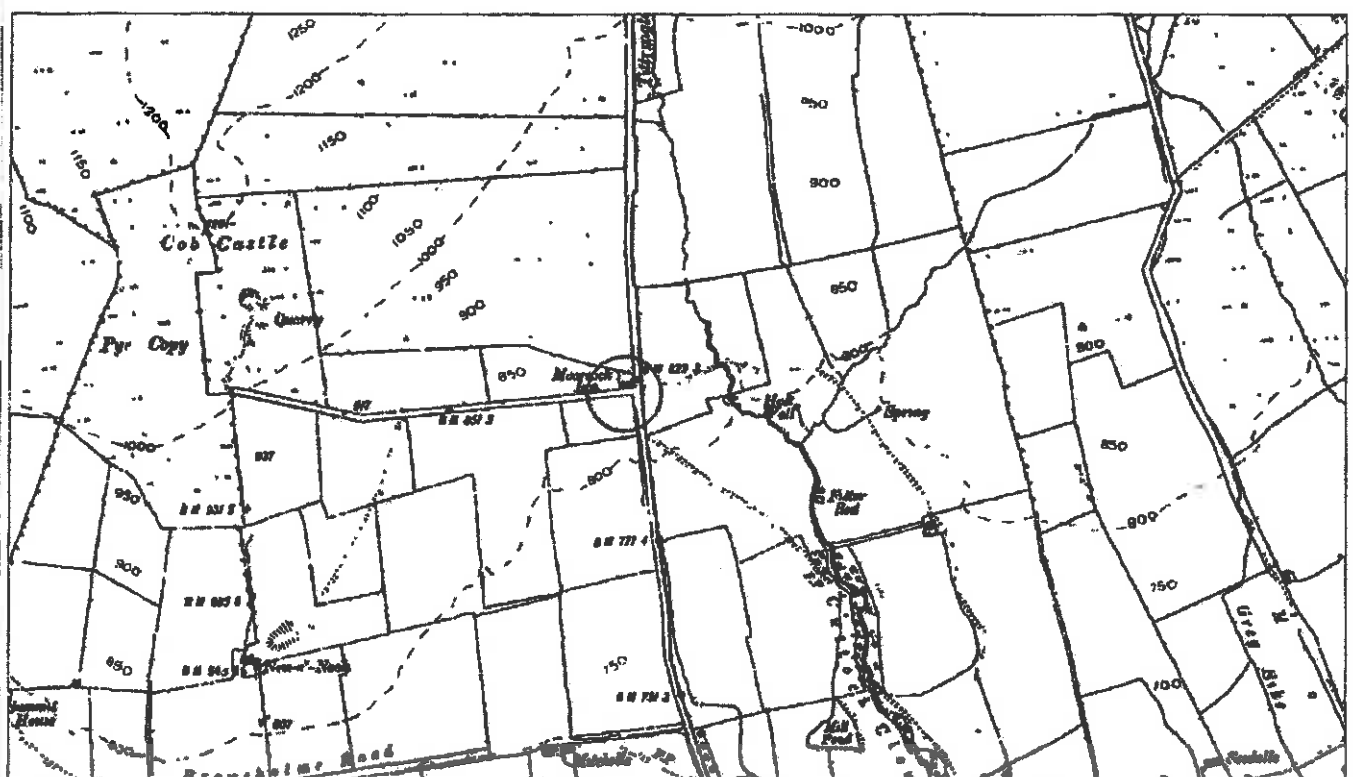
Moorcock Inn 1909

- 2.3 The 1909 map shows the name changed to Moorcock Inn and the paddock or enclosure at the rear is no longer shown. A single storey outbuilding is shown to the rear which is clearly ancillary to the main building and traditionally-built from stone and slate. There is also a lean-to on the east side of the building, possibly to provide travellers with cart storage. Image 5 of Appendix B we believe could be dated between 1890 and 1909 by tallying the name of the building in the photo to the map regression. This image also shows that the east road-facing section (referred to in the footprint analysis as Range B, as not yet being built).

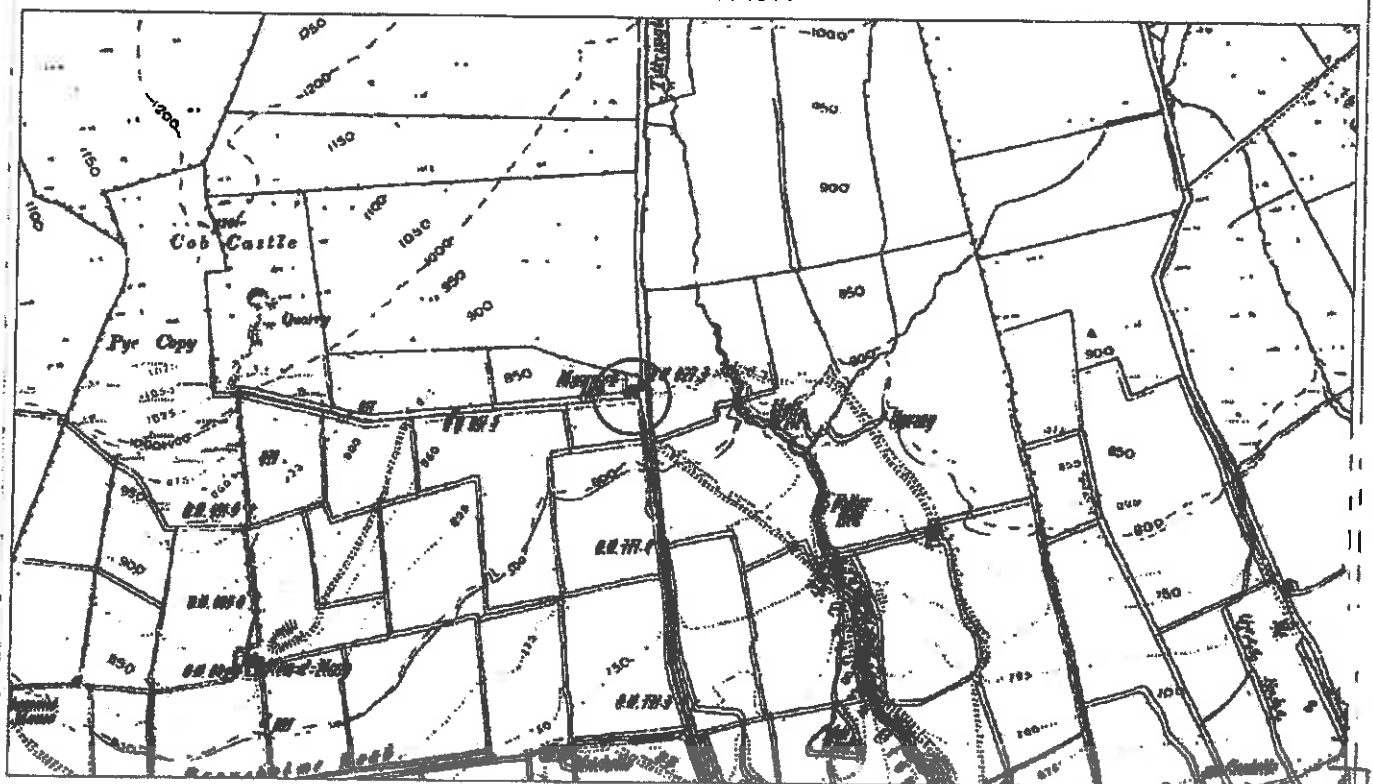
Moorcock Inn 1914

2.9 The quality of the 1914 and 1930 maps are poor and show little change to the building. By 1955 there appears to be a side extension and the chamfered cornered building (Range B) extant. In fact, Image 2 at Appendix B is dated 1925 and also shows Range B as extant. It is fair to conclude, then, that the single storey range to the rear of the old farmhouse (Range A) was demolished and Range B was constructed between 1909 and 1925. This observation is wholly consistent with the observations made on site.
