HERITAGE STATEMENT

FOR PROPOSED REPAIR OF GATE PIERS AND BOUNDARY WALL TO
NEWTON HALL, NEWTON IN BOWLAND, LANCASHIRE , BB7 3DY

REF: 5270 VERSION 1.01 DATE: DECEMBER 2017

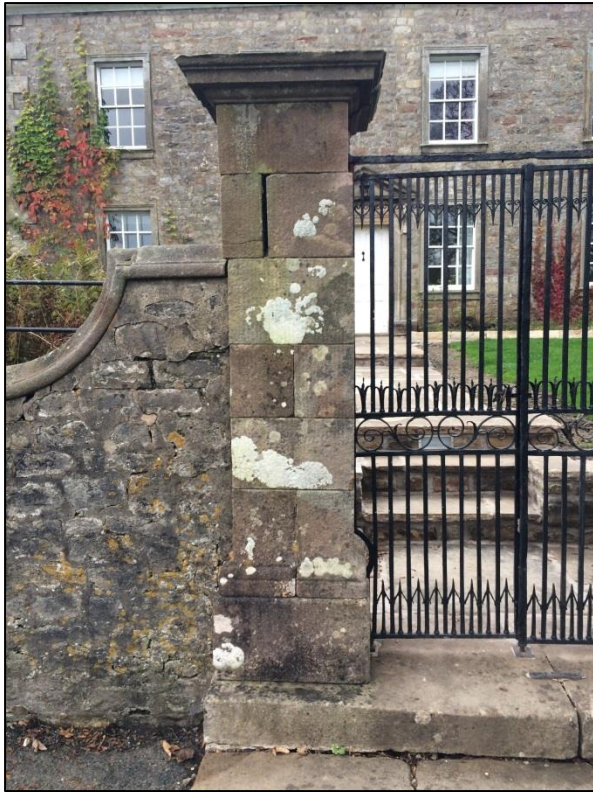
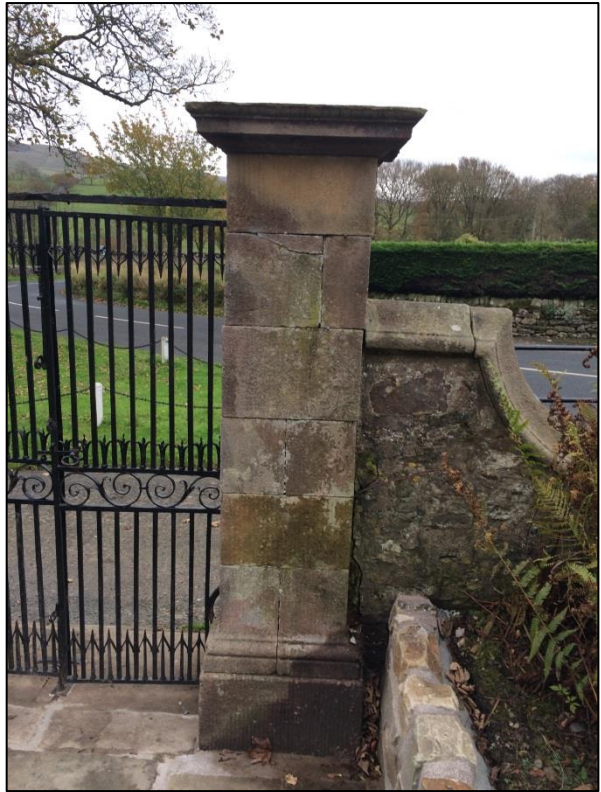
PL01: (Left) South elevation of the west gate pier. PL02: (Right) North elevation of the west gate pier.

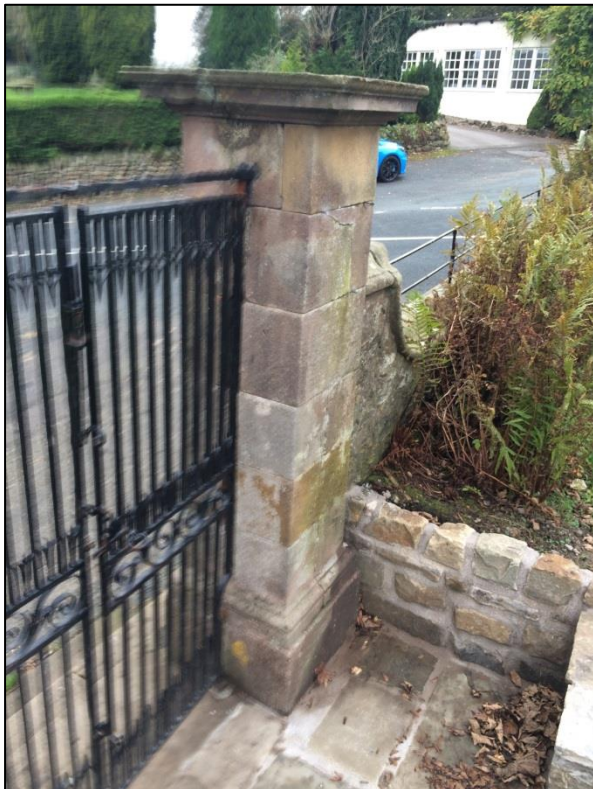
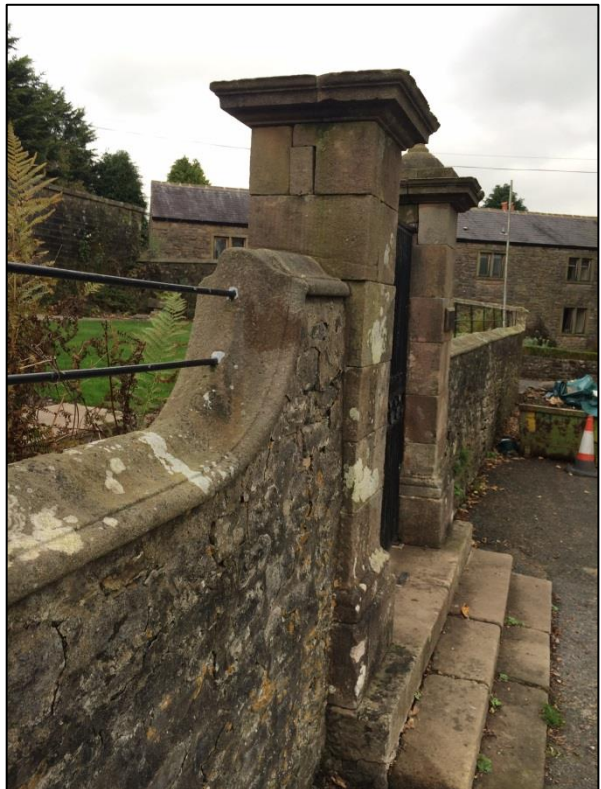
PL03: (Left) East elevation of the east gate pier. PL04: (Right) West elevation of the west gate pier.

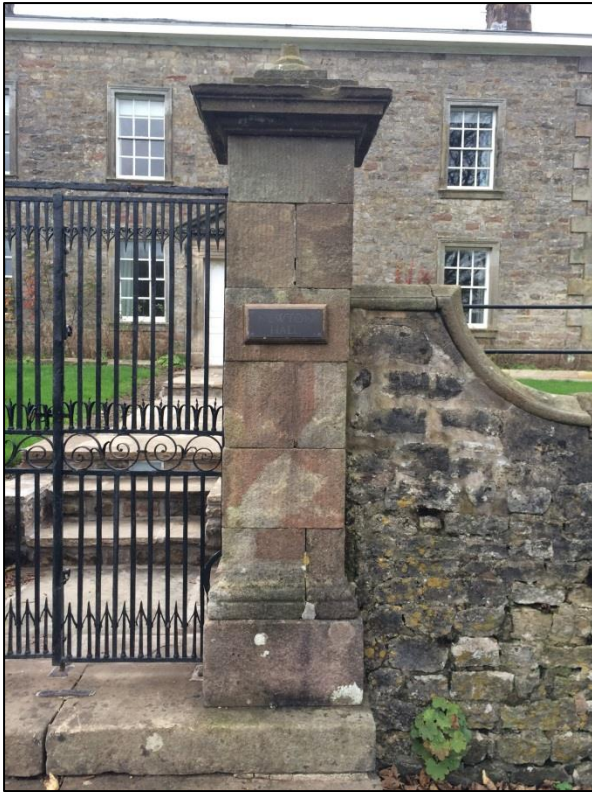
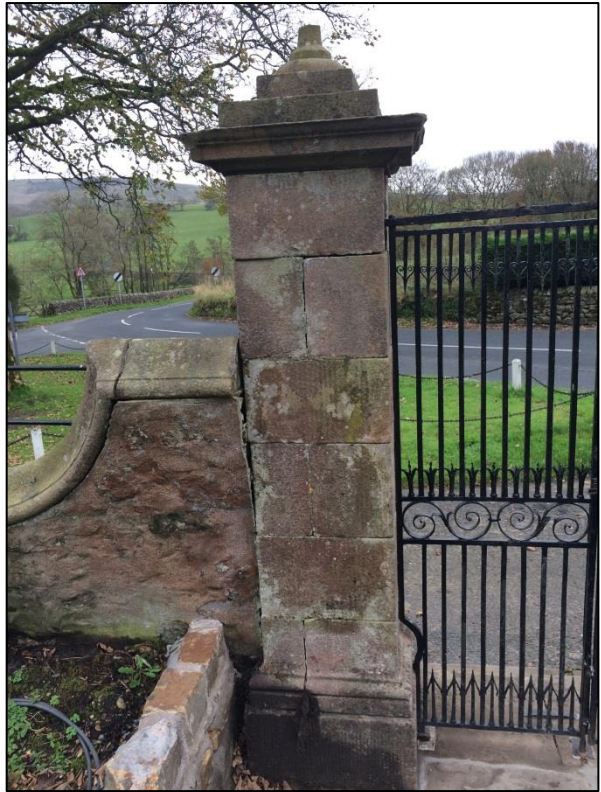
PL05: (Left) South elevation of the east gate pier. PL06: (Right) North elevation of the east gate pier.

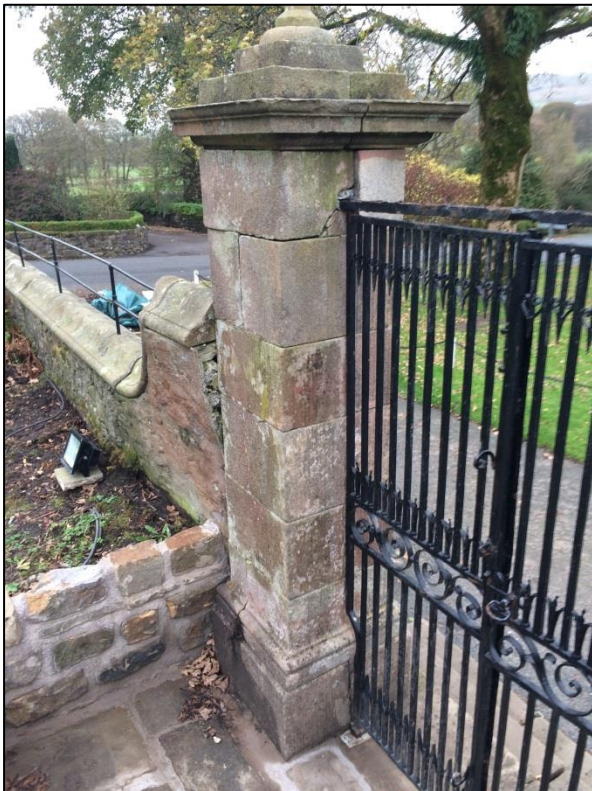
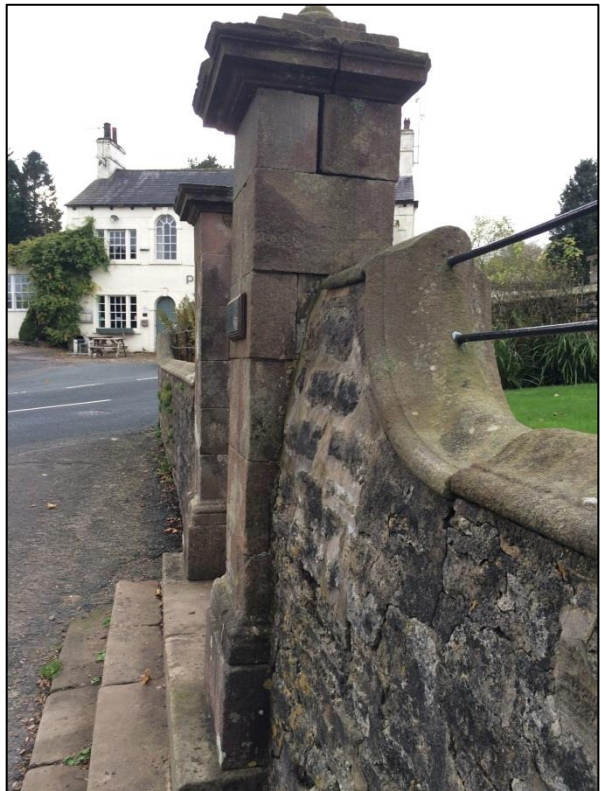
PL07: (Left) East elevation of the east gate pier. PL08: (Right) West elevation of the east gate pier.

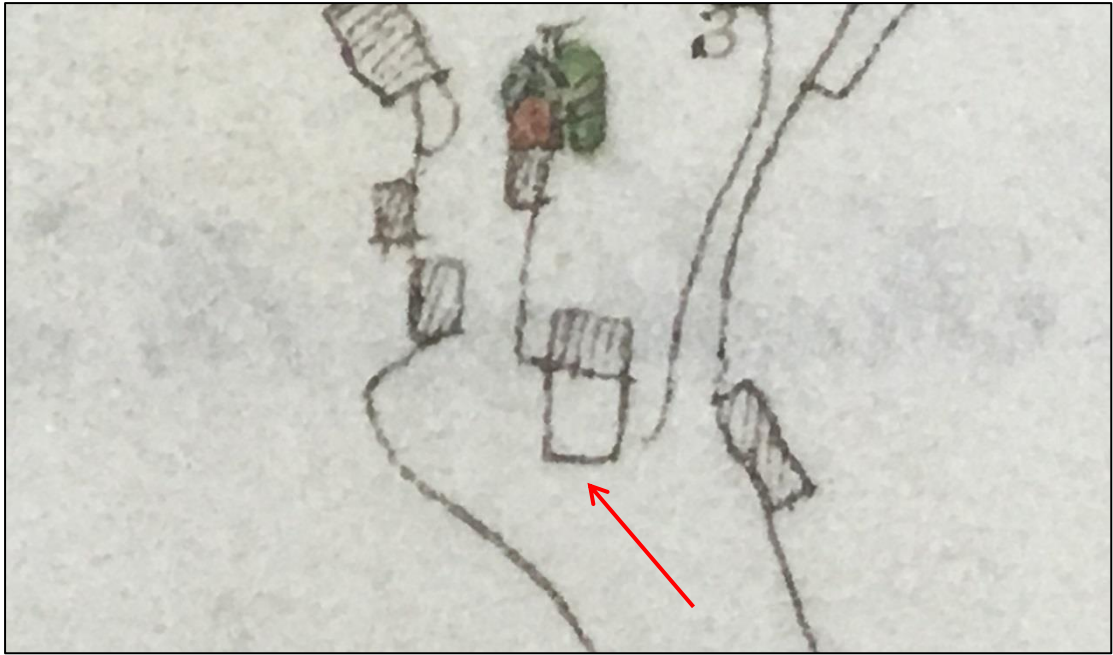
PL09: An extract from a map of Newton in Bowland dated 1765.⁵

The above map of 1765 shows newton hall with a boundary located to the south and it is expected that gate piers and walling were extant at this time as part of the redevelopment and construction of Newton Hall indicating an increased social status for the building.

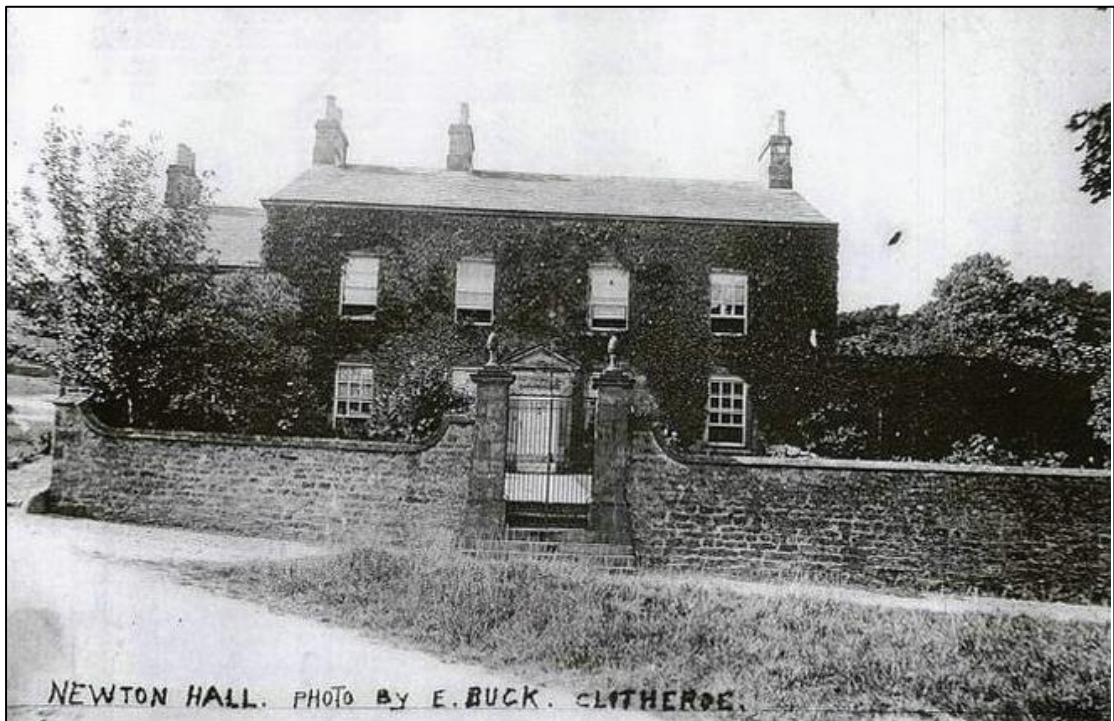
PL10: Early 20th century photograph of Newton Hall.

The photograph clearly shows the gate piers and walls as well as individual stonework and pointing to the walls. The photograph also shows the pineapple finials which unfortunately have since been stolen.

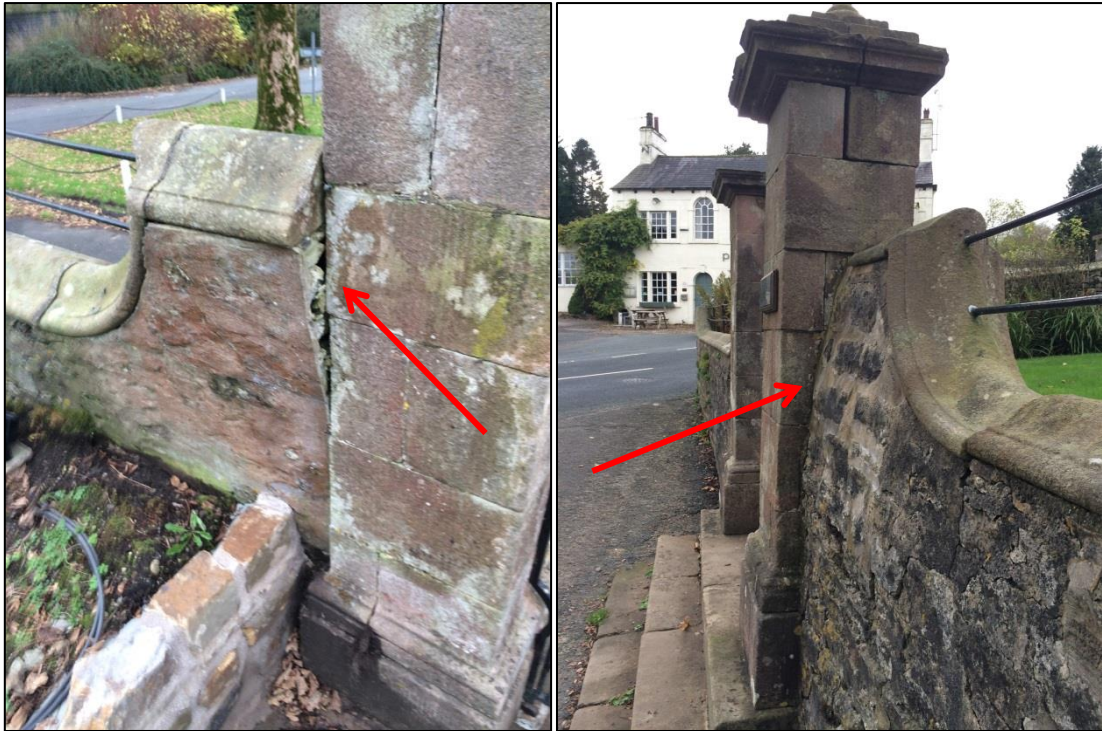
The affected section of wall which abuts the east gate pier is currently leaning and has become unstable as a result. The wall is proposed to be rebuilt as it now presents a health and safety risk to the occupants of Newton Hall and members of the public.

PL13: (Left) and PL14: (Right) discernable lean noted to east section of boundary wall.

Dismantling and subsequent rebuilding of the abutting section of wall to the east gate pier. Existing stonework to the affected section of wall to be re-bed and repointed throughout.

Prior to the dismantling of the affected wall, the affected section of wall is to be raked out in order to remove the existing cement mortar pointing from the wall surface. Raking out of existing masonry is to be strictly done by hand using the correct hand tools i.e. a mason's quirk. Under no circumstances should mechanical methods of removal be used in order to prevent damage to the stonework.

Each individual stone is to be clearly numbered and its orientation and finished face is to be clearly marked and clearly identified using an appropriate reference number. This will allow the stonework to be erected back in its original order, orientation and finished face. Once numbered, or during numbering, the wall is to be photographed so that each stone can be accurately re-bed into its corresponding place as part of the rebuilding of the gate piers. Photographs are to consist of overall and detailed photographs and should be carried out by the contractor to the satisfaction of the local authority conservation officer. Each stone is to be numbered with a durable medium that will not be easily removed but can be removed when required, such mediums include chalk, HB pencil or water soluble paint, but this will depend on the hardness and texture of the stonework. Each stone is to be carefully cut out and removed by hand and through the use of hand tools. No mechanical equipment is to be used in order to dismantle the wall in order to minimise any potential damage to the

The dismantled section of wall using the dismantled stonework in the order that the stonework was dismantled in using photographs as reference. All stone are to be laid on to a clean and clear surface of the stone below. All rebuilding is to be carried out using a Hydraulic Lime Mortar 1:3 using moderately hydraulic lime NHL 3.5 and well graded aggregates from 2.5mm to 75 microns. All aggregates to be to BS EN 13139:2002 and to be well graded, non – staining, clean, sharp, coarse sand and be uncontaminated by clay and silt (Provisional specification only). All rebuilding work will be carried out during a period of suitable weather so as to avoid periods of high and low temperatures.

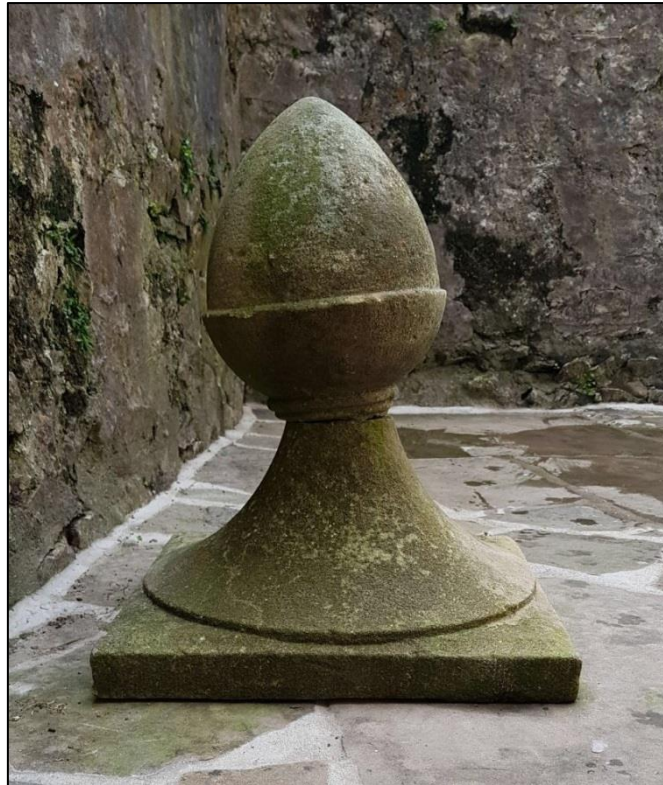
It is proposed that reclaimed acorn finials are installed to the top of gate piers in order to replace the previously stolen pineapple finials.

PL11: Proposed reclaimed acorn finial.
