**BAT SURVEY AT -
21 HUMBER STREET
LONGRIDGE
PR3 3 WD**

**DATE AND TIME OF VISIT
10th Dec 2017 2.00pm**

REFERENCE. Mr and Mrs Berrington

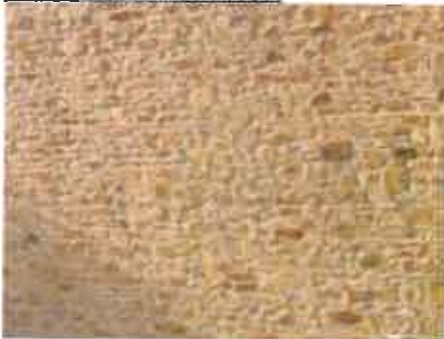
The walls are random natural stone, dressed stone to the front elevation.

The walls and pointing are all in perfect condition, with no cracks or crevices which bats could enter.

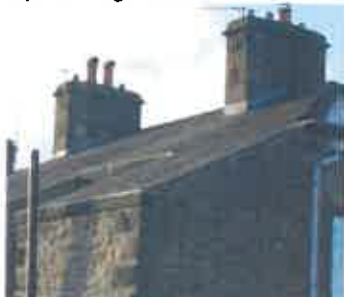
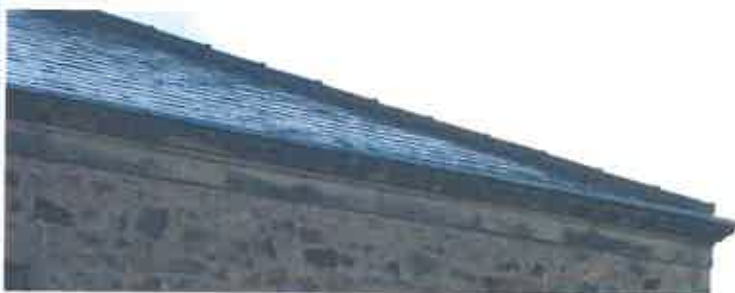
The roof is pitched with a hip to the gable and a lean -to over the outshot to the rear. The finish is blue slate with hip and ridge tiles. There is a stone gutter detail to the front and side elevation.

The roof appears (observed from the ground) to be in excellent condition all the slates are tight fitting the ridge and hip tiles are well pointed and in good condition. The chimney flashing also appears in very good condition.

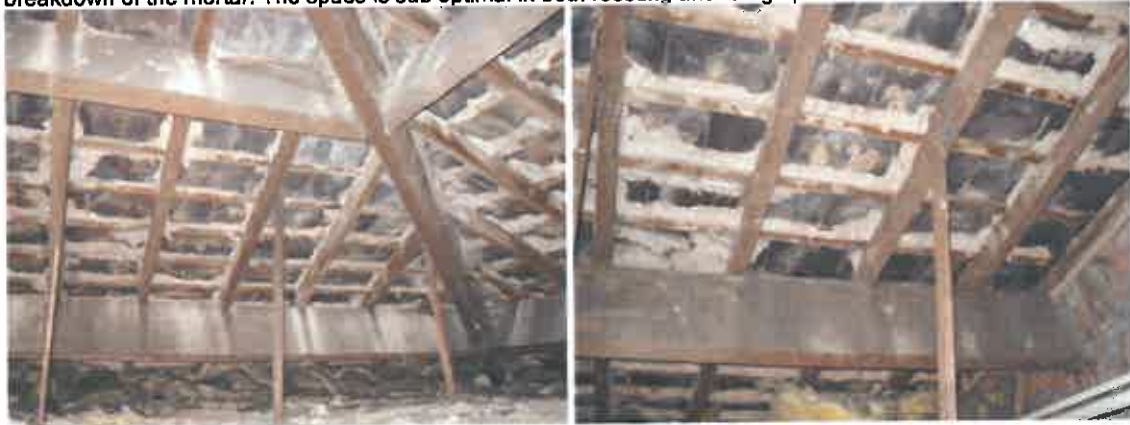
The roof construction is timber purlins, hip rafters, rafters and battens the slate is pointed on to the timbers. The timbers are in reasonable condition with no rot, cracks or crevices. The space is dusty formed with the breakdown of the mortar. The space is sub optimal in both roosting and forage potential.
