Arboricultural Constraints Appraisal

in Relation to Proposed Construction
of Detached Residential Property at

**Pyethorn Meadows, 150 Whalley Road,
Wilpshire, Lancashire, BB1 9LJ**

September 2018

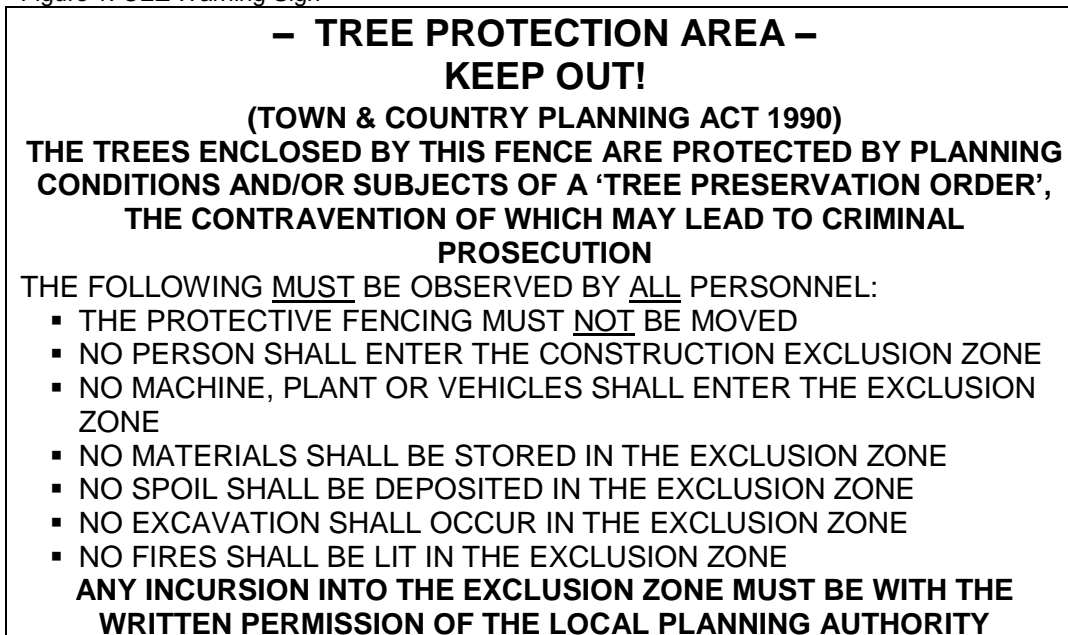
Figure 1: CEZ Warning Sign

8. be affixed with a 600mm x 300mm warning sign reading "TREE PROTECTION AREA KEEP OUT" (see Figure 1, below), at every 10.0 metre length of protective fencing.

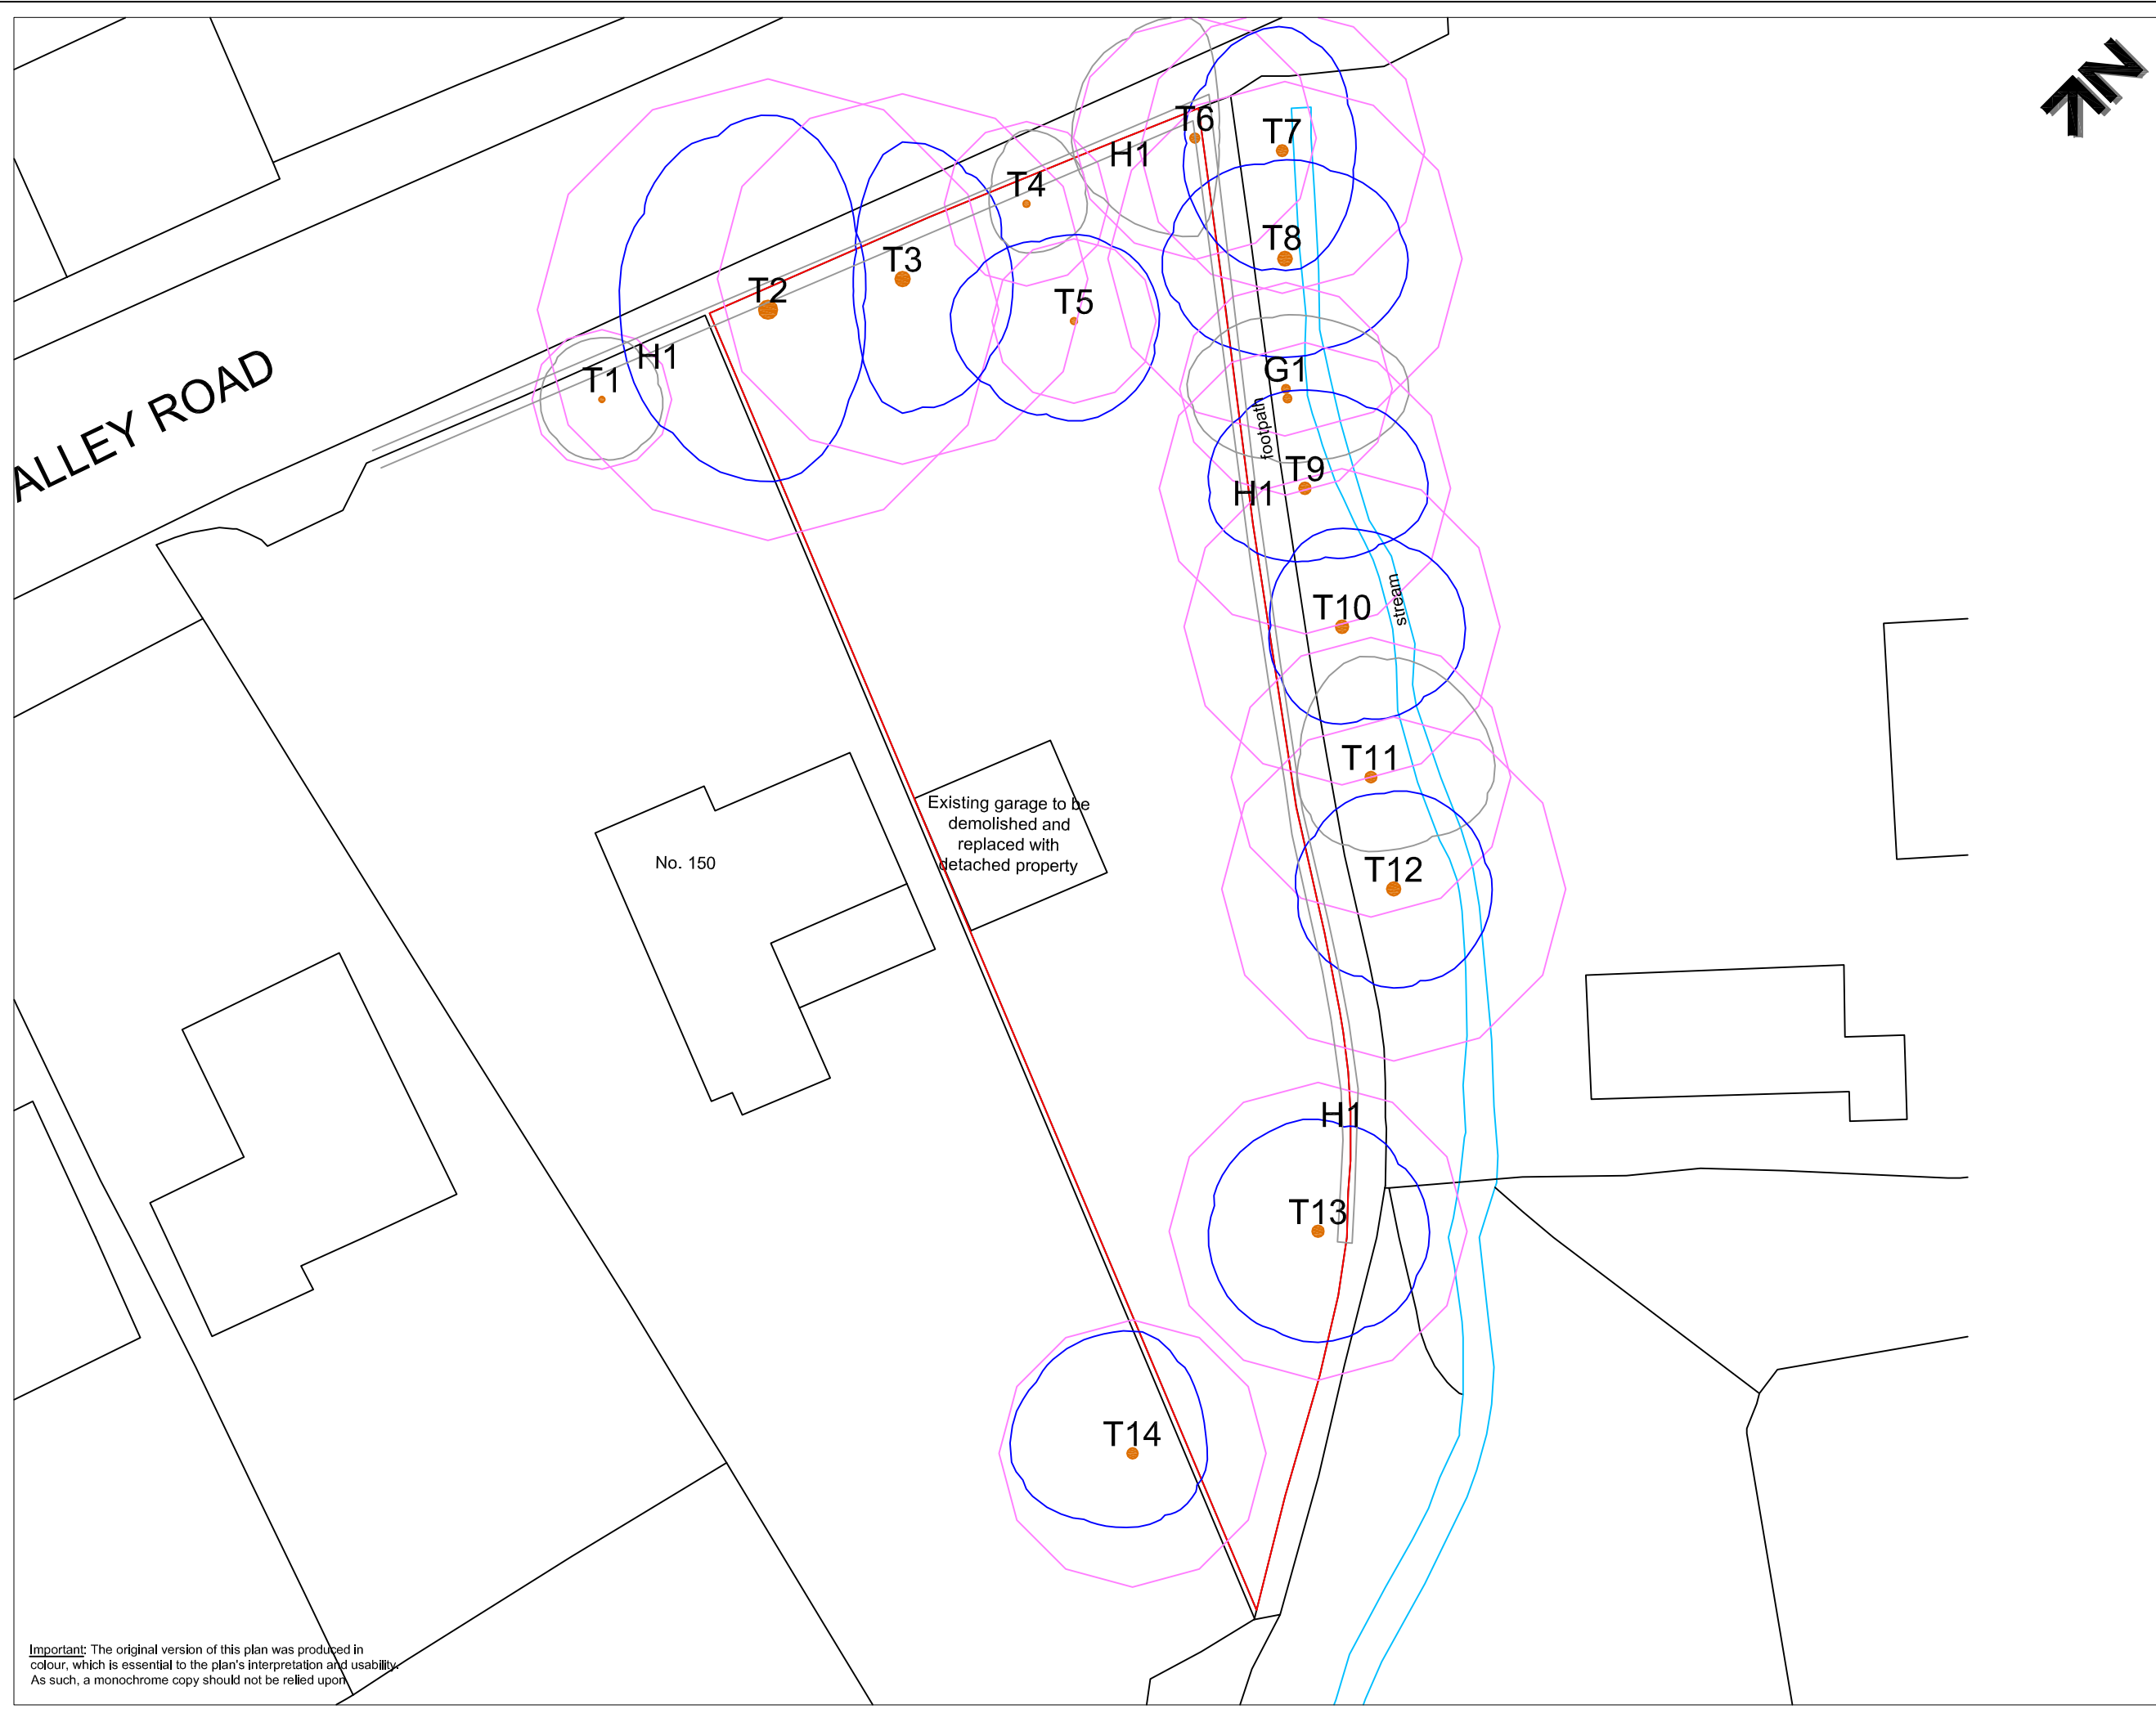
Title:
TREE CONSTRAINTS PLAN
 In Relation to Proposed Construction of Detached Residential Property

Note: The tree stem locations were not included on the Ordnance Survey based site plan(s) provided, and were subsequently plotted by the arboriculturist at the time of the survey, using GPS and, where possible, measurement from existing site features. As such, the locations of the trees cannot therefore be considered to be entirely accurate

- RPAs
 Area(s) of Ground Around Trees that Should be Protected Throughout Development Works with Protective Fencing to form a Construction Exclusion Zone - see Temporary Protective Fencing Specification
