project:
Brabins Almshouses, 29Windy Street, Chipping, Lancashire

drawing title:
Rear Elevation - Slobbered Render

scale: 1:50 at A2		
drawn: LM	checked: CB	
date: July 2018		
project no. 1608	drg. no. 05	rev. -

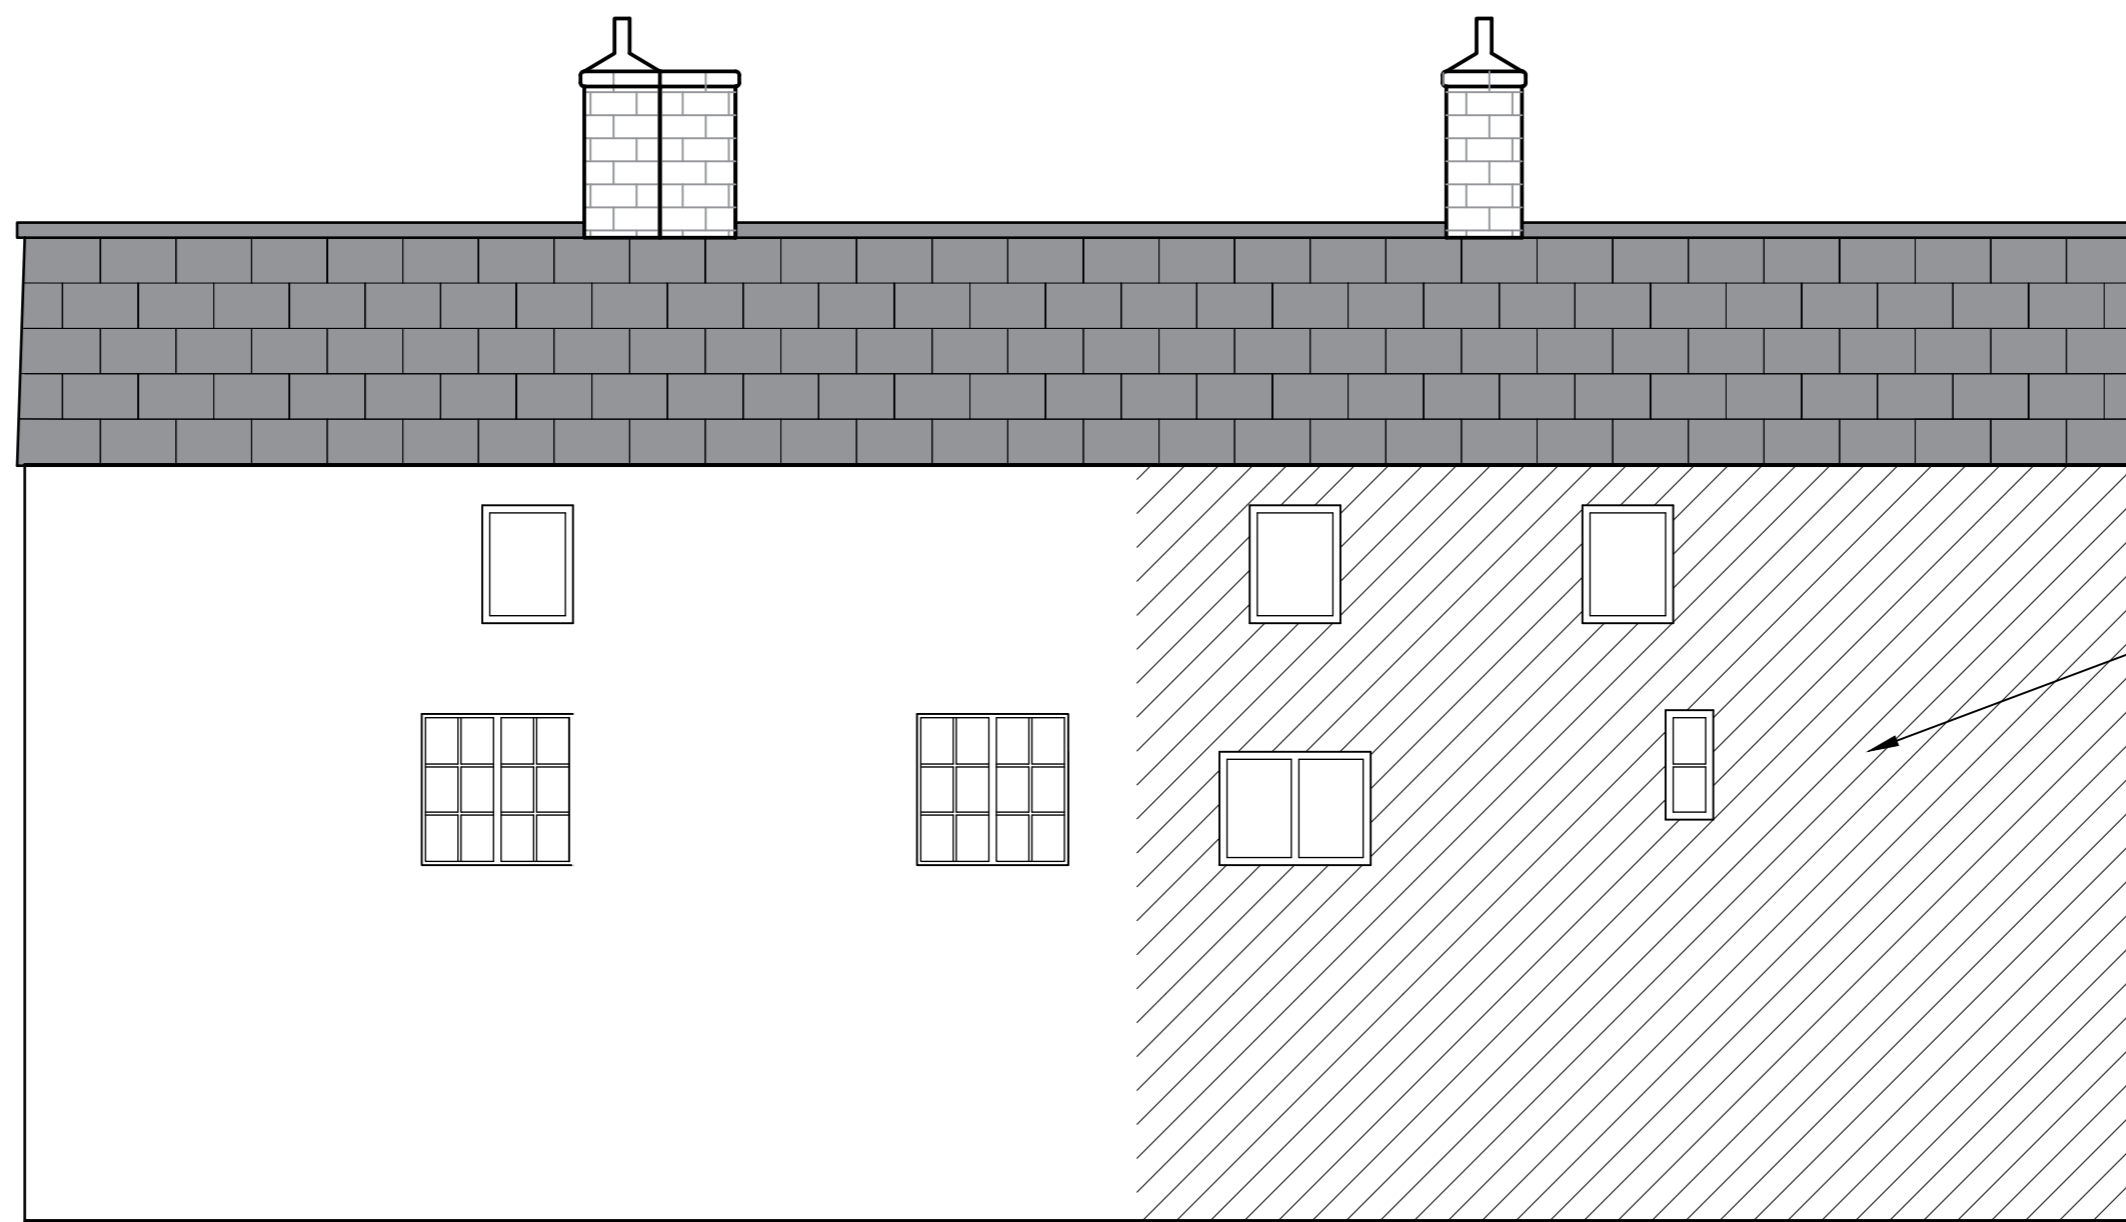
Rear Elevation - Slobbered Render
(Scale at 1:50)

Highlighted area of works to slobbered render

Works to Slobbered Render at Rear Elevation

Carefully rake off defective cement/lime based mortar from masonry face and joints until all cement based material is removed, ensuring that the top/bottom shoulders of the joints are well recessed. Heavy machinery and angle grinders should not be used in order to reduce the risk of damaging the original stonework. Joints should be thoroughly cleaned with clean water using brushes or a low pressure hose. All loose materials, dust and debris must also be removed to avoid issues with the joints. Once the wall is pointed with recessed joints, the lime should be 'slobbered' over the face of the rear elevation. This should be similar to a thin layer of render, making sure that the sandstone rubble masonry is not completely covered with the faces of the rubble stones still visible. The existing is a good example of this and other pictures can be provided.
