Design and Access Statement for Proposed Extension to Roefield Leisure Centre

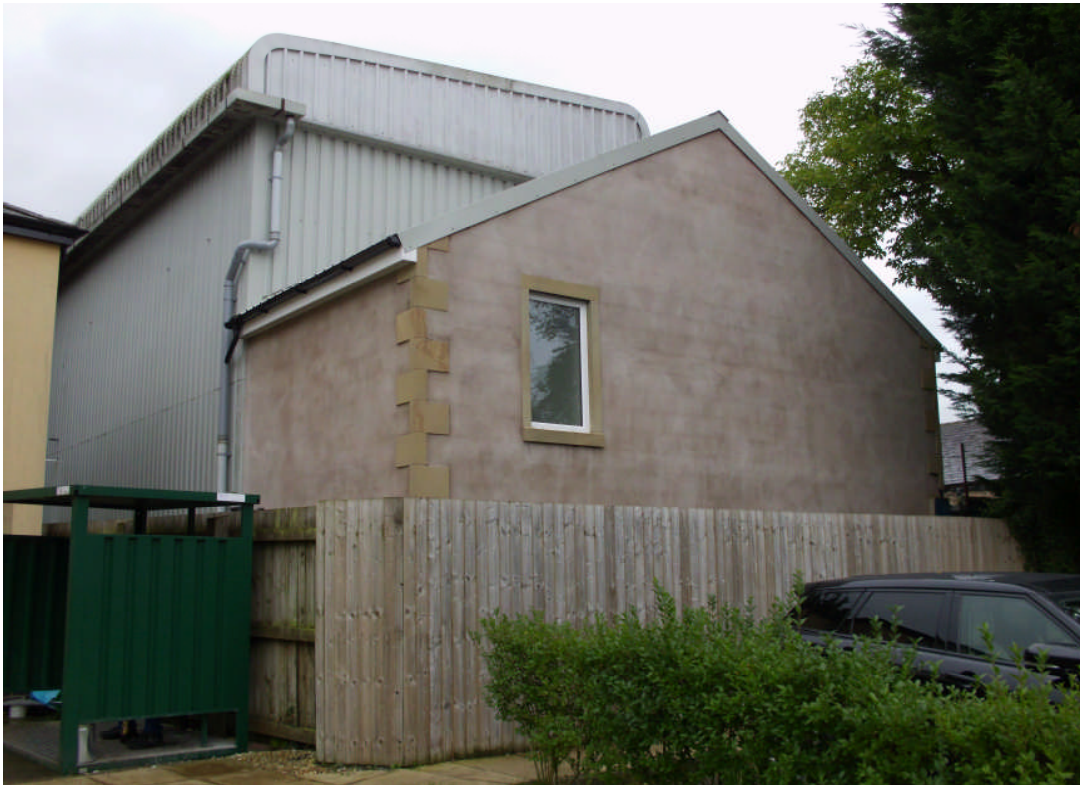
The view from Roefield Specialist Care entrance area

- 1.3 The 2 metre high vertical timber fence obscures the lower part of the buildings, almost hiding the toilet block formed in blockwork with bucket handle pointing. The vertical grey polycoat cladding was used to cover a building with a specific requirement that of housing a climbing wall. The latest extension is of block construction, rendered with quoins and a grey polycoated steel roof, blending from industrial feel of the Climbing wall unit and the walls into the elevation of the Care home adjacent.

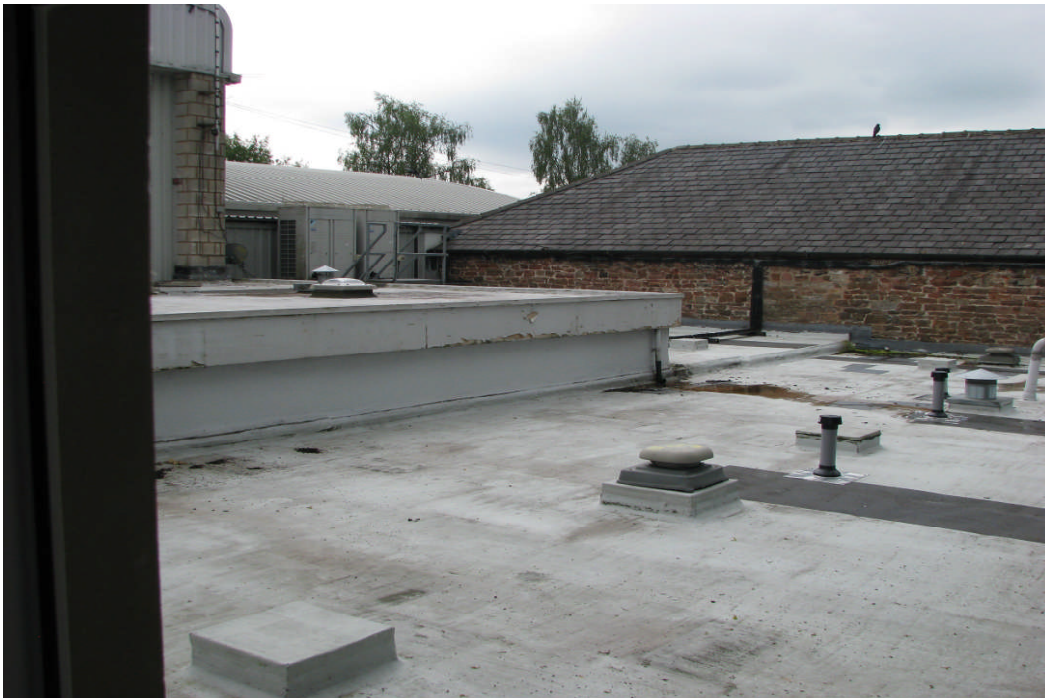
- 3.1 Based on the requirement of membership pressure for more gym and exercise space. It was decided that we could form an open space over the single storey section to the rear of the former Barn.

Existing roof area

- 3.2 The proposed location of the extension to form the open space and addition sporting facility is situated at the rear of the Climbing wall building and the existing changing block. i.e. the north west part of the site, adjacent to the boundary fence with Roefield specialist care.
- 3.3 The size of the extension is set by the existing walls of the barn/gym and the climbing wall room on two sides and distance from the boundary set by the existing building lines.
- 3.4 The choice of construction material to form the new extension is based on adjacent materials used on the existing structures. The floor loading will need to be evaluated to ensure it is structurally capable to carry the chosen weigh requirement.

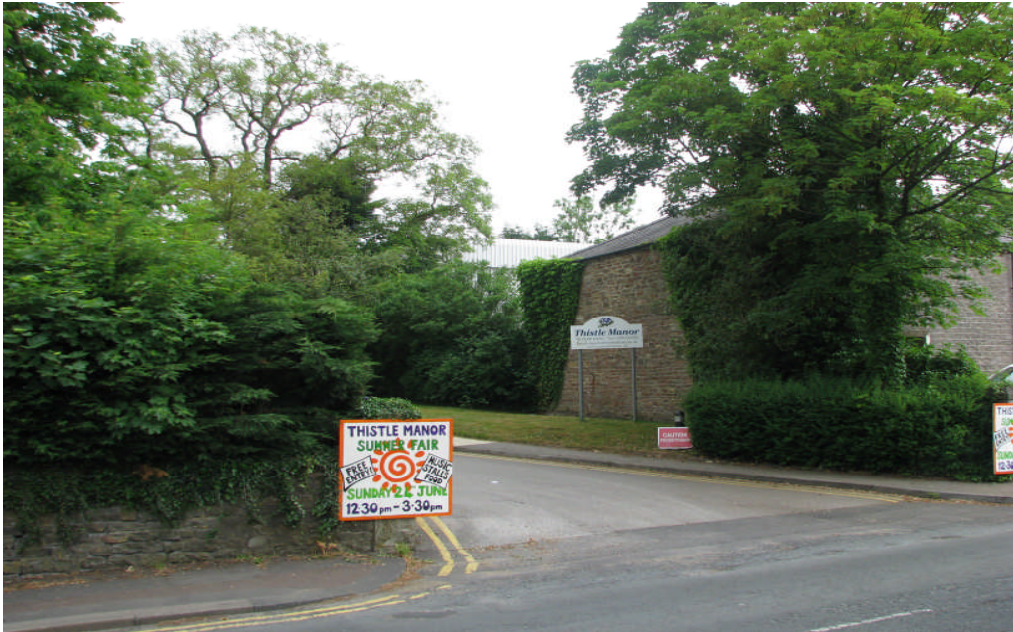
- 3.5 Firstly we would form a pike gable end on the wall of the existing barn in matching local stone outer skin, a 100mm cavity and a pointed block interior. We would form in block and render the western side elevation, paint grey to match the Leisure centre polycoated steel giving a colour blend into the existing metal gable end but with a style to match the adjacent buildings. The roof would be in polycoat steel to tie into the ex gable wall.

View from Edisford Road

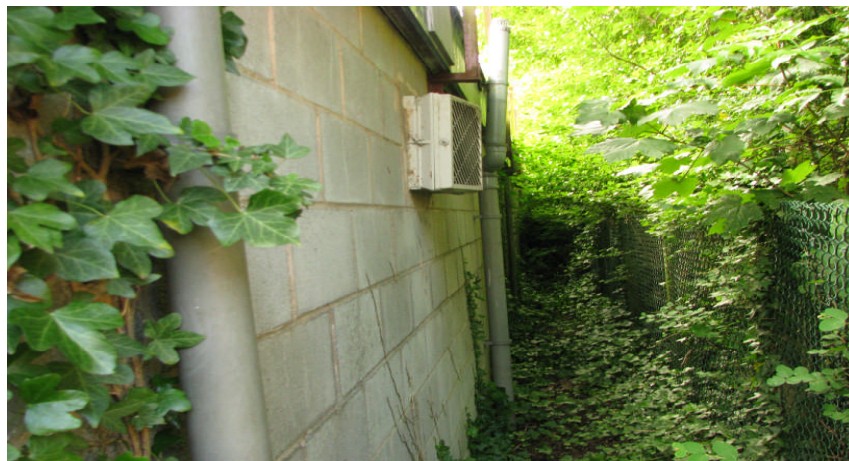
- 3.6 The ground floor elevations will have high level extractor fans from the toilets and a fire door out onto a steel fire escape formed in the existing side space. The first floor will have windows for natural light on the western elevation. The gutters and rainwater pipes to be in grey PVC.
- 3.7 The fire escape runs along the rear of the building at present and is approved by the fire authority so the located of a fire escape door and steel external staircase will not reduce the escape conditions.

Passage for proposed fire escape
